To: Dan Crawford, Port of Tacoma
From: Suzanne Dudziak, Greylock Consulting LLC
Date: March 10, 2014
Re: Sampling & Analysis of Building Materials at 4918 & 5024 Marine View Drive,
Tacoma, Washington on February 25, 2014

subject: PIONEER PSA: 069750 Task Order #04: Marine View Drive Properties Hazardous Materials Assessment

Hazardous Materials Survey

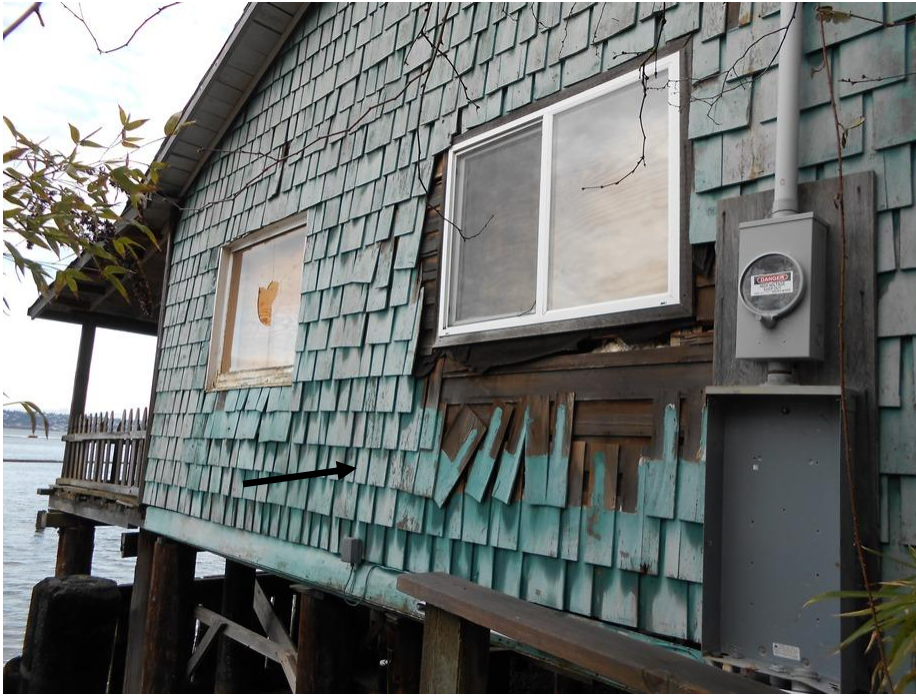
1. Sample 4918-22514-1 Green Shingles

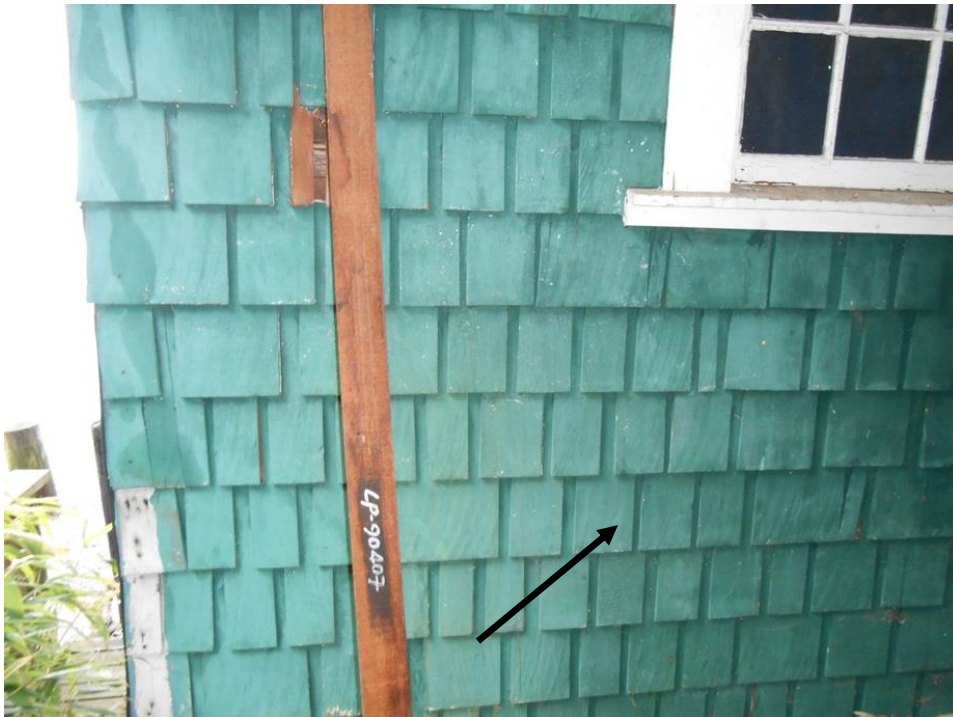
2. Sample 4918-22514-2 Green Shingles

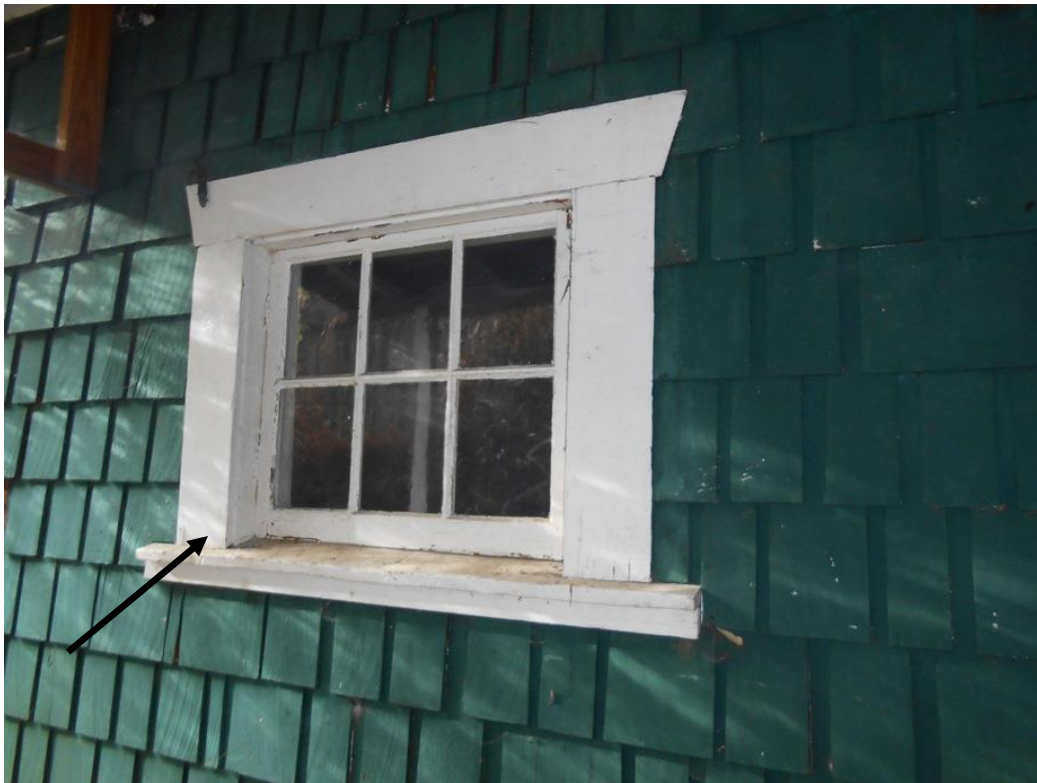
3. Sample 4918-22514-3 White Window Framing

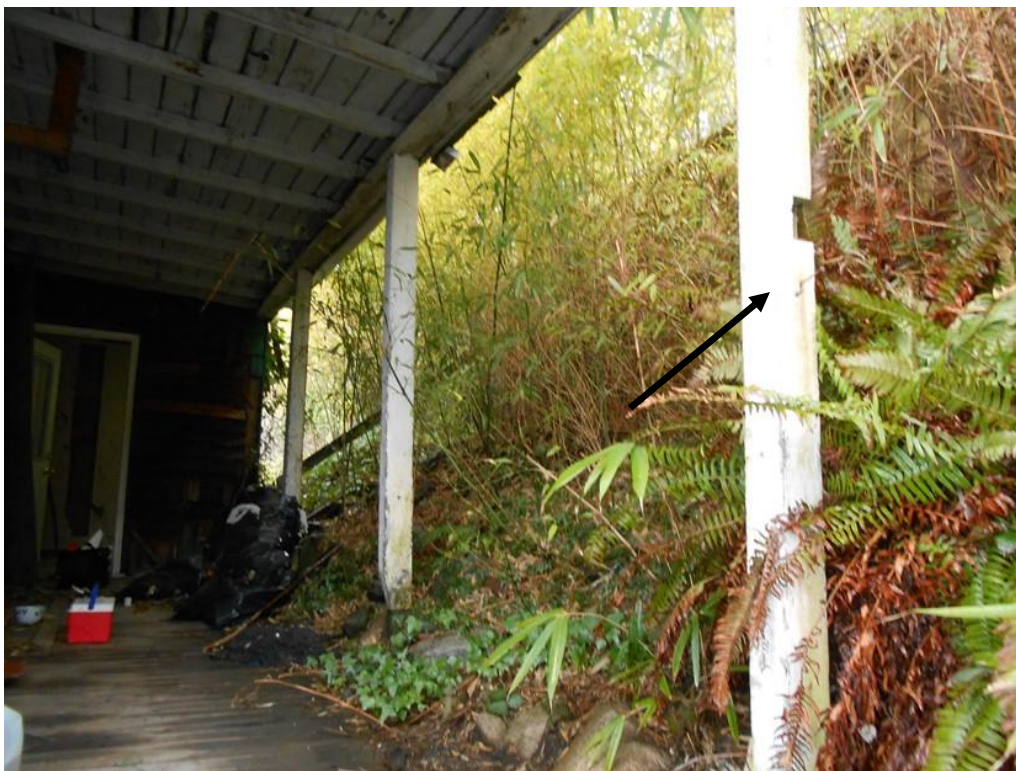
4. Sample 4918-22514-4 White Posts

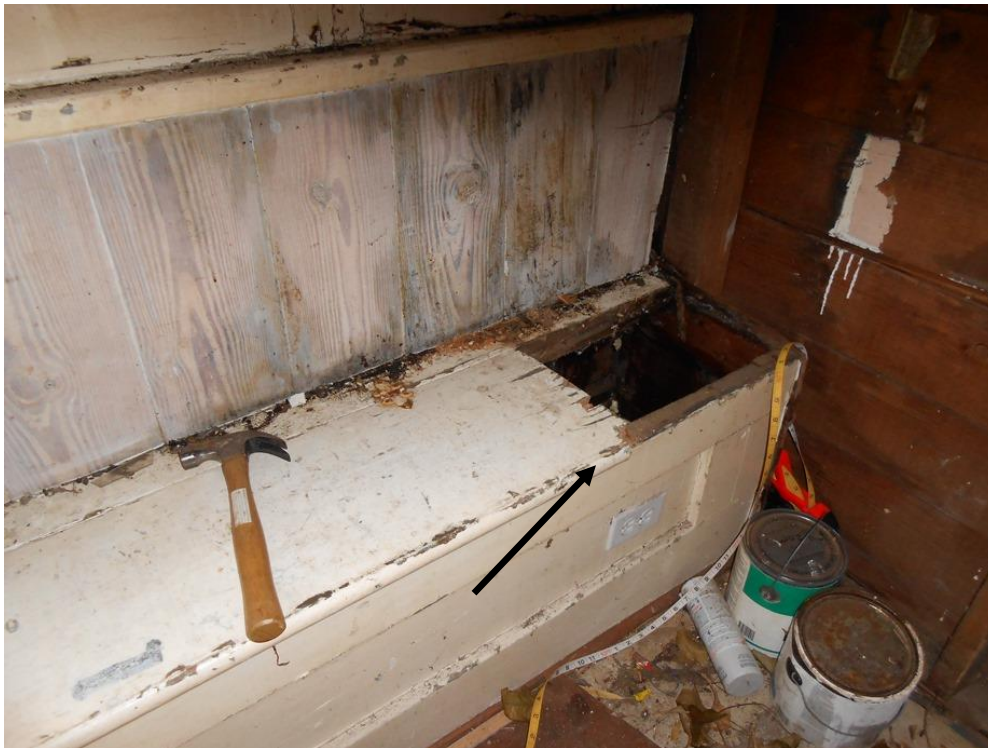
5. Sample 4918-22514-5 Bench

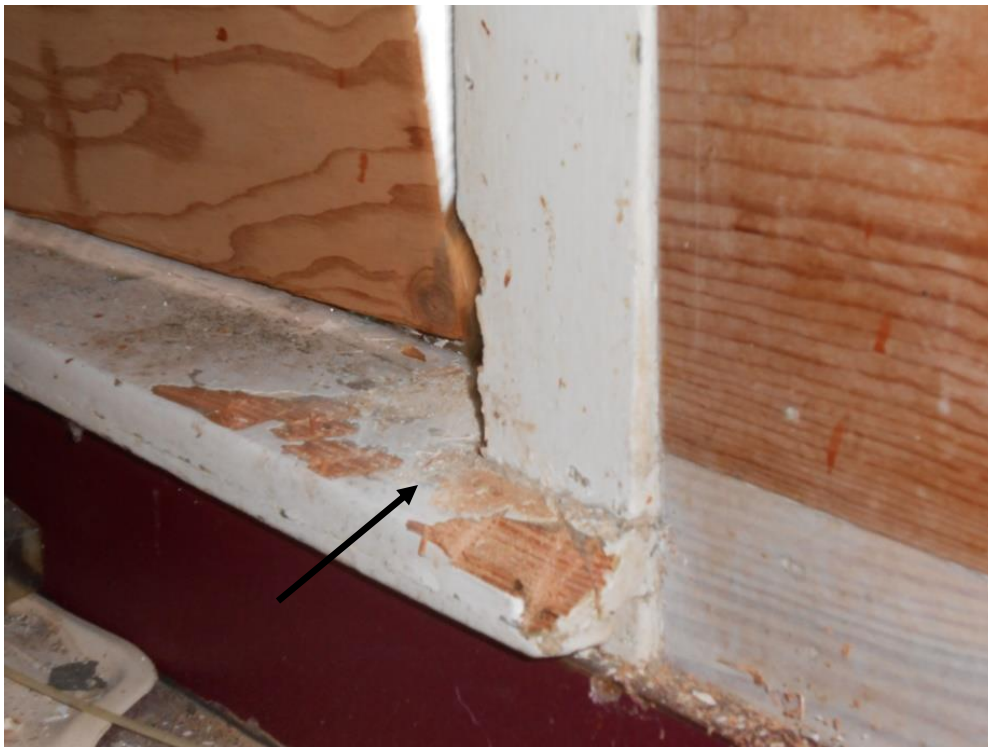
6. Sample 4918-22514-6 Window Framing

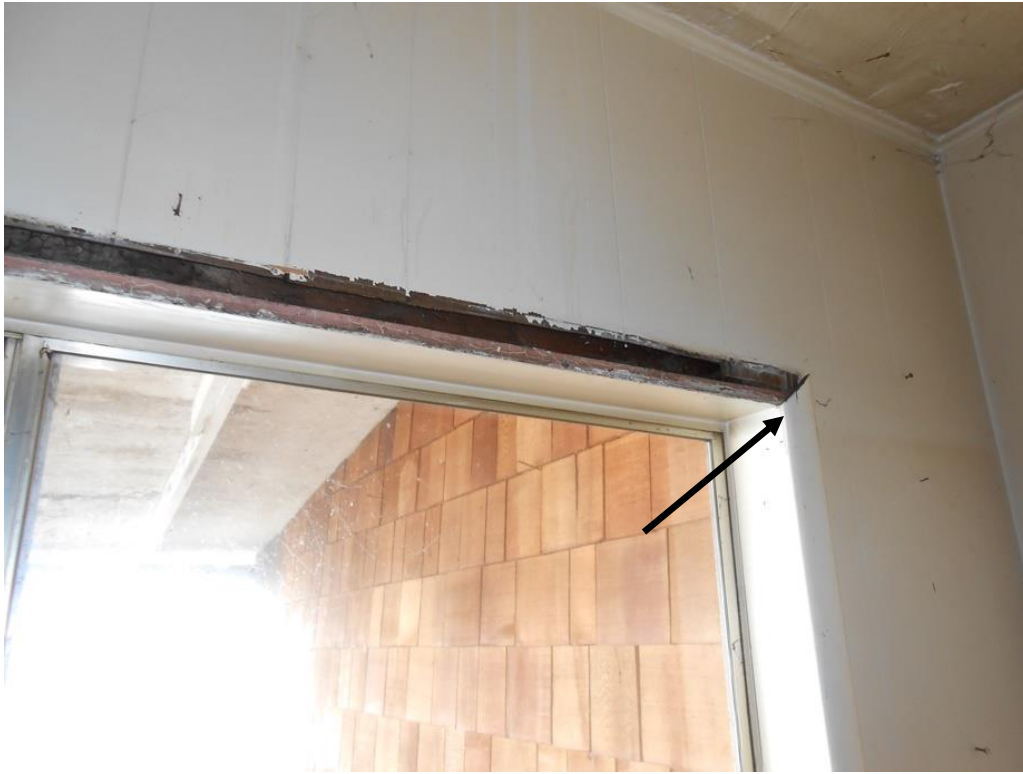
7. Sample 4918-22514-8 Window Framing

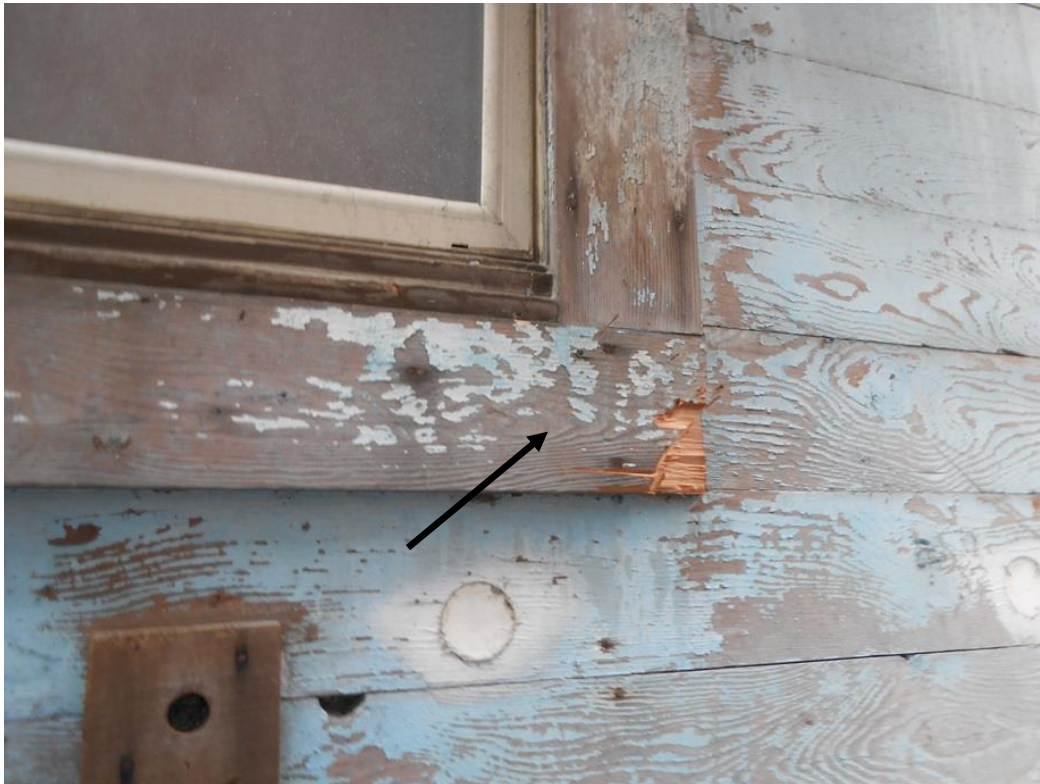
8. Sample 5024-22514-1 Window Framing

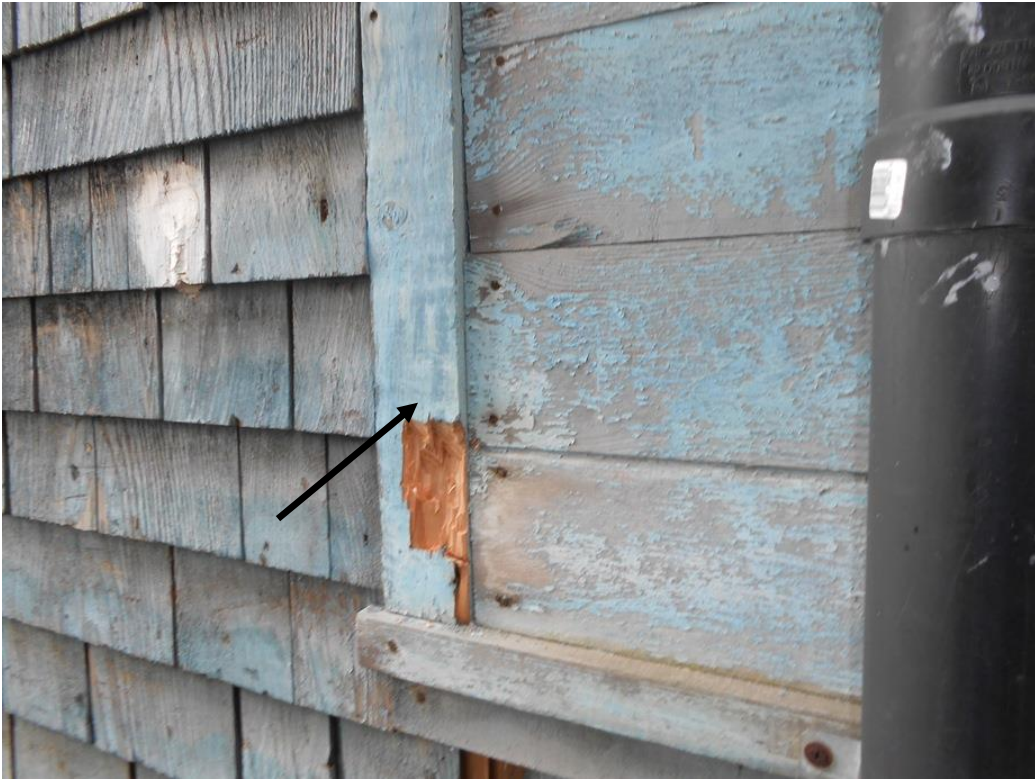
9. Sample 5024-22514-2 Window Framing

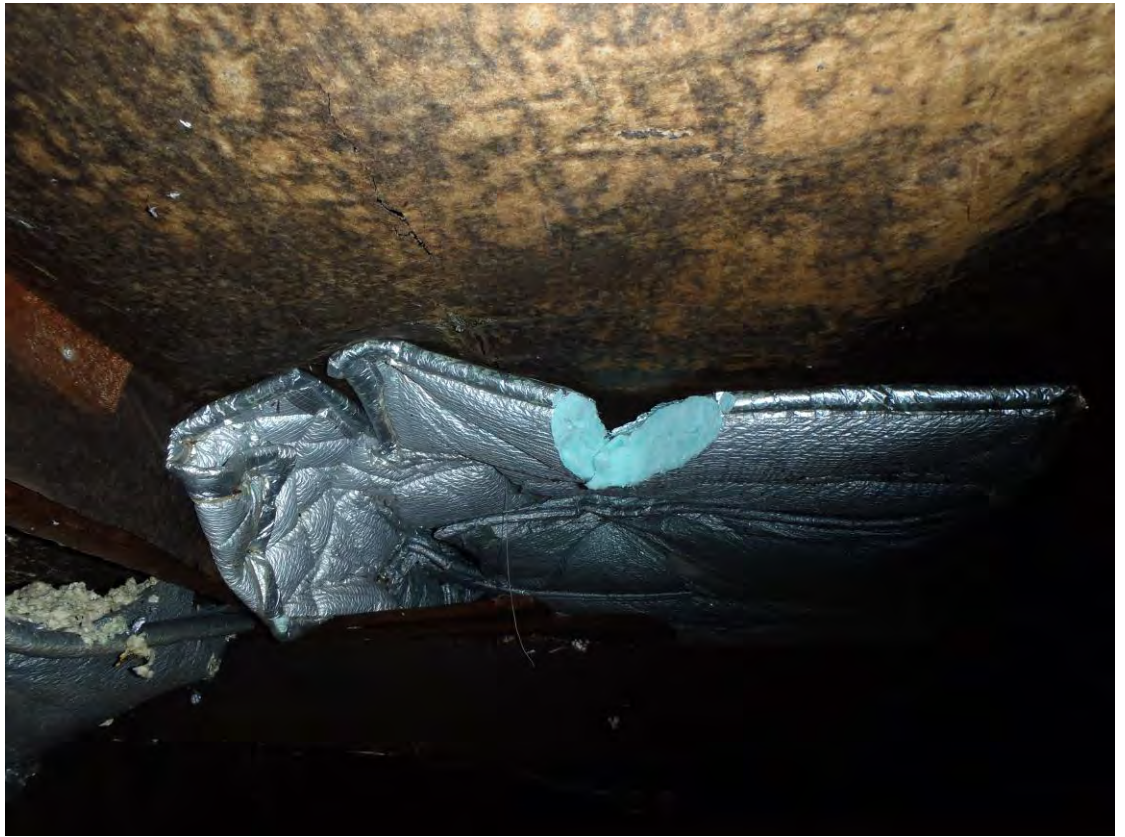
Photo No. 25: 4728 –
Insulation Material
Beneath Building

Description:
Silver wrapping/blue
inside insulation
material beneath 4728
building.

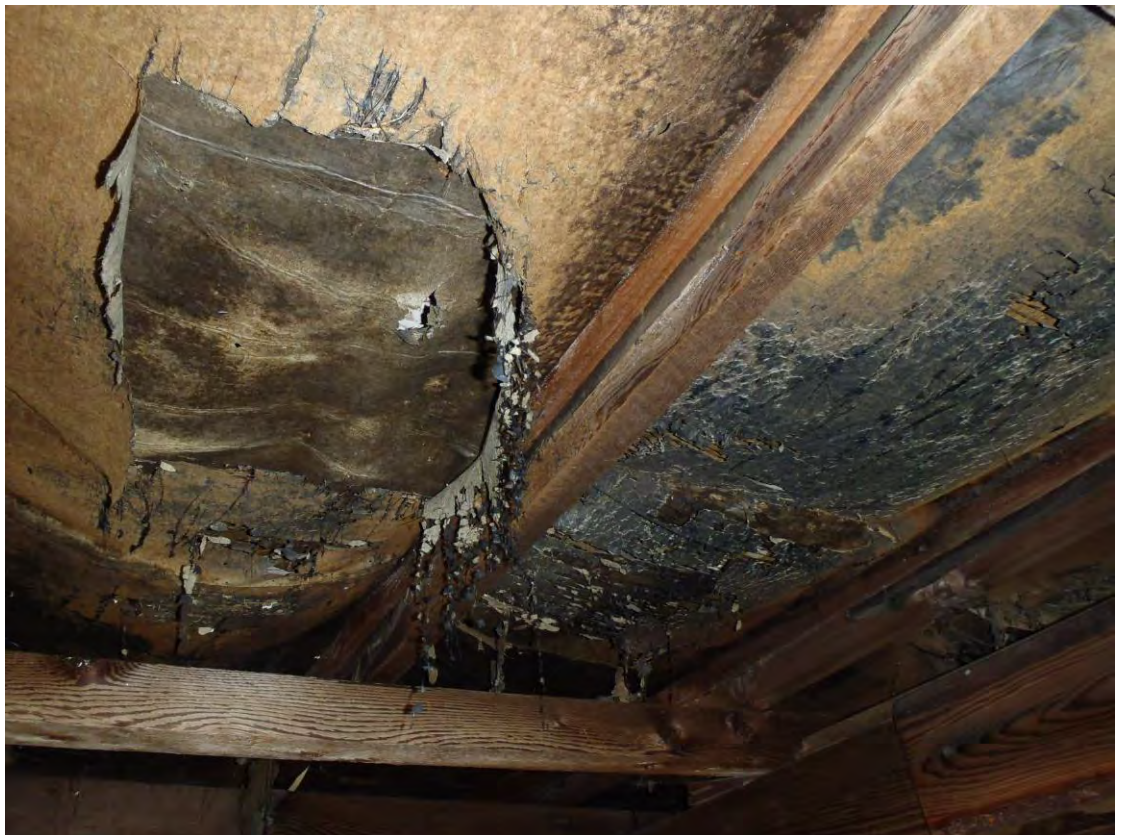
Photo No. 26: 4728 –
Insulation Material
Beneath Building

Description:
Deteriorating
black/fibrous insulation
wrap material beneath
4728 building.

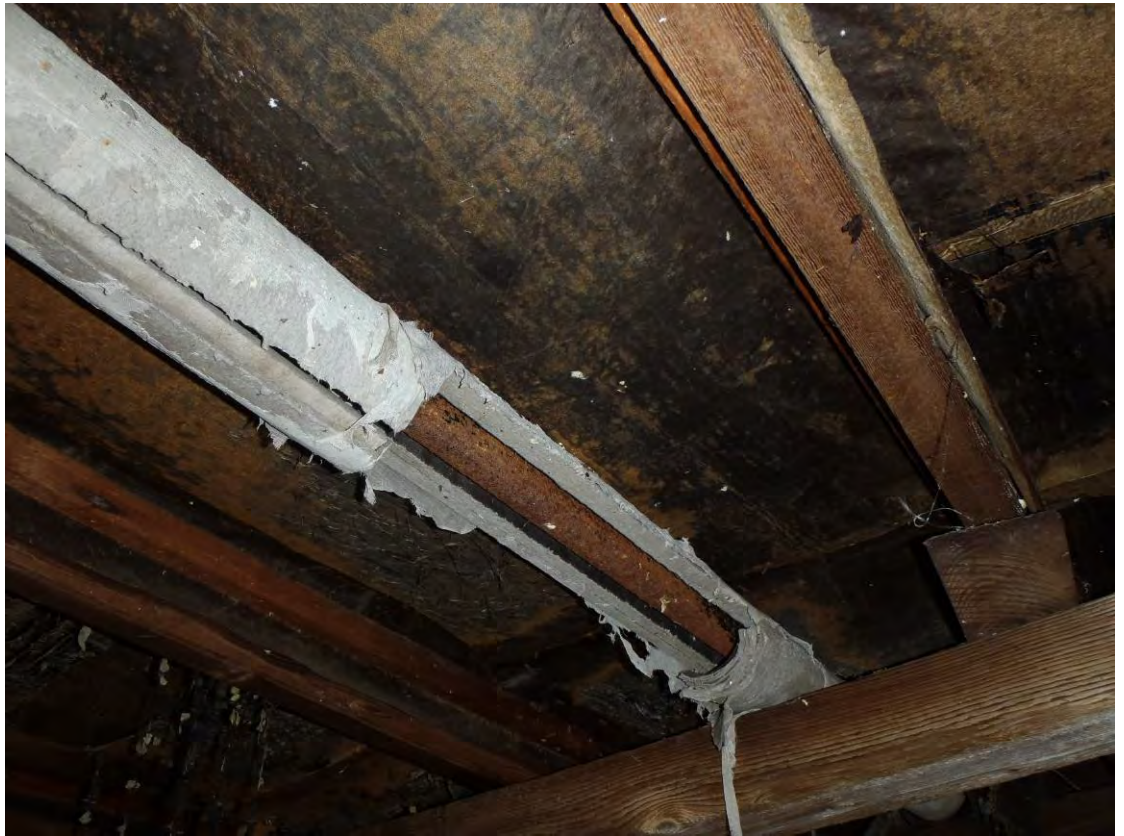
Photo No. 27: 4728 –
Insulation Material
Beneath Building

Description:
Pipe wrap material
beneath 4728 building.

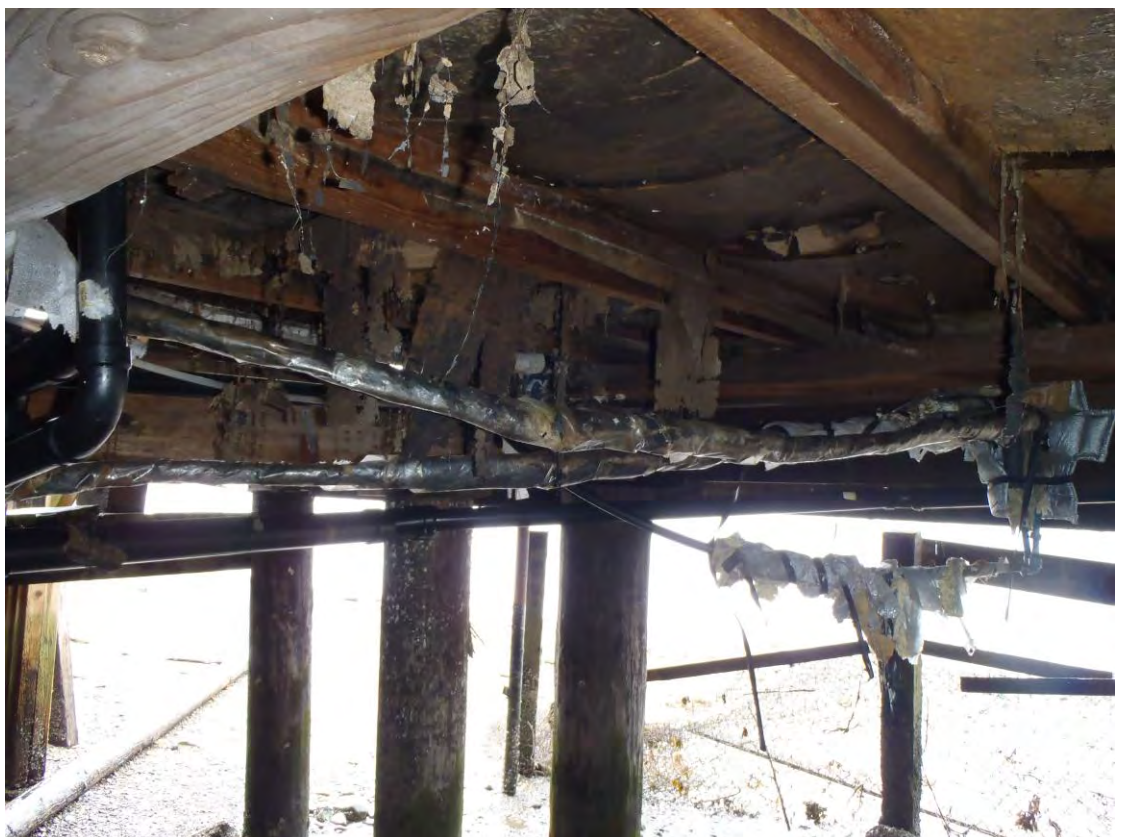
Photo No. 28: 4728 –
Insulation Material
Beneath Building

Description:
Pipe section with
various types of pipe
wrap insulation
material.

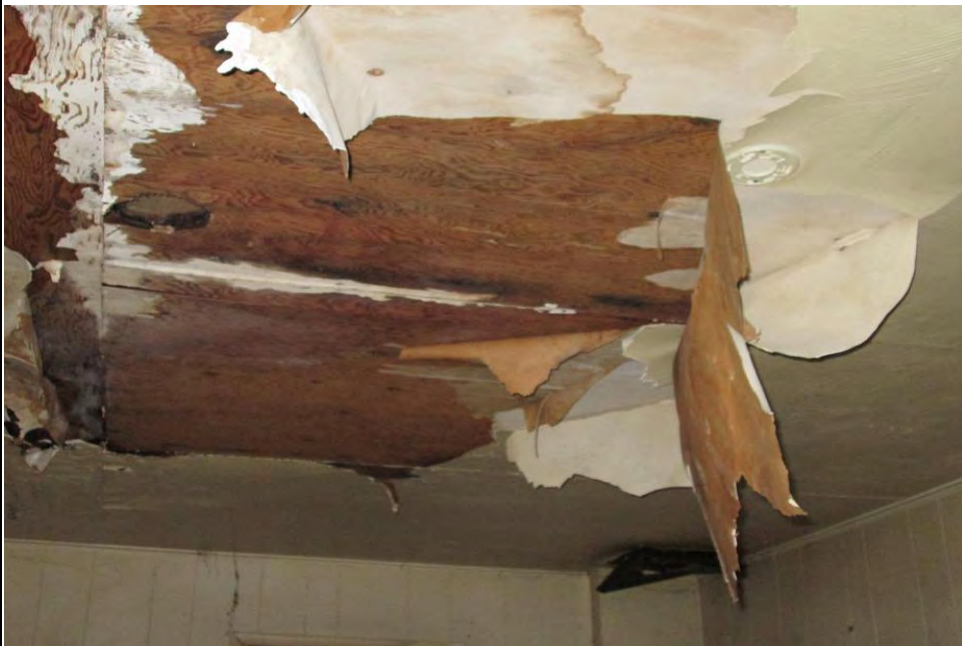
Photograph #2		Description

Sample 4918-4 Ceiling Material from Living Room 5% Chrysotile

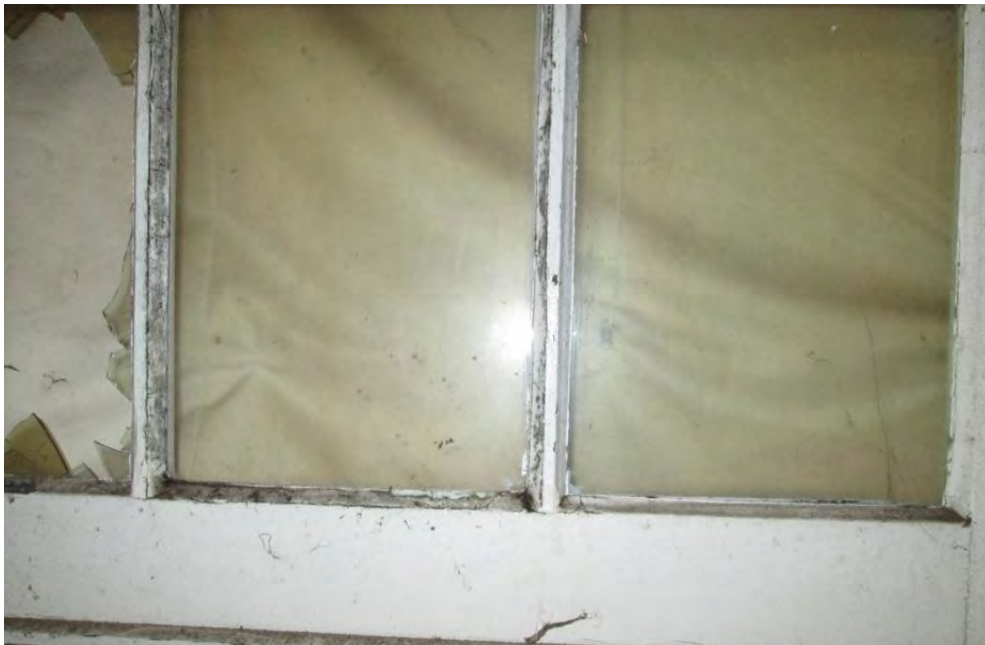
Sample 4918-5 Caulk/Window Glaze 3% Chrysotile
Photograph #4		Description

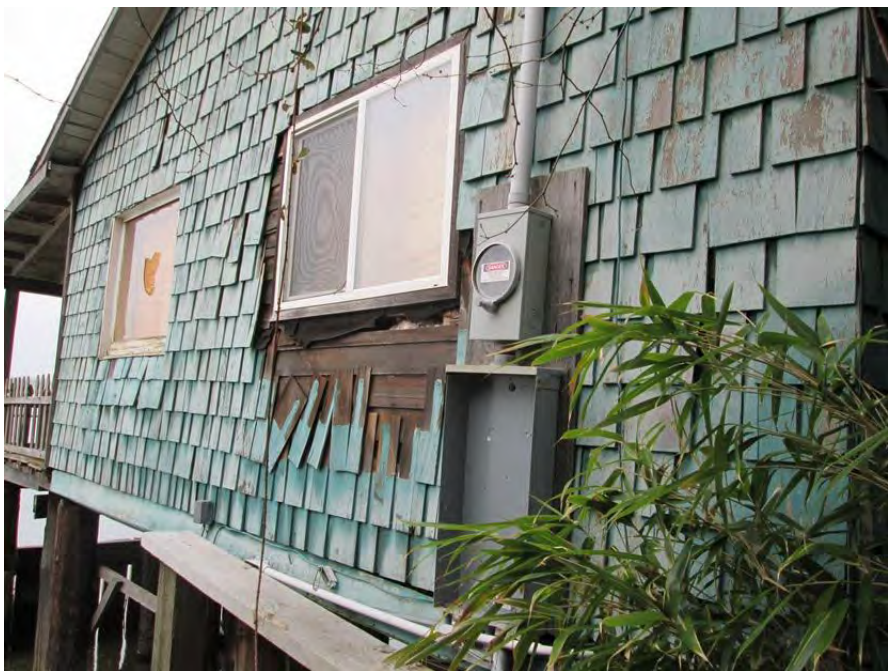
<p>4918 LBP Survey</p> <p>6- Lt Green Paint on Shingles</p> <p>7- Lt Green over Red Paint on Shingles</p>

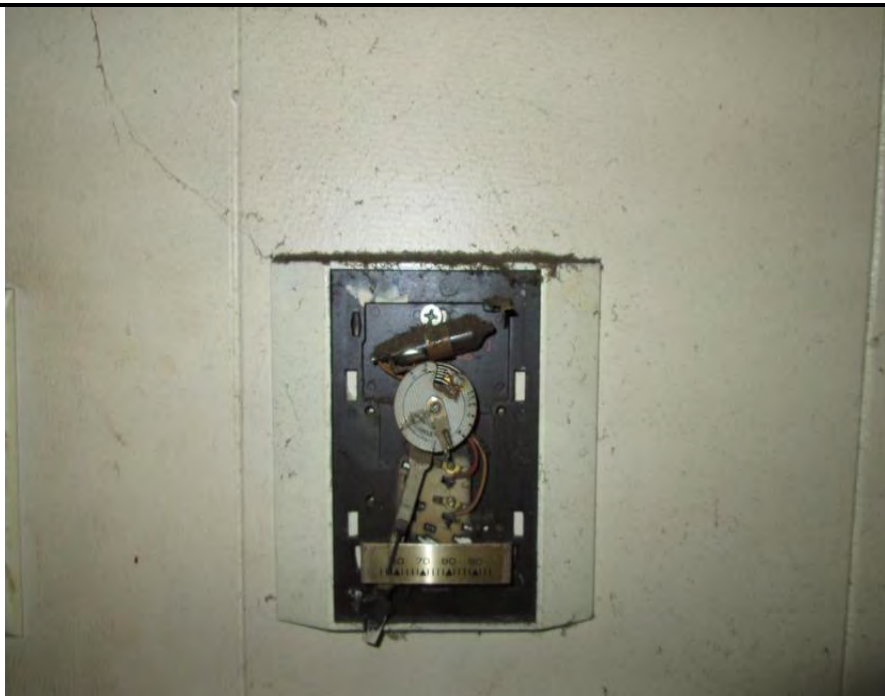
Photograph #10		Description

4918 Living Room: Thermostat with mercury ampule
