2023 Facility Condition Assessment Report - Final

**Task Order No. 06 – West Hylebos Log Dock
On-Call Marine Structures Facility Condition Assessment Services 2023-2027
Contract No. 071856
Port of Tacoma
Tacoma, Washington**

December 22, 2023

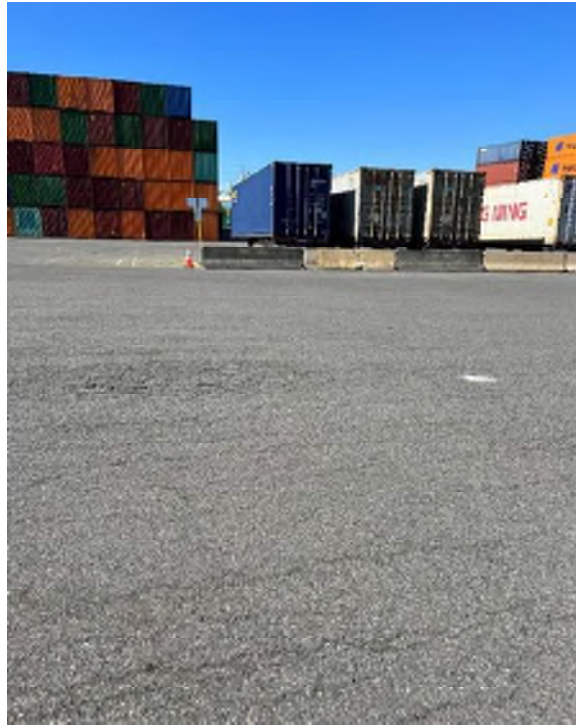
The asphalt and concrete deck overlay is in **poor** condition. Widespread minor cracks and ruts are present along the entire surface of the asphalt overlay (Appendix A, Photo 1). Widespread minor to major cracks, ruts, spalls, and delamination are present along the concrete overlay surface. There are isolated areas where spalled concrete have been filled with cold patch between Bent 2 and Bent 25. Areas of concrete spalling with exposed reinforcement was observed primarily between Bent 25 to Bent 100 (Appendix A, Photo 2). Cumulative surface area of spalled concrete pavement over the wharf is approximately 2,800 square feet.

Photo 1 – Typical Alligator Cracking of Asphalt Deck Overlay.

1. Replace all cracked and spalled concrete pavement overlay. A waterproof concrete overlay is critical to preserving the longevity of the timber structure below.

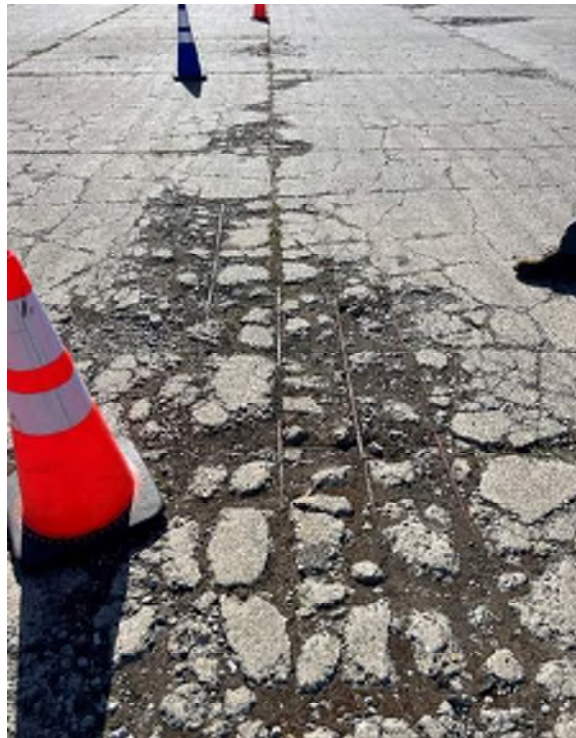
Photo 2 –Spalling of Concrete Overlay with Exposed Reinforcement at Bent 34. Similar Damage Present in Multiple Locations between Bent 25 and Bent 100.

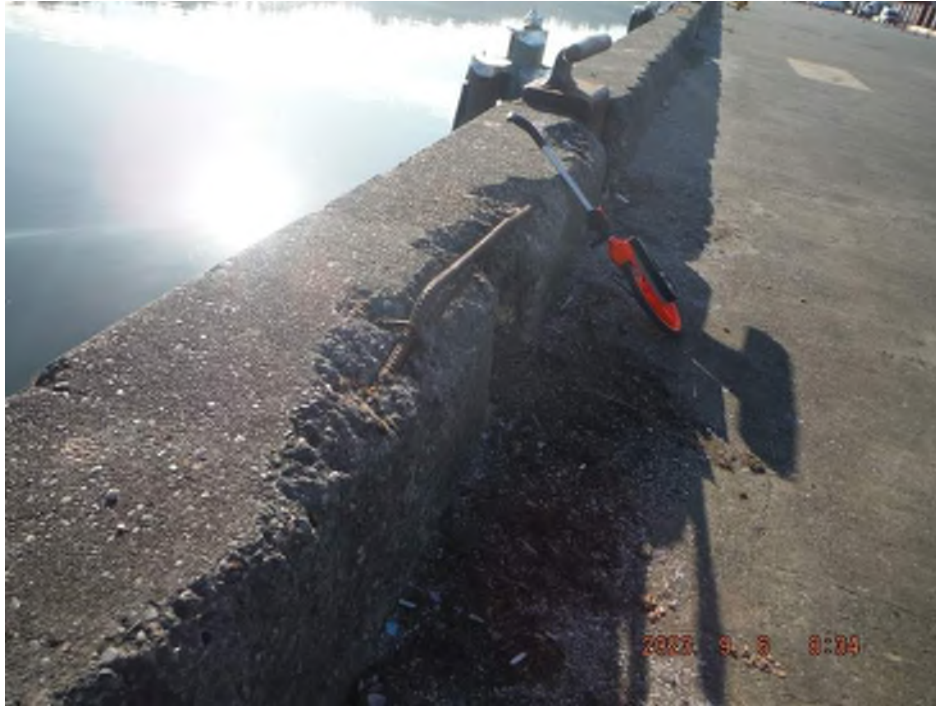
The concrete bullrail is generally in **fair** condition. Minor to major spalls are present along the entire length of the landside edge. Impact spalls with exposed reinforcing steel are present and are up to 9 feet long (Appendix A, Photo 3).

Photo 3 – Concrete Bullrail Mechanical Spall with Deformed Bar at Bent 25.

2. Repair bullrail impact spalls with exposed reinforcing.
3. Replace mooring fittings exhibiting major to severe deterioration.
4. Replace fender piles with major or severe damage.

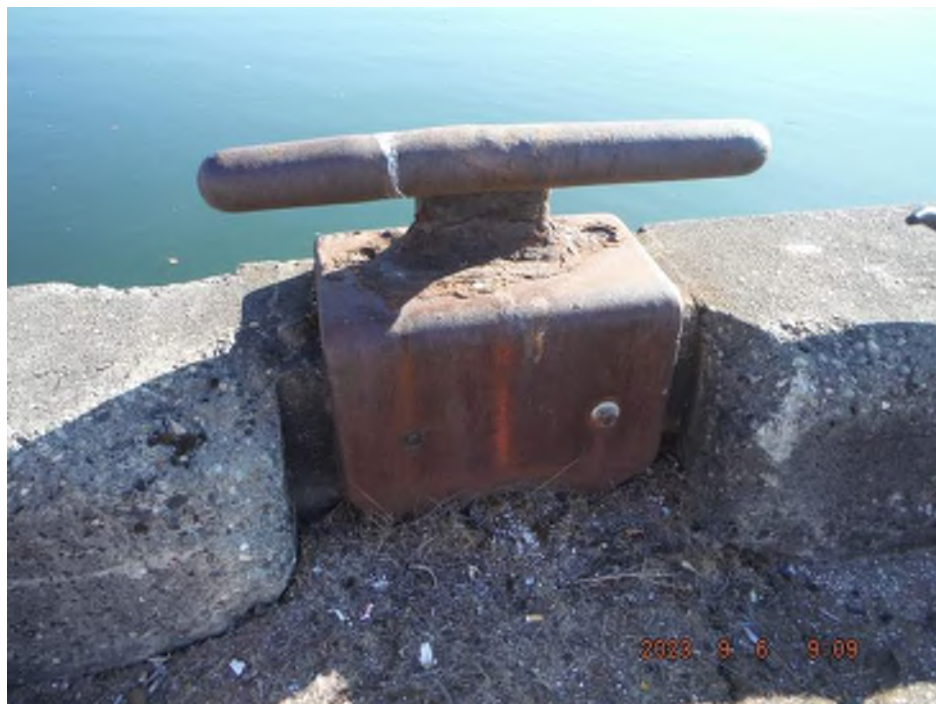
Photo 4 – Cleat with Section Loss at the Neck, Missing Anchor. Surrounding Bullrail Mechanical Spalling at Bent 79.

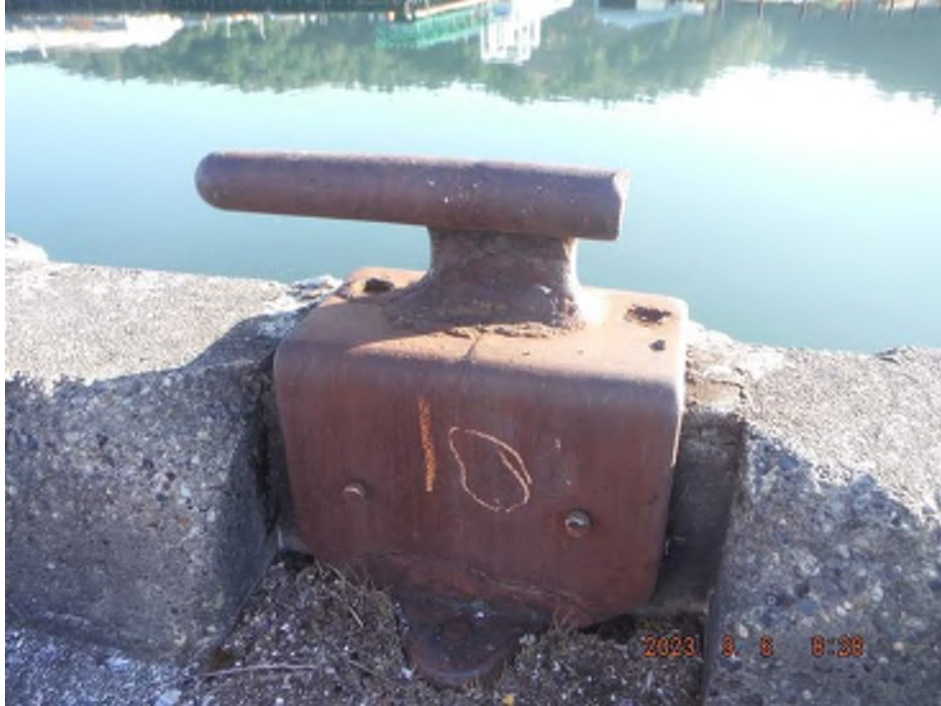
Photo 5 – Cleat with Broken Ear at Bent 10.

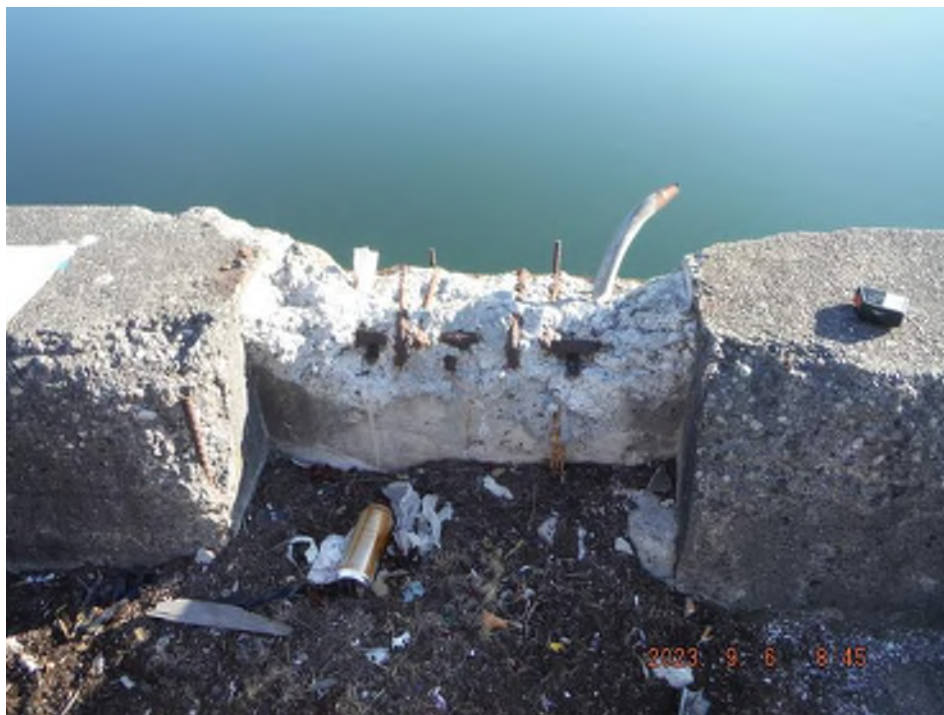
Photo 6 – Missing Cleat at Bent 43.

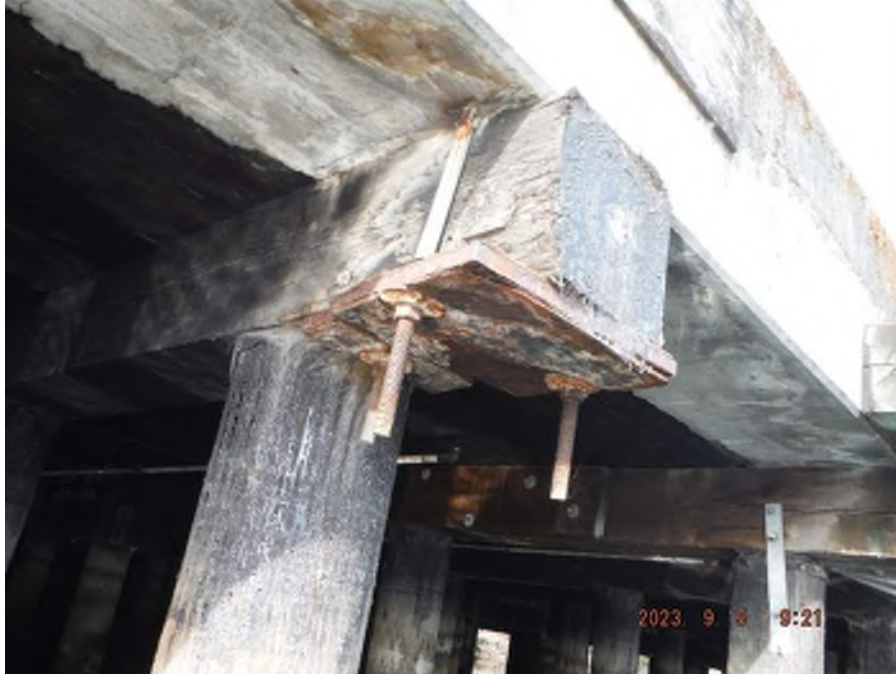
The mooring fittings are in **poor** condition. Coating loss, heavy corrosion with loose scale, and noticeable corrosion of fasteners are present on all the steel cleats. At 11 locations, Bents 2, 18, 26, 30, 34, 52, 61, 70, 79, 87, and 101, the cleats and concrete mounting locations have major to severe deterioration, including section loss on the neck of the cleat (Appendix A, Photo 4), and open corrosion spalls on the mounting locations with exposed reinforcing. The ear of the steel cleat at Bent 10 is broken (Appendix A, Photo 5) and the cleat at Bent 43 is missing (Appendix A, Photo 6). There is moderate to major corrosion of the cleat anchor plates that bear against the pile cap soffits (Appendix A, Photo 7).

Photo 7 – Moderate Corrosion of Bearing Plate that Anchors the Mooring Fitting at Bent 101.

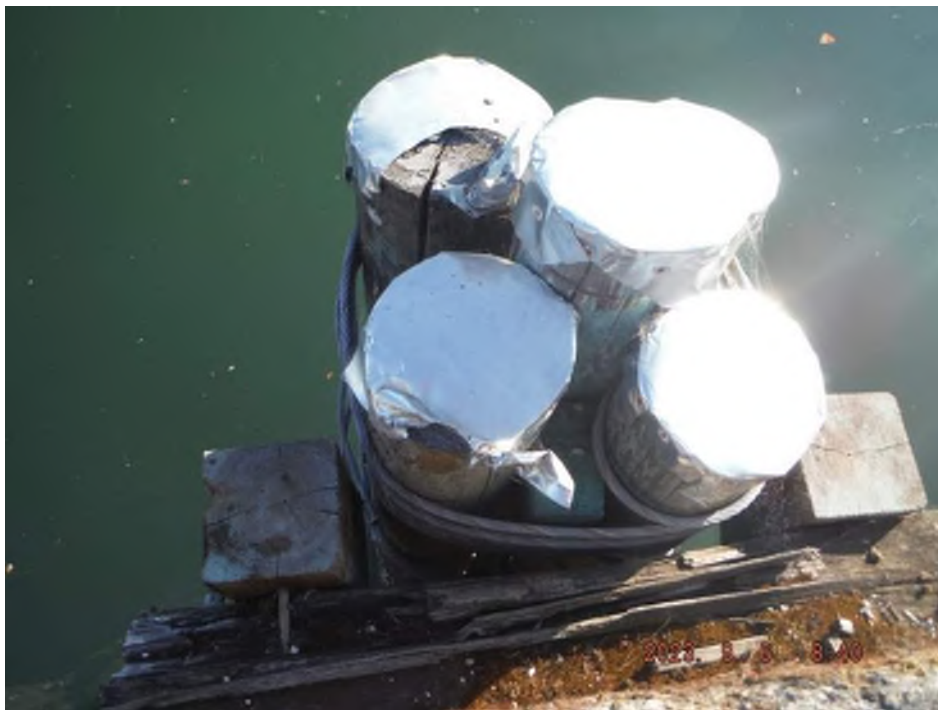
Photo 8 – Split Wale with Exposed Anchor and Rot. Split Pile with Torn Sheet Metal Hats at Bent 34.

5. Replace fender system wales and chocks with major or severe damage.
6. Replace steel fender system pile wraps with major or severe damage.
7. Replace all torn or missing sheet metal pile hats on fender piles.

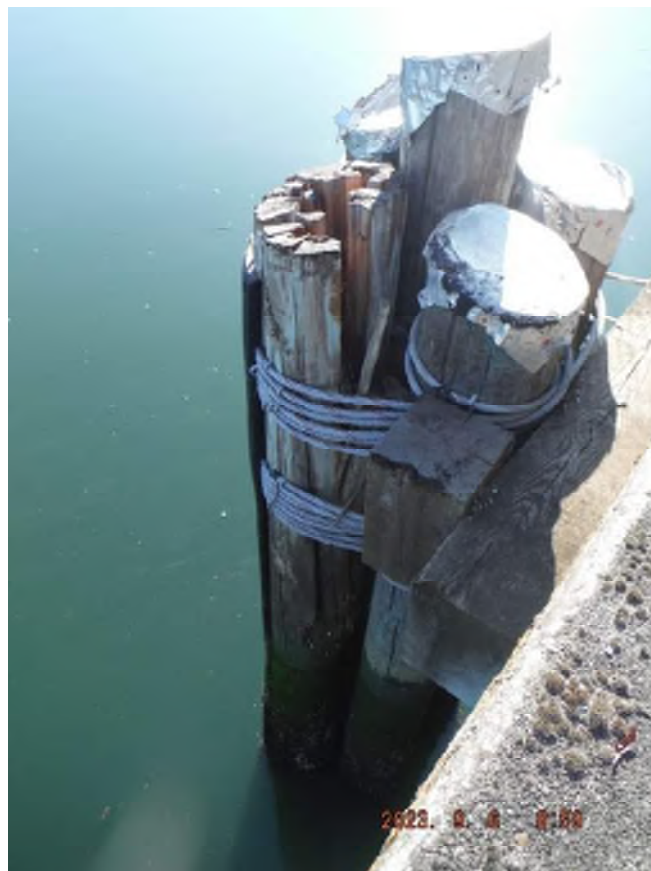
Photo 10 – Top of Pile Crushed with Missing Sheet Metal Pile Hat and Missing Timber Chock at Bent 57.

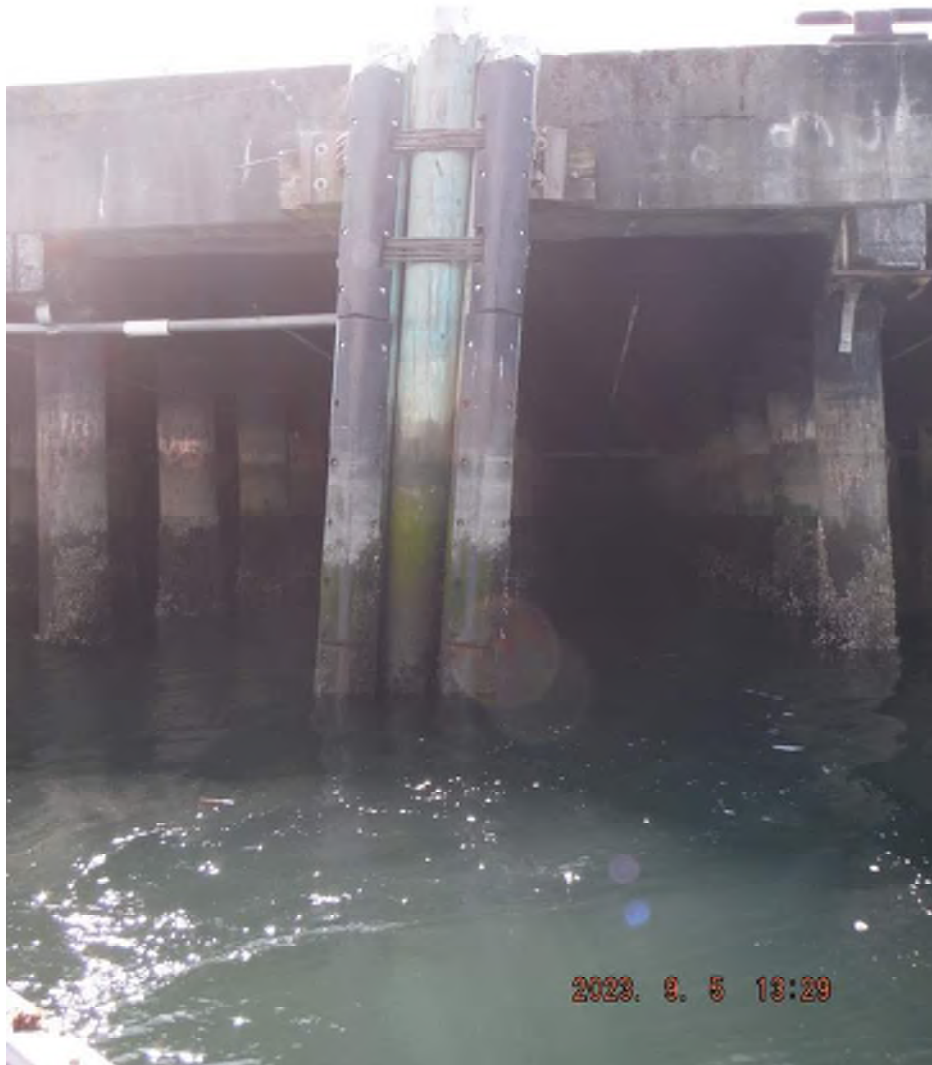
Photo 11 – Fender Piles Out of Plumb and Split Chock at Bent 104.

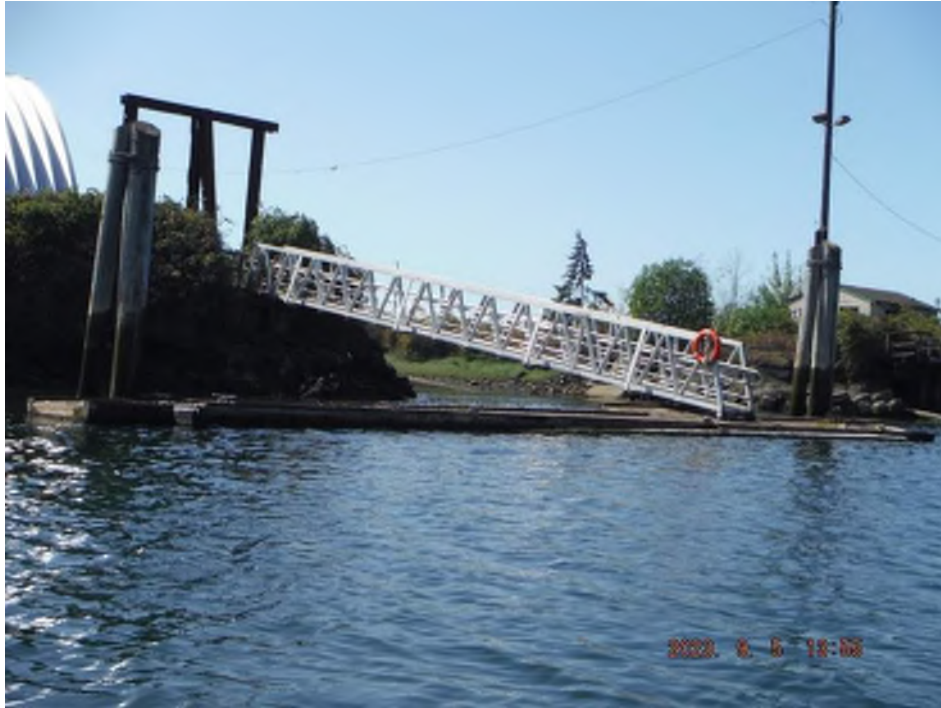
The timber floating docks are in **poor** condition. The walking surfaces are covered in moss and debris and the docks have a moderate to major list to the outboard side and low freeboard (Appendix A, Photo 12). The galvanized hardware and chains securing the docks to the guide piles have moderate to severe corrosion with section loss. One of the two galvanized chains that secure the southeast float to the guide piles is broken, leaving only one lashing chain to hold the entire southeast float on-location. There are two locations where major to severe rotting of the timber wale is present on the northwest float and one instance of major rot on the southeast float.

Photo 12 – Southeast Float Listing.

8. Install supplemental floatation at the floating docks to correct listing and low freeboard. Consider decommissioning or replacing these floats.
9. Replace broken/missing chain hardware that secures floats to guide piles.

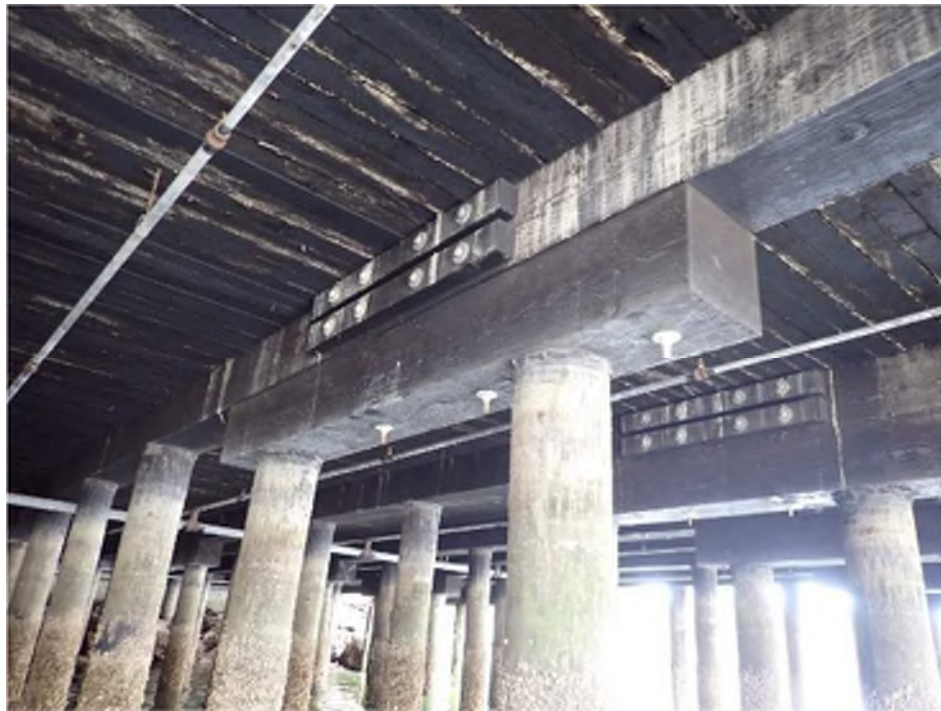
Photo 13 – Typical Pile Cap Splice.

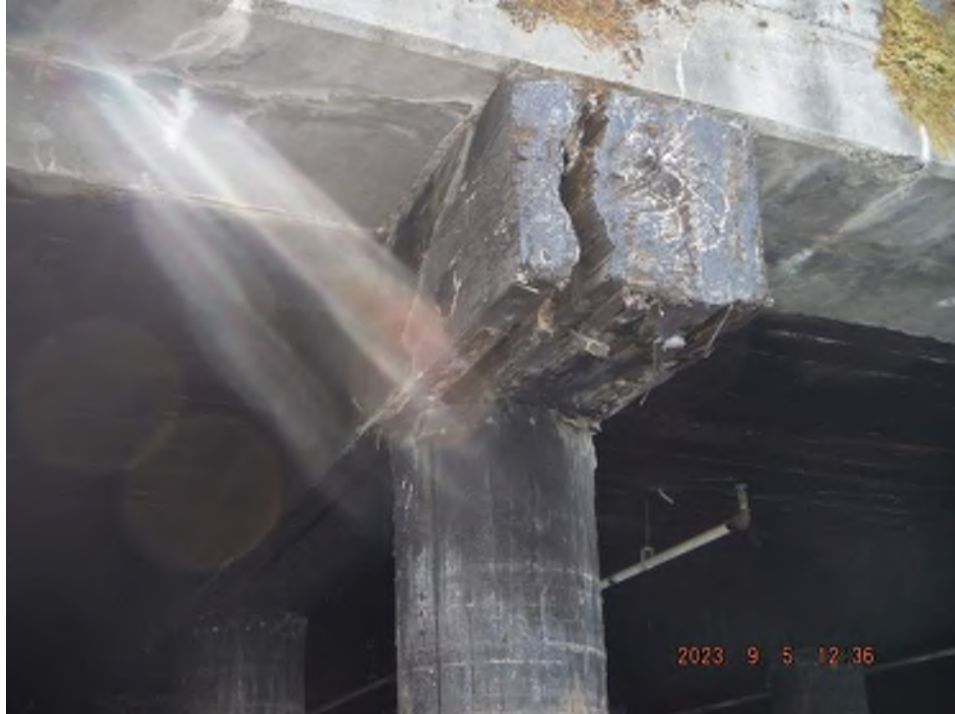
The timber pile caps are in **satisfactory** condition. The majority of timber pile caps exhibit only minor to moderate signs of deterioration, including checks and splits less than 1/2-inch wide. The bolted plate connection to the bulkhead cap exhibits only minor surface corrosion. Pile cap repairs have been performed in isolated locations that consist of a replacement pile cap butted against the original cap and lap spliced with two 3-inch by 12-inch timbers. The splice is typically located at the midspan (Appendix A, Photo 13). There is a major split on the outboard face of the pile cap at Bent 88 (Appendix A, Photo 14).

Photo 14 – Major Split in Pile Cap End at Bent 88.

10. Replace pile caps with major splitting.
11. Replace missing/detached segments of firewall.
12. Repair major spalling in bulkhead concrete cap.
13. Install FRP Jacket on bearing piles with major or severe damage.

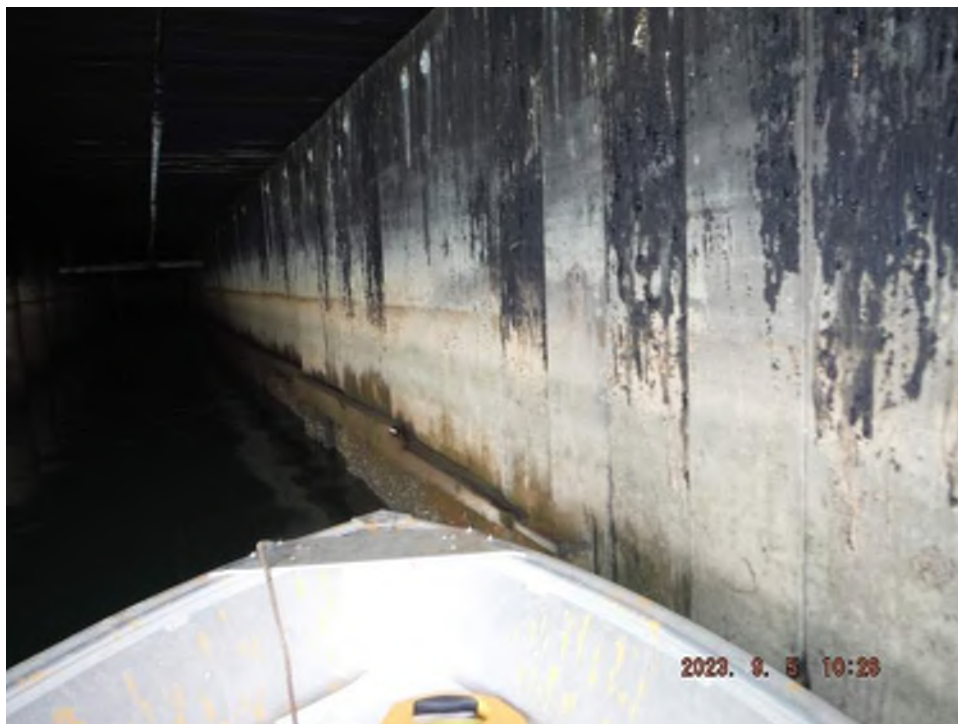
The timber firewalls are in **fair** condition. Above-water, the firewalls show localized areas of minor to moderate damage or deterioration (Appendix A, Photo 15). Localized areas of major to severe deterioration are present, particularly below mean lower low water. Segments of firewall are missing or partially detached at Bents 33, 49, and 97.

Photo 15 – Typical Above-Water Condition of Firewall.

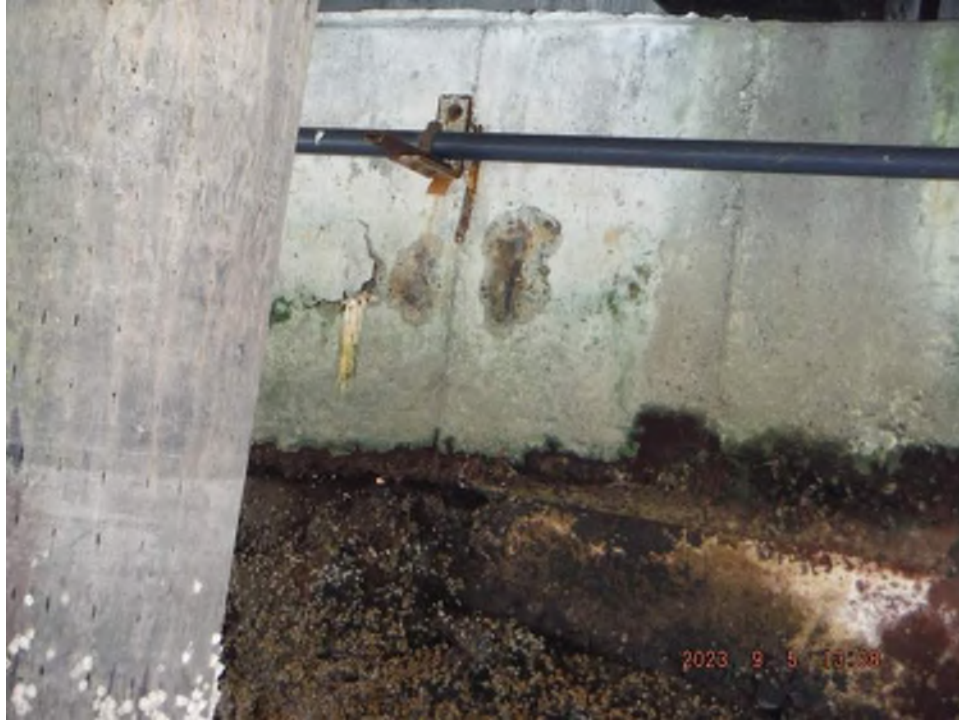
The bulkhead is in **fair** condition. Minor to moderate erosion of the slope armoring is present at multiple locations, which has exposed the pile cap soffit and the battered timber piling. The erosion varies in height up to 24 inches high. The erosion is not expected to result in reduction of structural capacity in the abutment because it is fully supported on the batter piles; however, slope erosion may result in sinkholes in the unpaved area in the future. No sinkholes were observed from above-deck at this time. The concrete portions of the bulkhead show no widespread damage but does have spalling with exposed reinforcement near Bent 110 (Appendix A, Photo 16).

Photo 16 – Open Spalling with Exposed Reinforcement in Bulkhead Pile Cap at Bent 11.

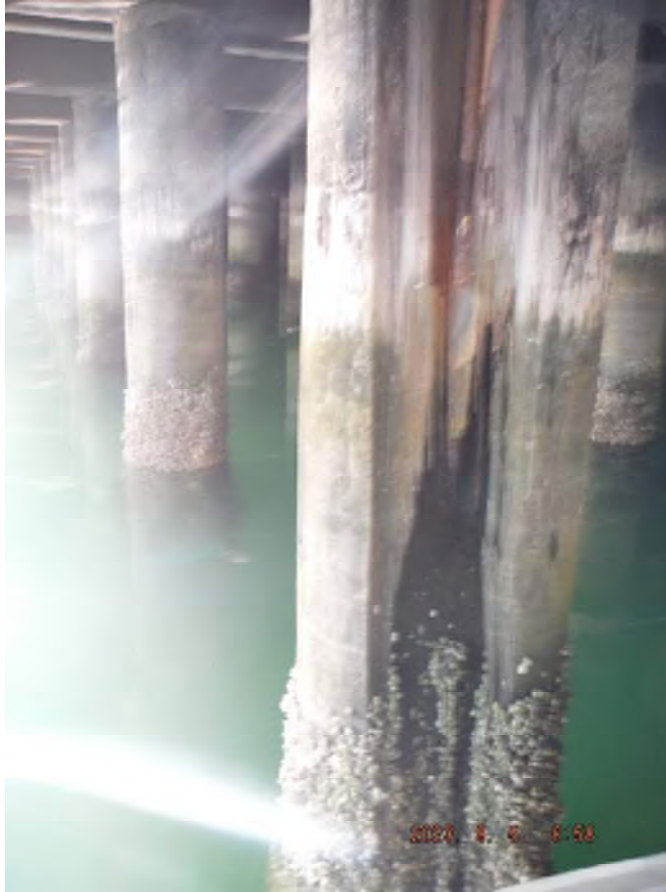
In general, the timber piles are in **fair** condition. Appendix A, photo 17 shows a typical underwater Level II pile cleaning. The majority of piles inspected exhibit minor to moderate signs of deterioration, including checks, shakes, splits, and gouges of less than ½-inch wide. Approximately 25 percent of the piles inspected show evidence of minor marine borer deterioration with less than 5 percent loss of section. Pile 4:B has major damage consisting of marine borer damage with 50 percent section loss (Appendix A, Photo 18). Pile 25:B is rated as major damage due to it being partially nonbearing under the pile cap.

Photo 18 – Pile Cross Section Major Loss at Waterline, Pile 4:B.

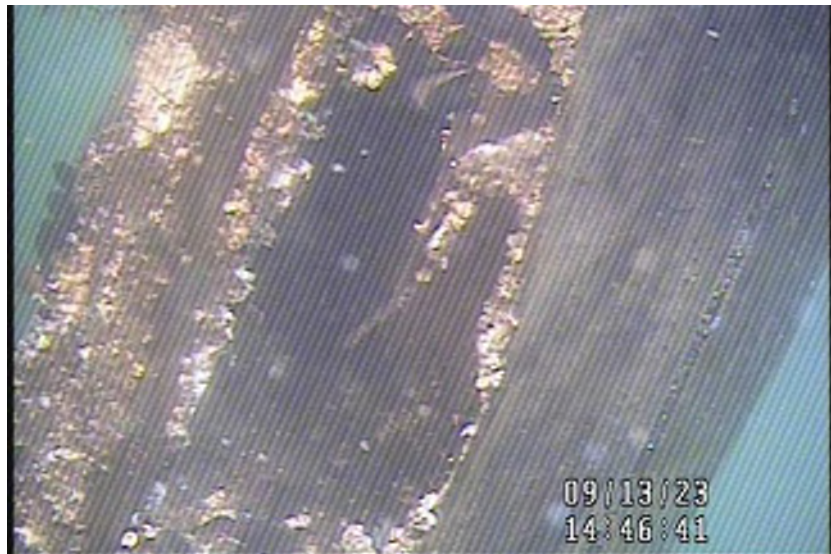
The floating dock guide piles and batter piles are in **fair** condition with typical minor abrasion. GP-2:A exhibits severe section loss with 20 percent remaining cross section (Appendix A, Photo 19).

Photo 19 – Cavity in Pile GP-2:A. Severe Section Loss.
