HAZARDOUS BUILDING MATERIALS SURVEY

Demolition

Commercial Structure
1110 Alexander Avenue
Tacoma, Washington

Med-Tox Northwest
Post Office Box 1446
Auburn, WA
MTNW Project A-8842.1

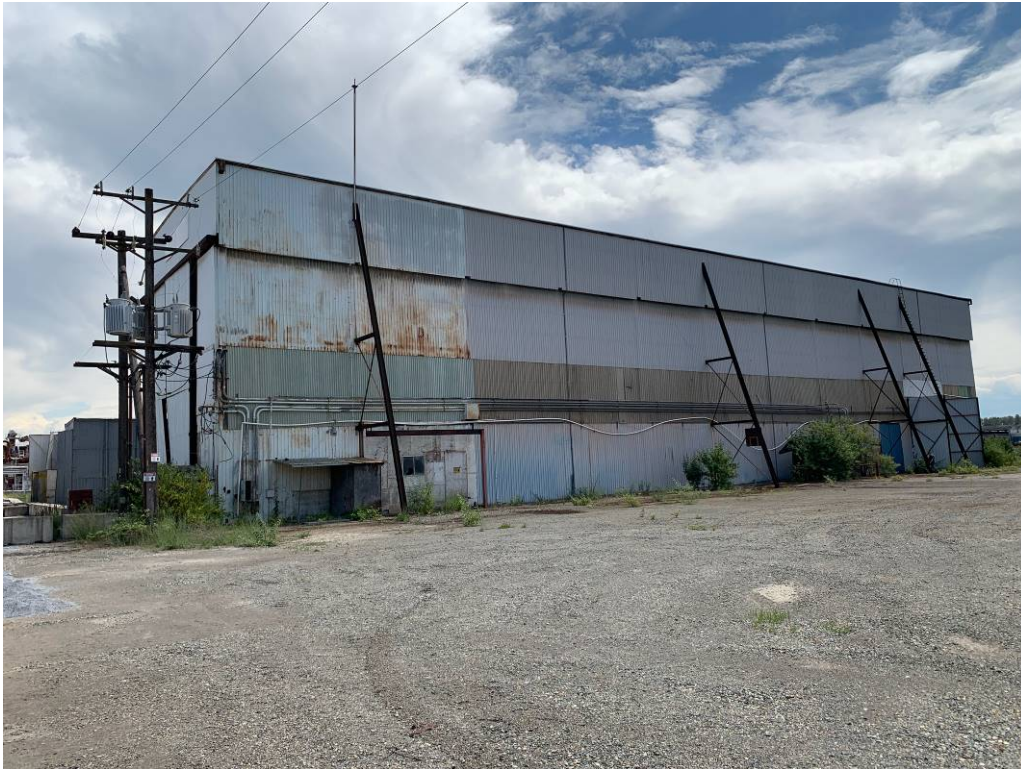
Photo 1: Main building facing southeast.

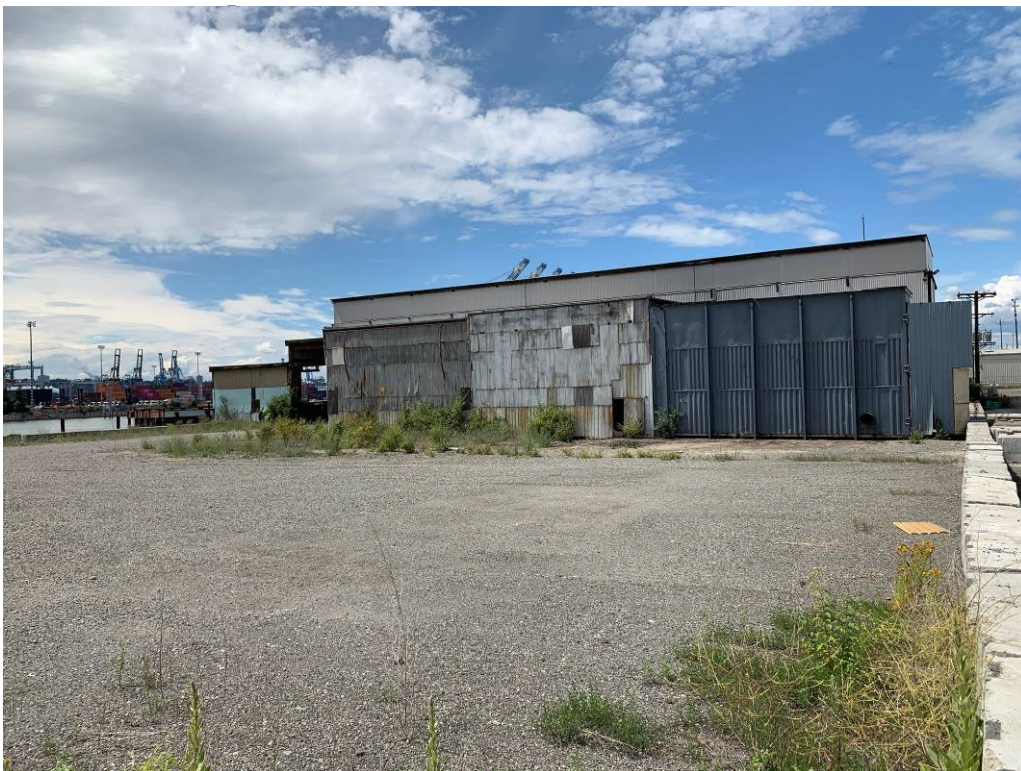
Photo 2: East side of buildings facing west.

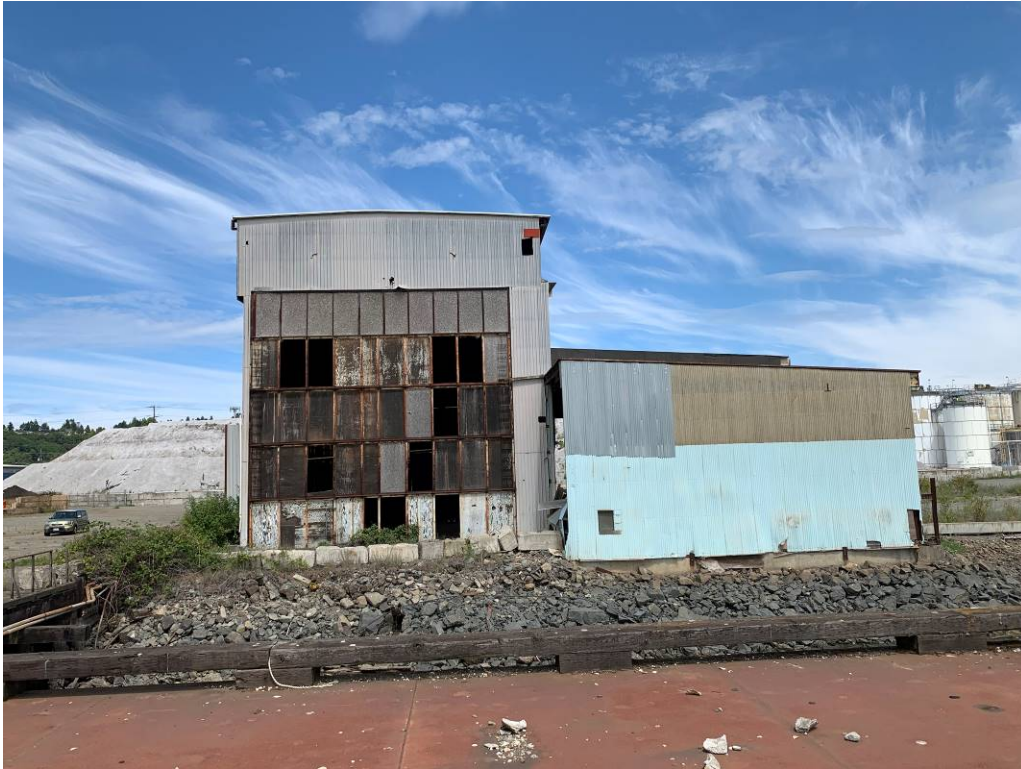
Photo 3: South side of the buildings facing north.

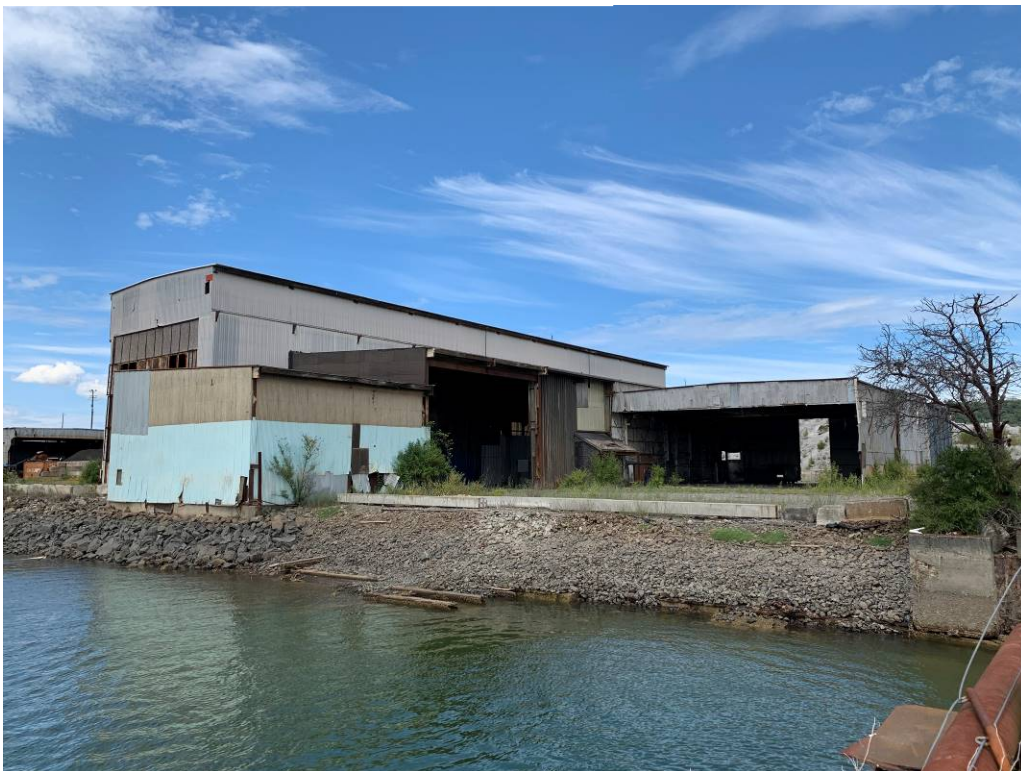
Photo 4: South and east sides of the buildings facing northwest.

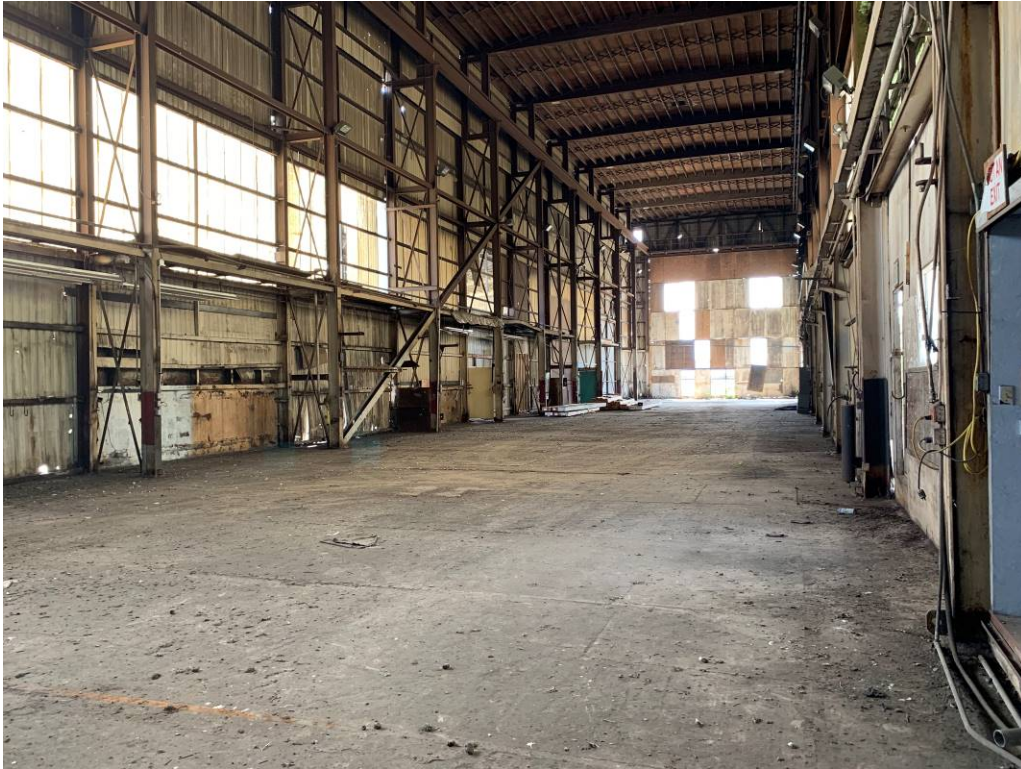
Photo 5: Interior of main building.
