EXISTING PHOTOGRAPHS

Existing photographs of the Maintenance building

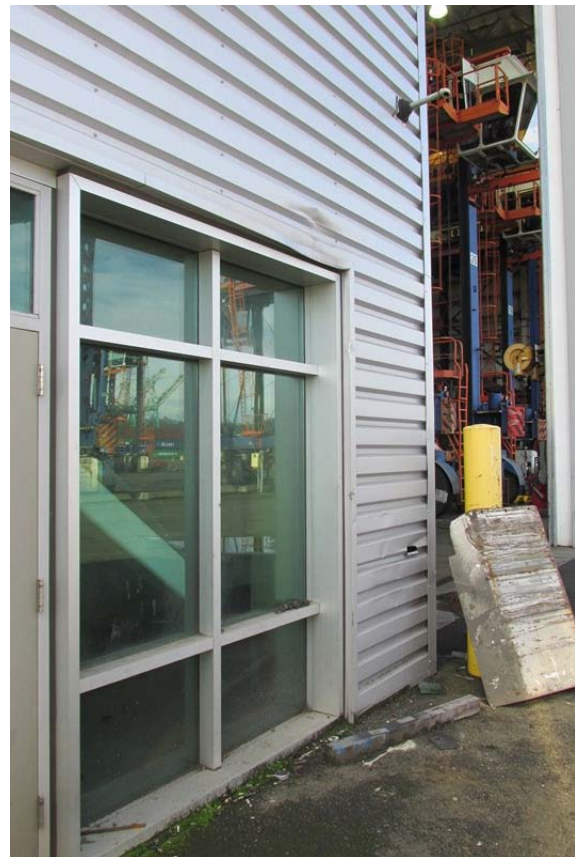
Figure 6 East Elevation, base of Tower at metal wall panel damage

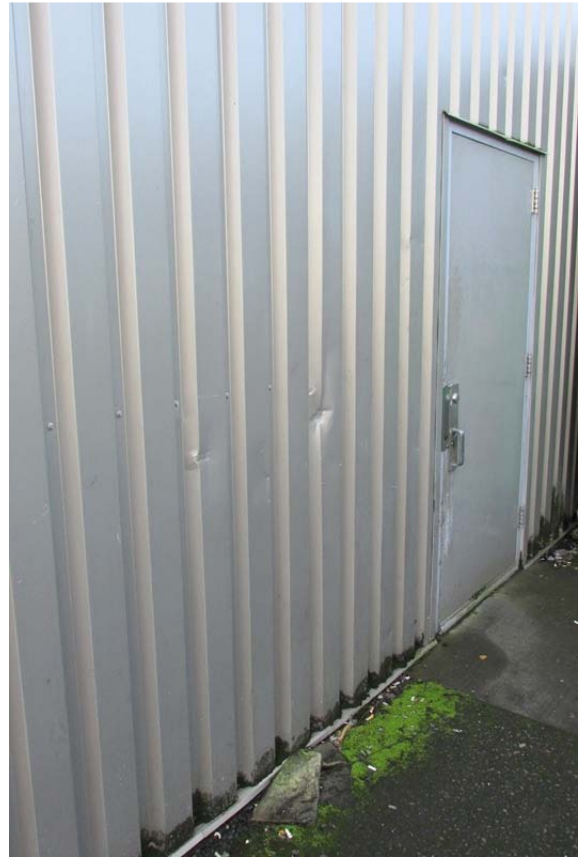
Figure 9 East Elevation, wall damage at northern end of building

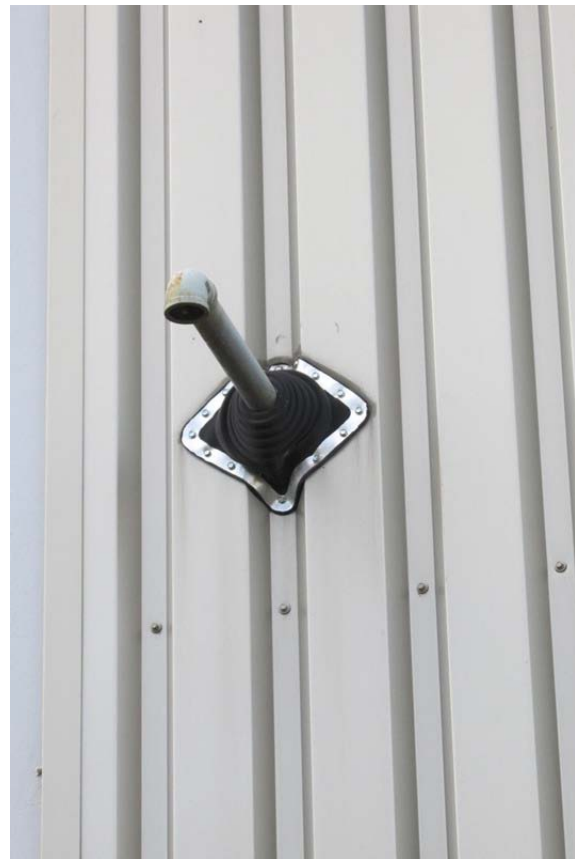
Figure 12 Boot flashing at vent pipe

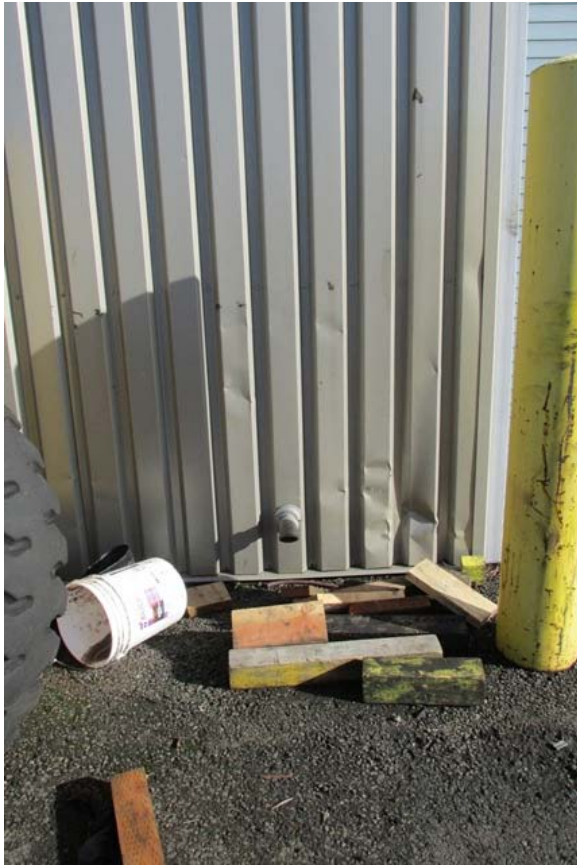
Figure 14 Damage to base of wall at north end of building

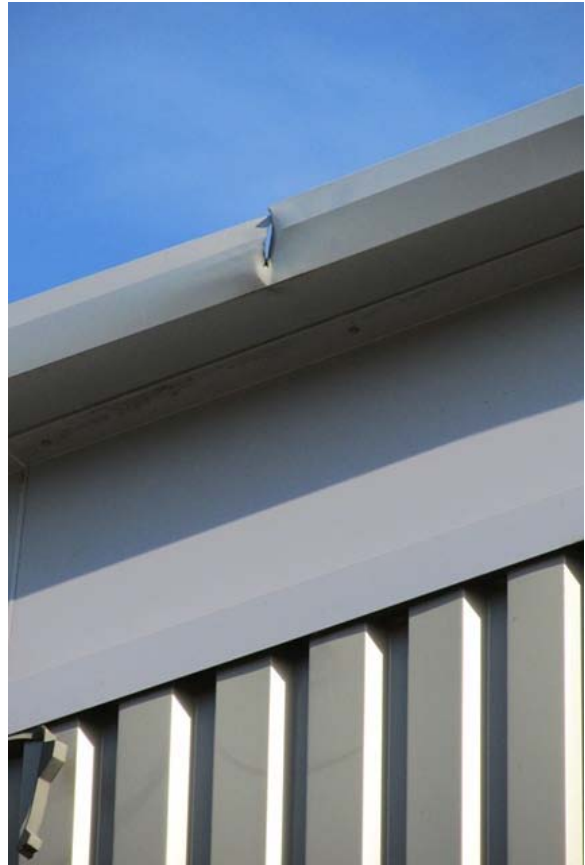
Figure 15 Damage to gutter over west wall

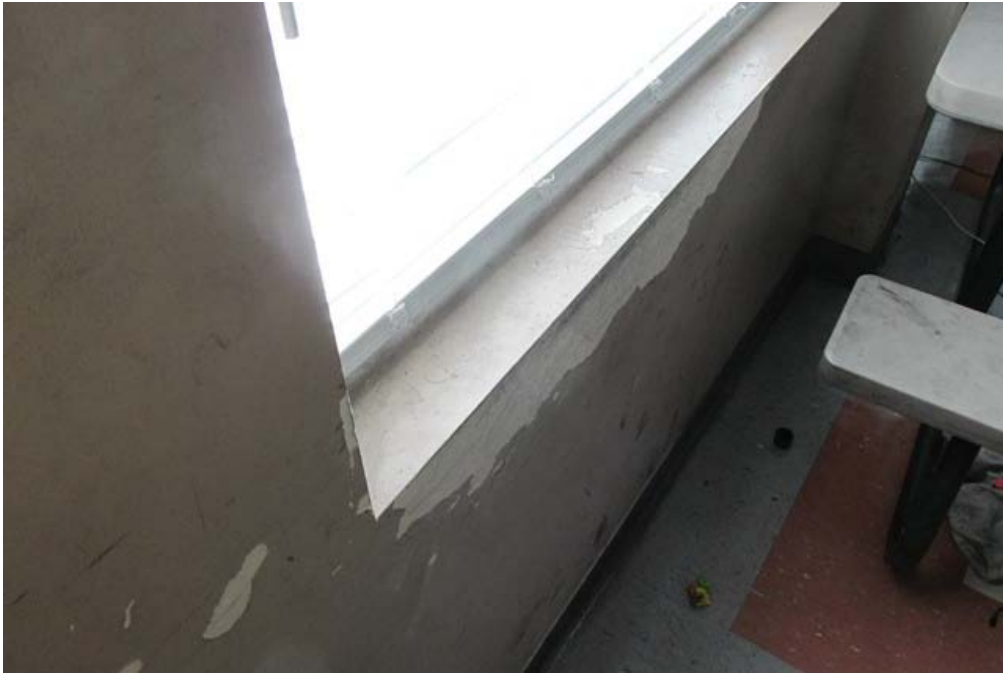
Figure 20 Interior window sill at Break Room

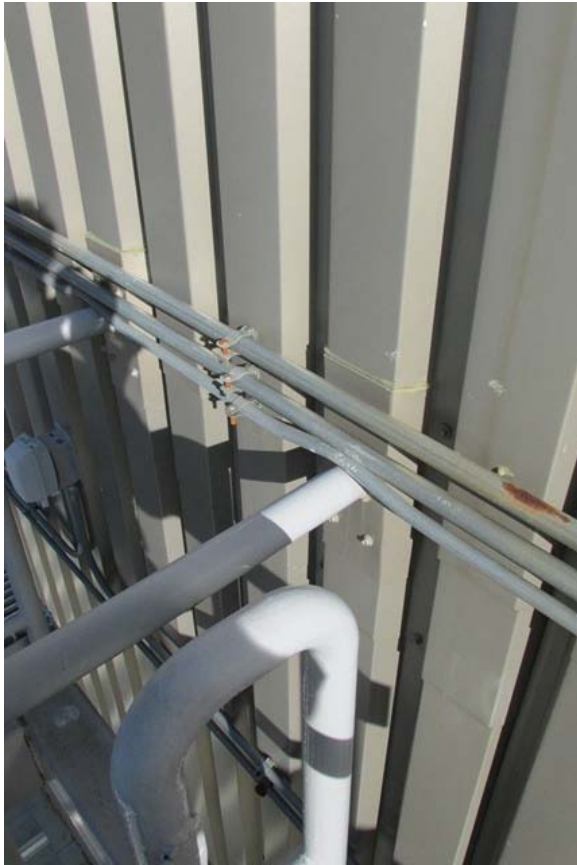
Figure 22 Wall penetrations thru west wall at Mech. Mezz.

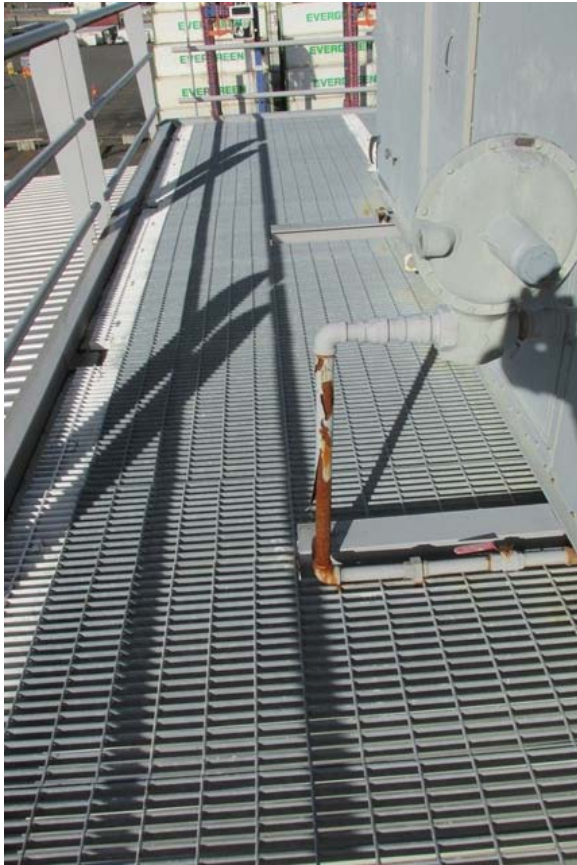
Figure 25 Mech. Mezz. Floor grating and pipe condition.

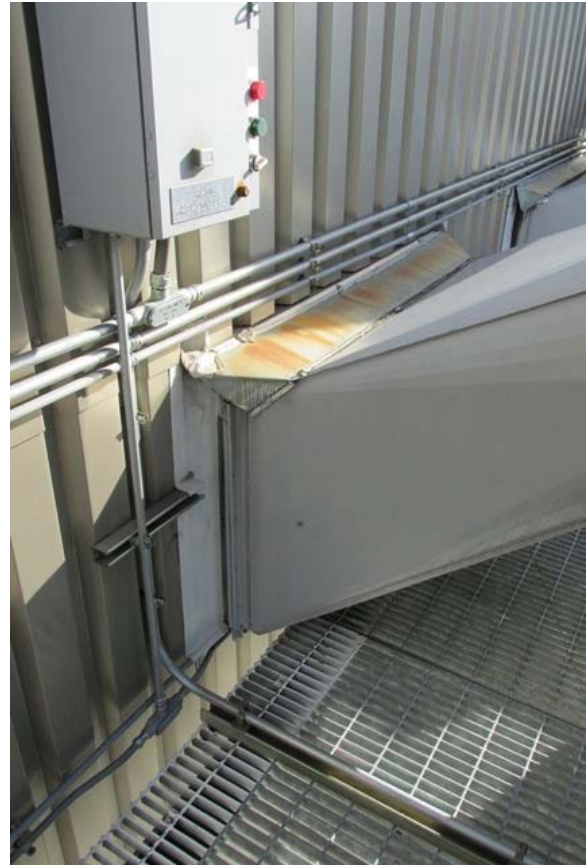
Figure 26 Mech. Mezz. Duct penetration of West wall.

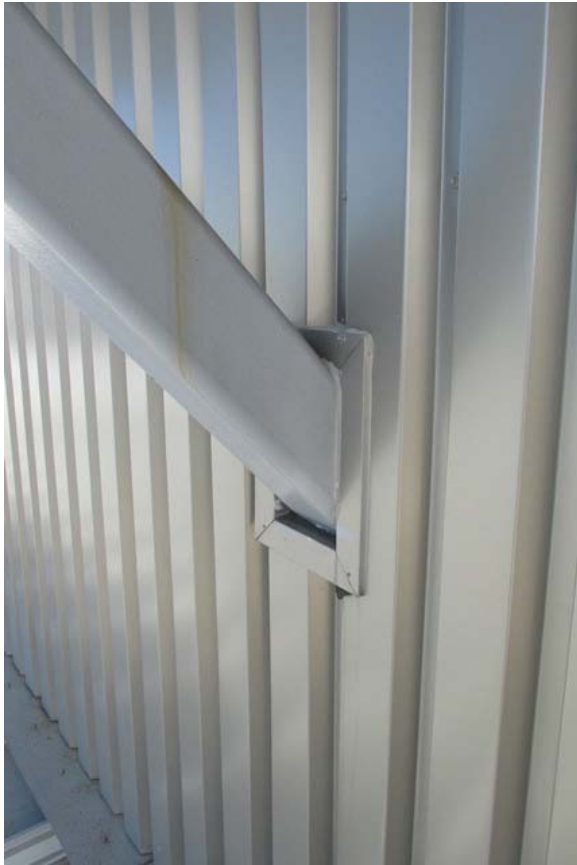
Figure 31 Wall penetration at Mech. Mezz support brace.

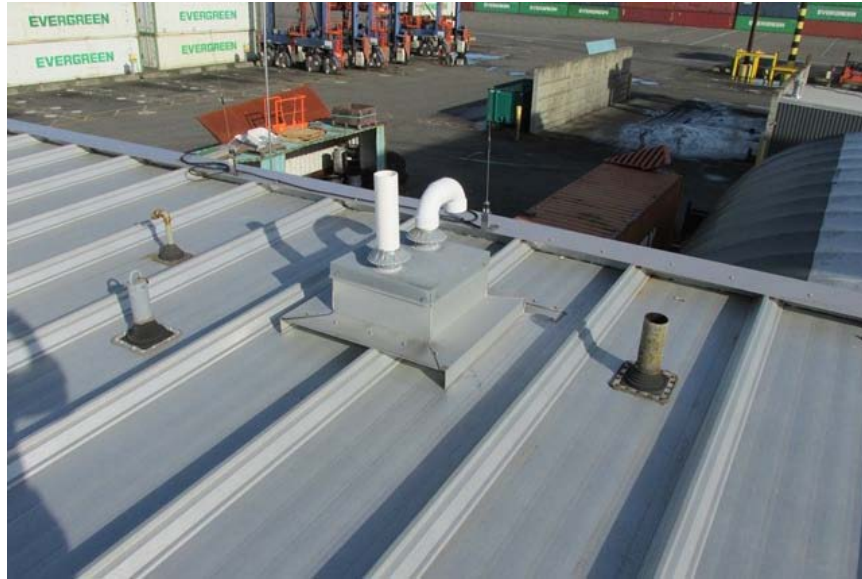
Figure 33 Roof Penetration over Service Bays North end of building view east.

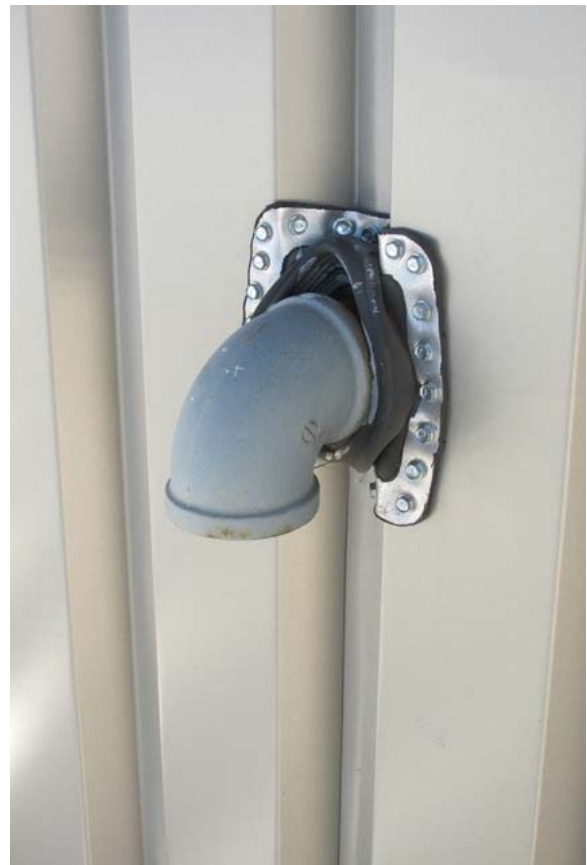
Figure 35 Wall Penetration boot condition.

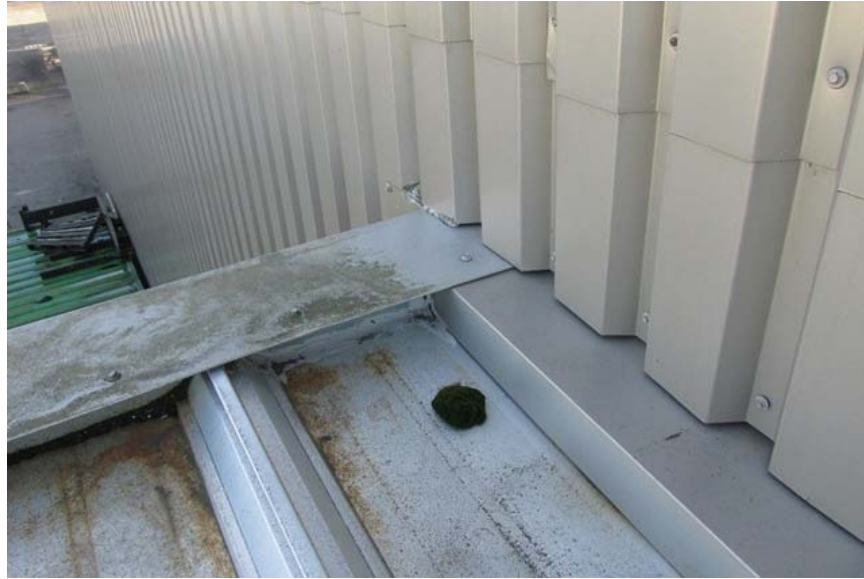
Figure 36 Roof edge condition at north end of Strad Service bay over lower roof, view East.

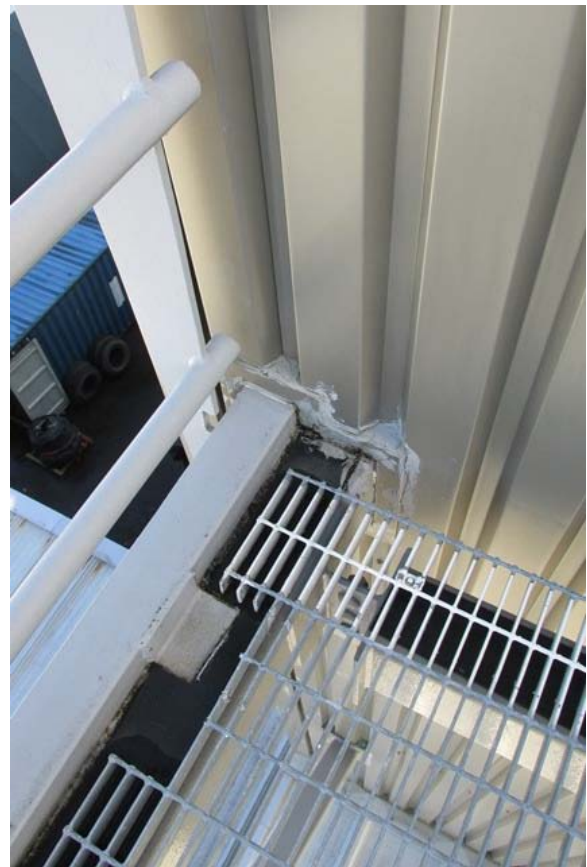
Figure 38 North end of Mech. Mezz at wall penetration.
