RE: TOTE Truck Scale Canopy Roofs

Project Overview:

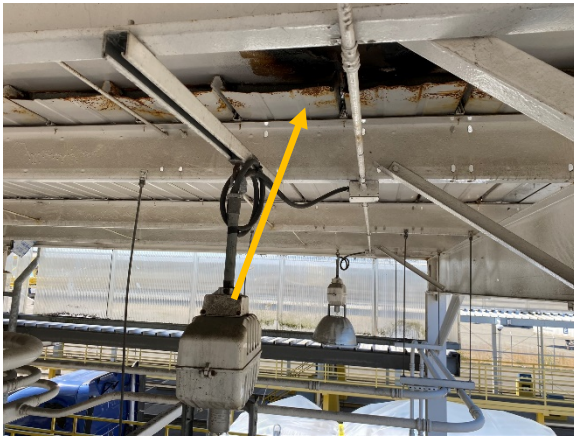
The existing roof assembly consists of standing seam metal roof panels installed directly over 8" structural "zee" purlins spaced at 5'-0" on center. All roofs are of low slope (approximately 1:12) and subject to harsh marine conditions within 300' of the shoreline. Significant deterioration of the roof panels was observed in spots from the underside as shown in Exhibit B. Widespread flaking of the panel finish is also seen on the underside, exposing the bare substrate of the metal panel in some locations per Exhibit C. The canopy structure itself appears to be in generally good condition, however structural channels along both rake edges were found to have considerable corrosion (Exhibit D).

Exhibit B – Deterioration at Underside of Panel

Deterioration of the upper main roof panels is widespread and generally beyond repair. A complete tear-off and replacement of the metal roofing at both canopies is recommended to protect the main structure below. In addition, c-channels at the rake edge of the canopy should also be replaced. Replacement roof panels should have a high-build Kynar finish suitable for marine conditions. The installation of bird deterrent at both canopies is also strongly recommended.

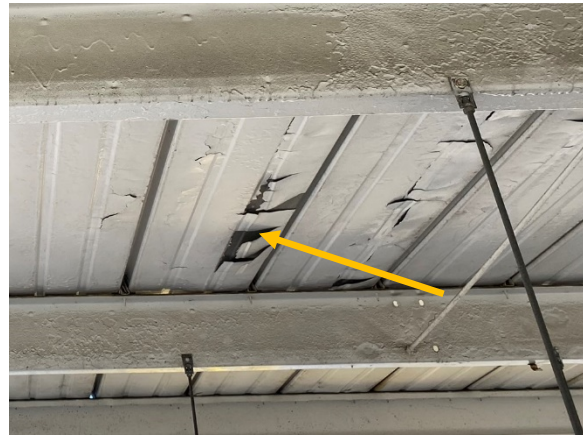
Exhibit C – Flaking and Exposed Panel Substrate

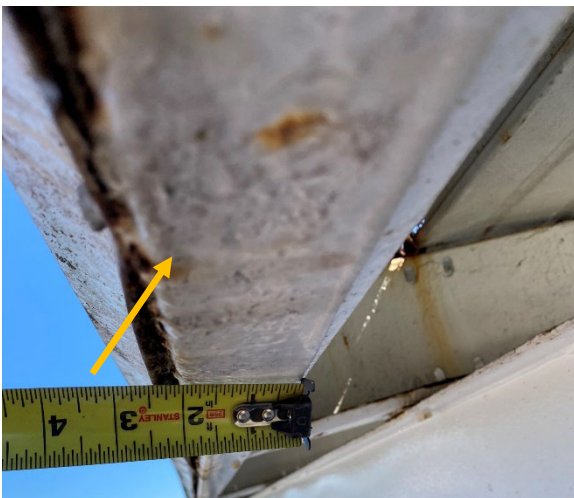
Exhibit D – Corrosion at Structural End Channel

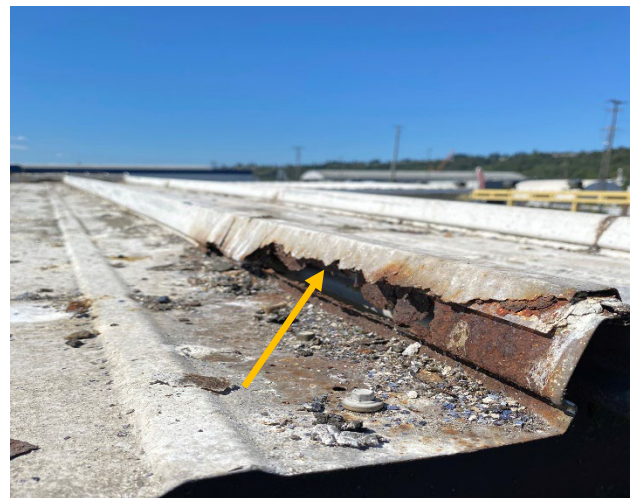
Deterioration of the existing metal panels becomes more apparent from the roof level. Exhibit E illustrates the standing seam portion of the panel corroded to the point of disintegration. This is generally more prevalent along the roof eaves however similar damage is observed near the panel edge at the ridge line. This author also encountered several nests with hostile, unabated seagulls while on the roof.

Exhibit E – Corrosion at Existing Roof Panel

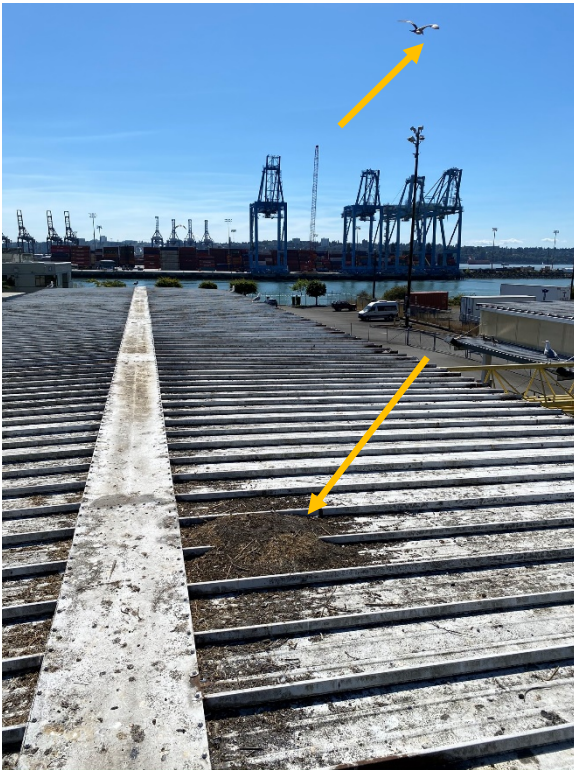
Exhibit F – Bird Nests at Canopy Roof

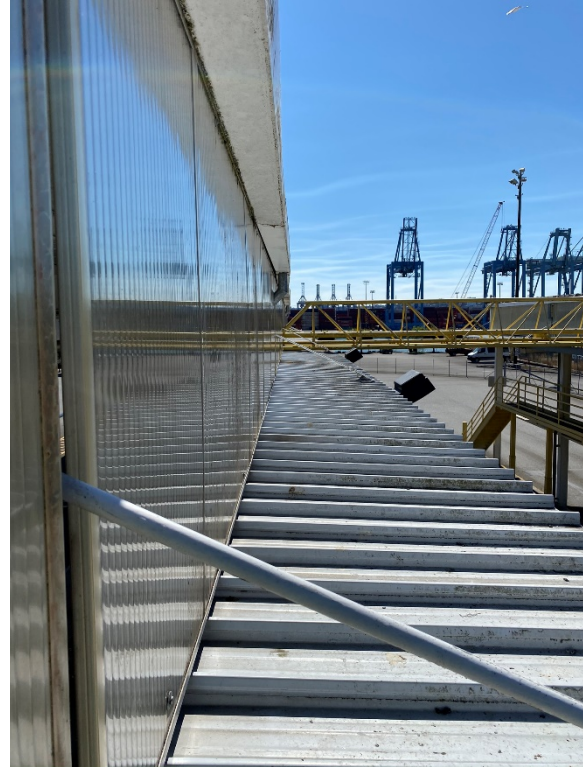
Lower roofs above the catwalk area are much smaller in size (approximately 5') and are in generally good condition (Exhibit G). Panels in this area have a different profile and appear to have been installed more recently than the main roof above. Panels extend beneath translucent wall panels at the peak and have no gutter at the eave.

Exhibit G – Lower Catwalk Roof

Panels above the lower catwalk area appear to be in good shape and show no signs of deterioration. At this time, no work is recommended in these areas.
