Memo

subject: Port of Tacoma: 1940 East 11th Street Building Soil Excavation Sampling and Documentation

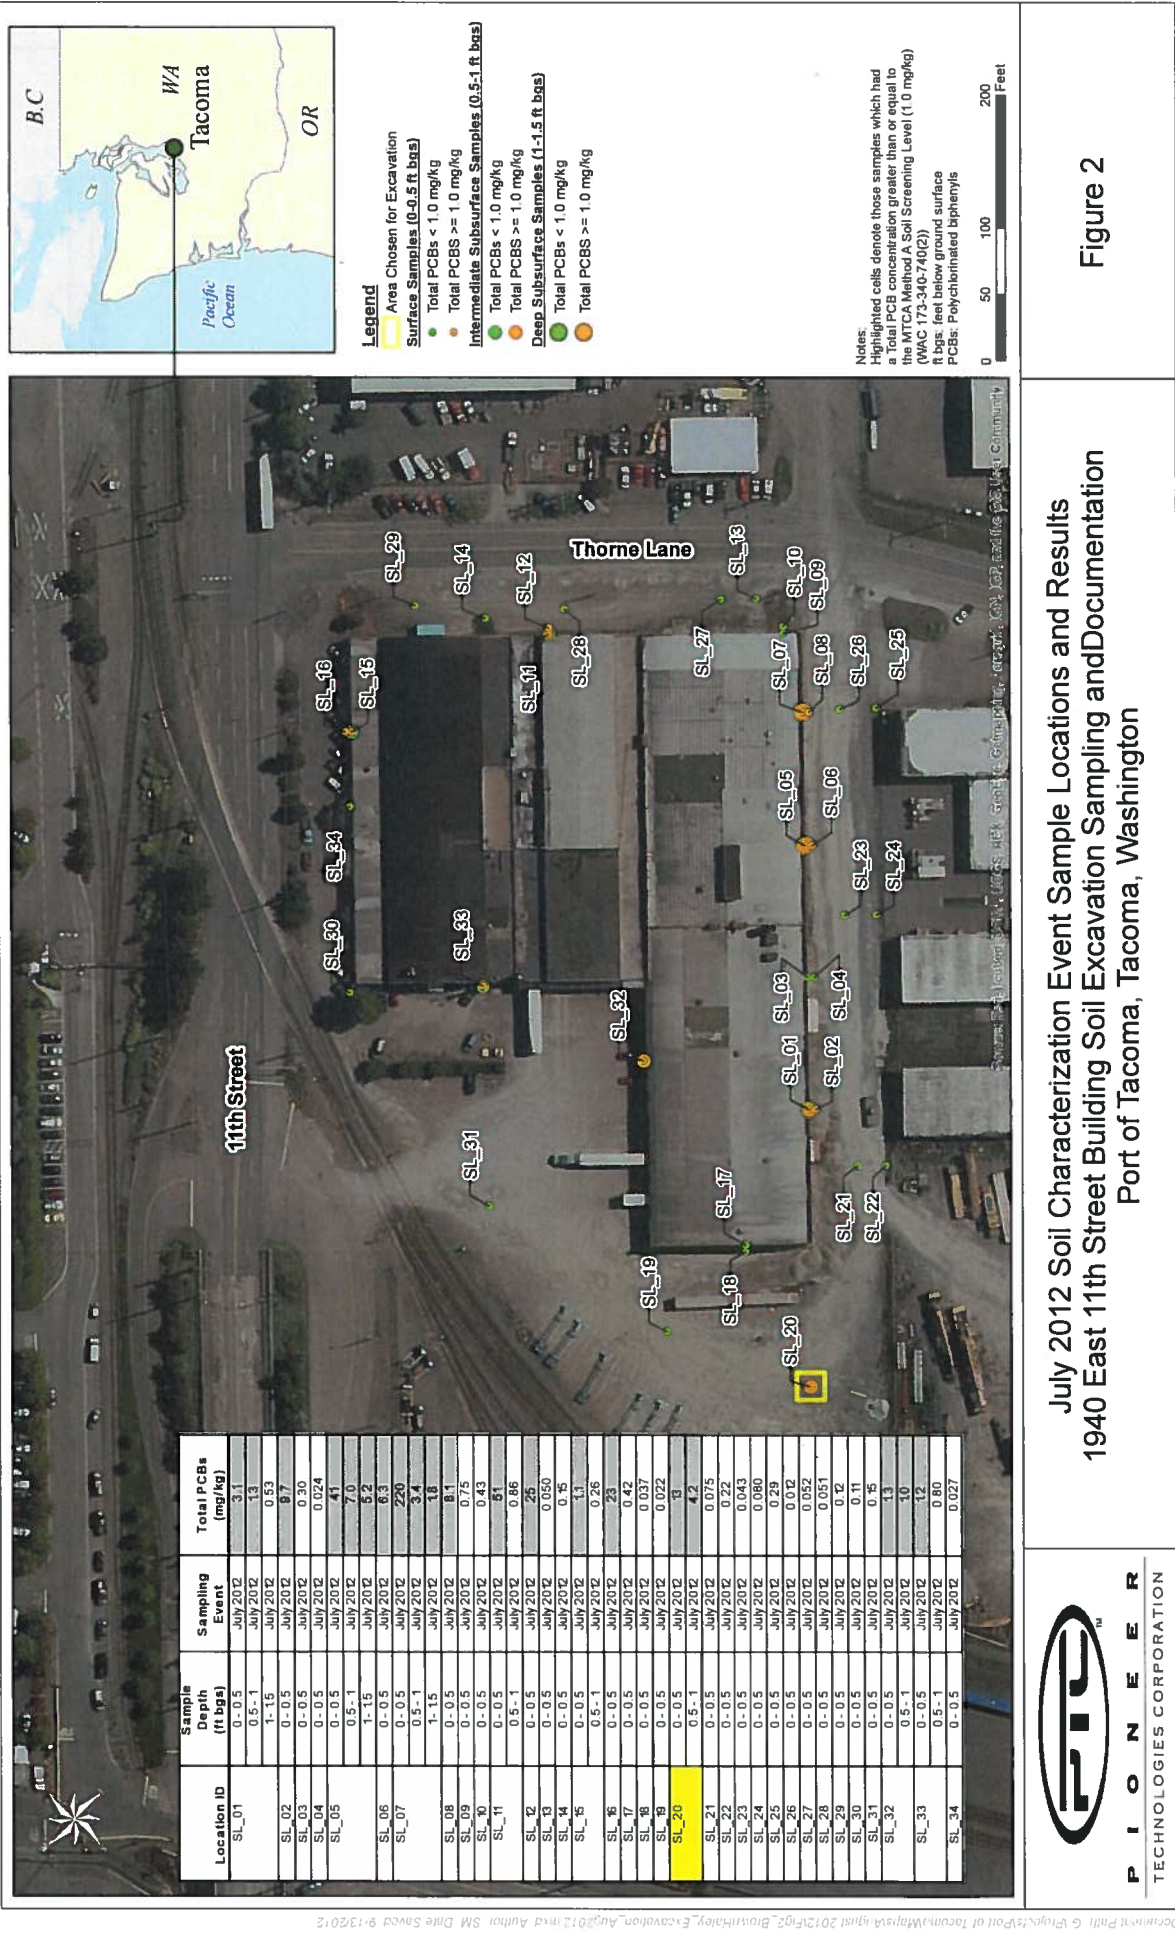
Figure 2

July 2012 Soil Characterization Event Sample Locations and Results
 1940 East 11th Street Building Soil Excavation Sampling and Documentation
 Port of Tacoma, Tacoma, Washington

PIONEER conducted a soil characterization event at the building in July 2012 (PIONEER 2012a). Results of that characterization event showed concentrations of PCBs in soil which exceeded the Model Toxics Control Act (MTCA) Method A Unrestricted Land Use soil cleanup level (CUL) of 1 mg/kg (WAC 173-340-740(2)) (Washington State Department of Ecology [Ecology] 2012). Exceedances in soil were located adjacent to the building, and in one location at the south end of the building in an open gravel area (SL_20) (see Figure 2). The excavation activities described in this memo were initiated to remediate the soil exceedances located in the open gravel area only. Other soil exceedances will be remediated during future building demolition and cleanup activities.

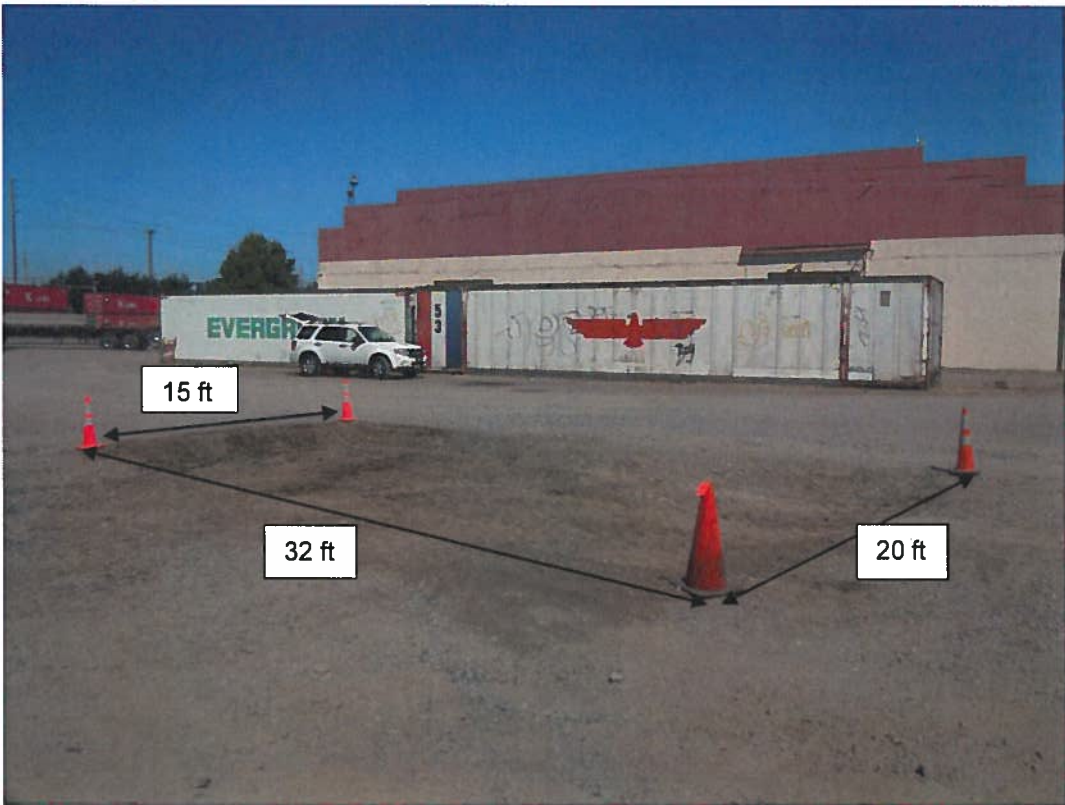
Photo No. 6: Site Condition

Date: 8/28/12	
Direction Photo Taken: North	
Description: Round 3 Excavation – Final excavation extent. Excavation area is 1 ft deep.

Round 3 excavation activities commenced on August 28th, 2012 on the northwest excavation sidewall (see Photos 5 & 6 and Figure 3). The approximately 5 x 20 foot excavation was advanced to one foot, extending northwest of the existing excavation sidewall. Approximately four cubic yards of soil were excavated and added to the existing soil stockpile near the loading docks (see Photo 8 and Figure 4).

The total PCB concentration from sample SW3_1.0_082812 was lower than the MTCA Method A CUL. Based on the results of this sample, no further excavations were necessary. The open excavation footprint was backfilled with clean gravel, and returned to the original grade.
