# Appendix A - Port of Tacoma SWPPP Short Form

# Hazardous Materials Survey

Port of Tacoma has contracted with Tetra Tech, Inc. (Tetra Tech), to conduct a Hazardous Materials Survey (Survey) prior to demolition of a small metal shed for a project known as the EBC Tenant Improvement (Tenant Relocation) Project No. 101686.01, Tacoma, Washington (the Site).

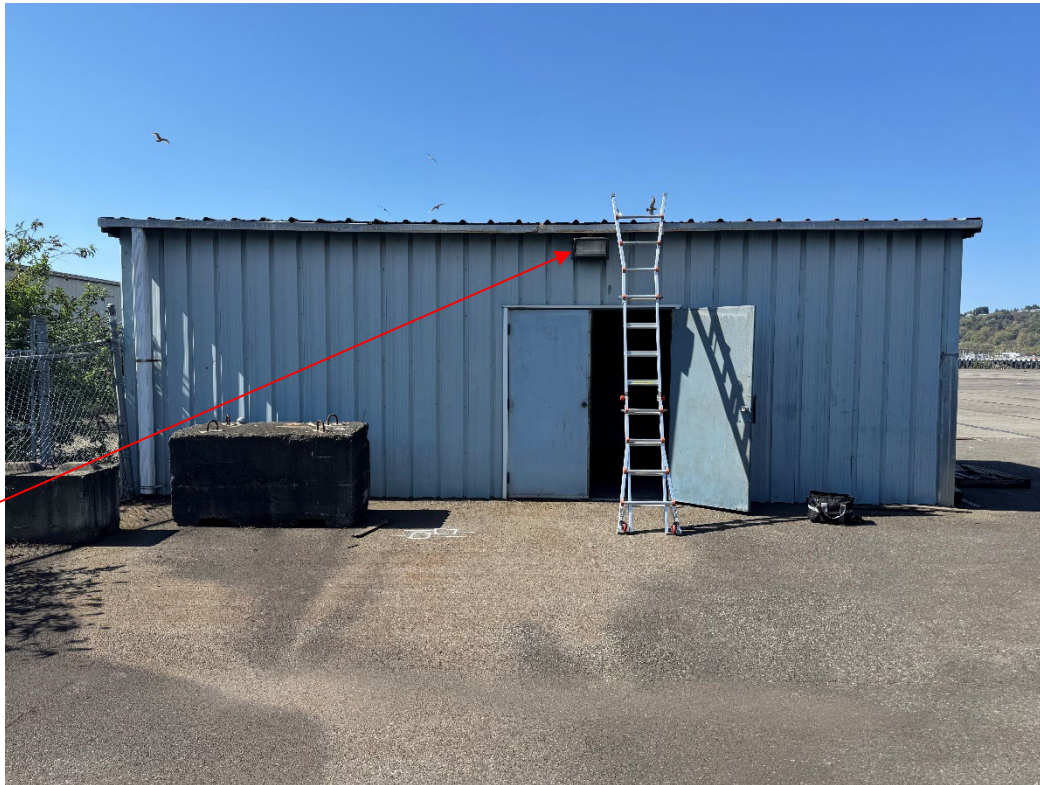
Photo 1 - Shed (12'W x 30'L x 10'H) to be demolished on EBC Tenant Property.

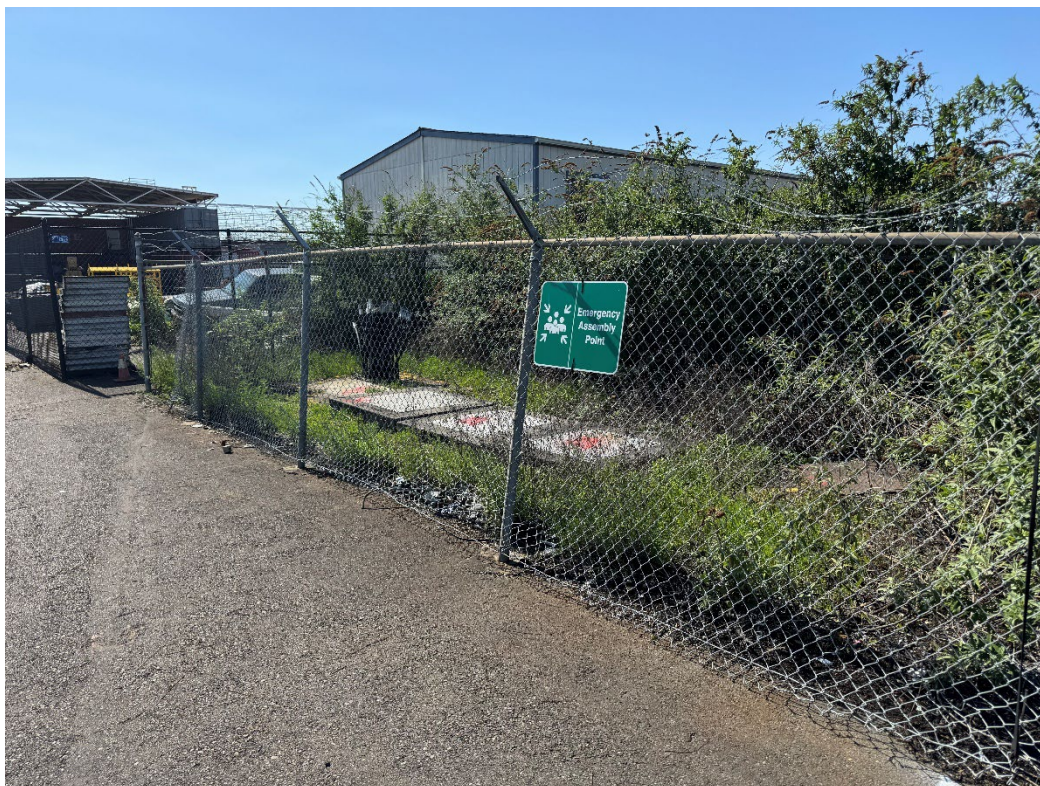
Photo 2 - Fenced area SW of Shed with former transformers, non-ACM power leads connected to vaults under Shed, and other exterior utility vaults. No ACM found in this area.

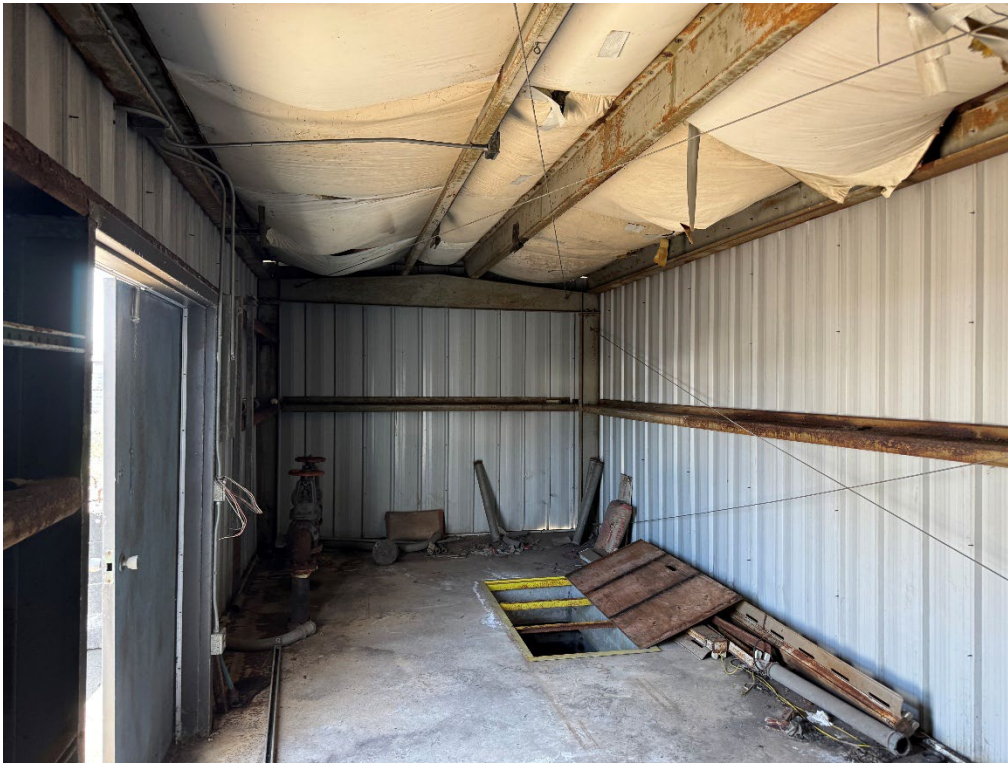
Photo 3 – Inside Shed, 8' Fluorescent Light fixtures with PCB ballasts on right.

All light ballasts are assumed to be magnetic ballasts which contain <50 ppm PCB. Ballasts without a “no-PCB” label are considered to contain PCBs >50 ppm. The Toxic Substance Control Act regulation requires special handling and disposal of building materials, including PCB light ballast (capacitors), that contain >50 ppm of PCBs. Tetra Tech recommends that all light ballasts be tracked, removed, handled, and disposed of in an appropriate manner. The ballasts with the “non-PCB” label (or something similar) shall be packaged for recycle by an approved recycling facility.

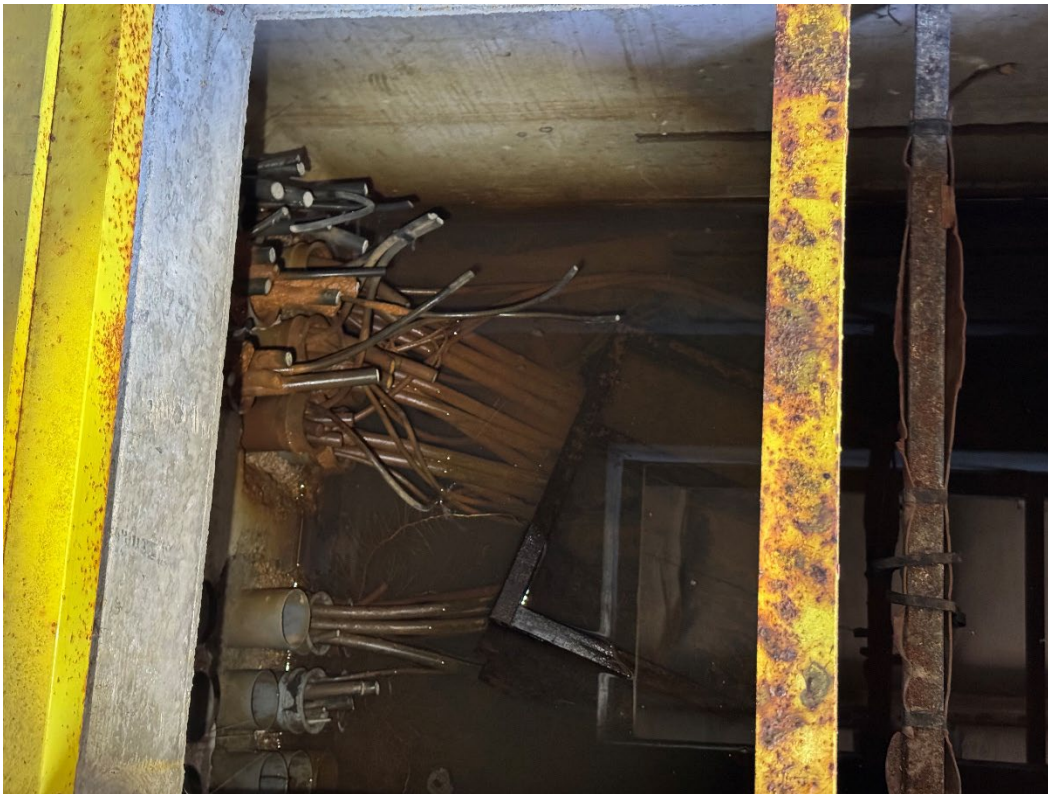
Photo 4 – Inside flooded vault, wires are non-ACM, conduit is plastic, not suspect ACM.

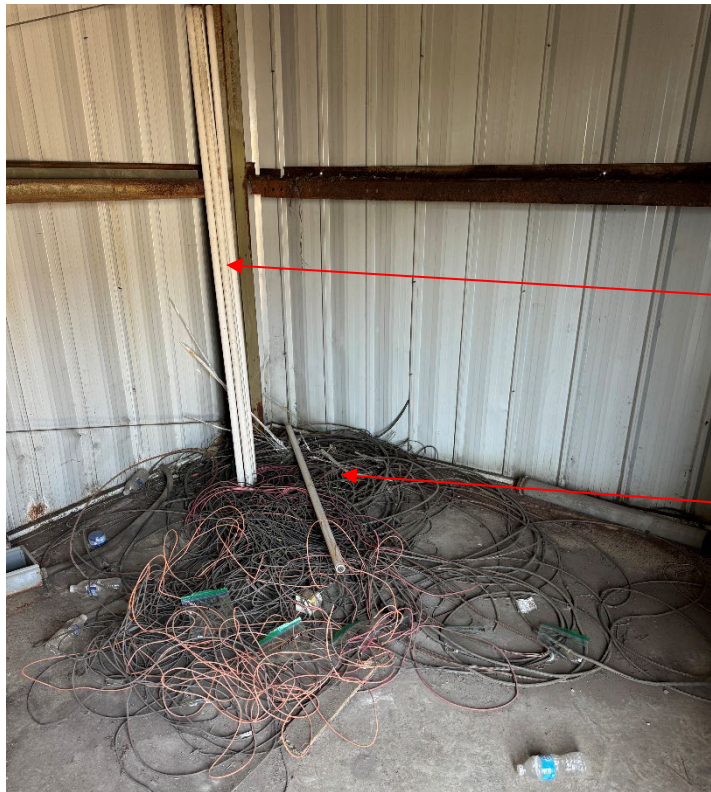
Photo 5 – Pile of non-ACM wire, along with 8' mercury containing fluorescent light tubes. 1 broken tube in corner over lights.

Mercury-containing fluorescent light tubes.

Broken mercury light tube mixed in with piles of non-ACM wire.

- Immediately place lamps showing evidence of leakage, damage, etc. into a container following removal.
- Use appropriate cleaning techniques to clean the damaged light tube, and clean or dispose of building materials impacted by the broken light tube (see **Appendix D**, Photolog).

A mercury cleanup will be required prior to demolition.

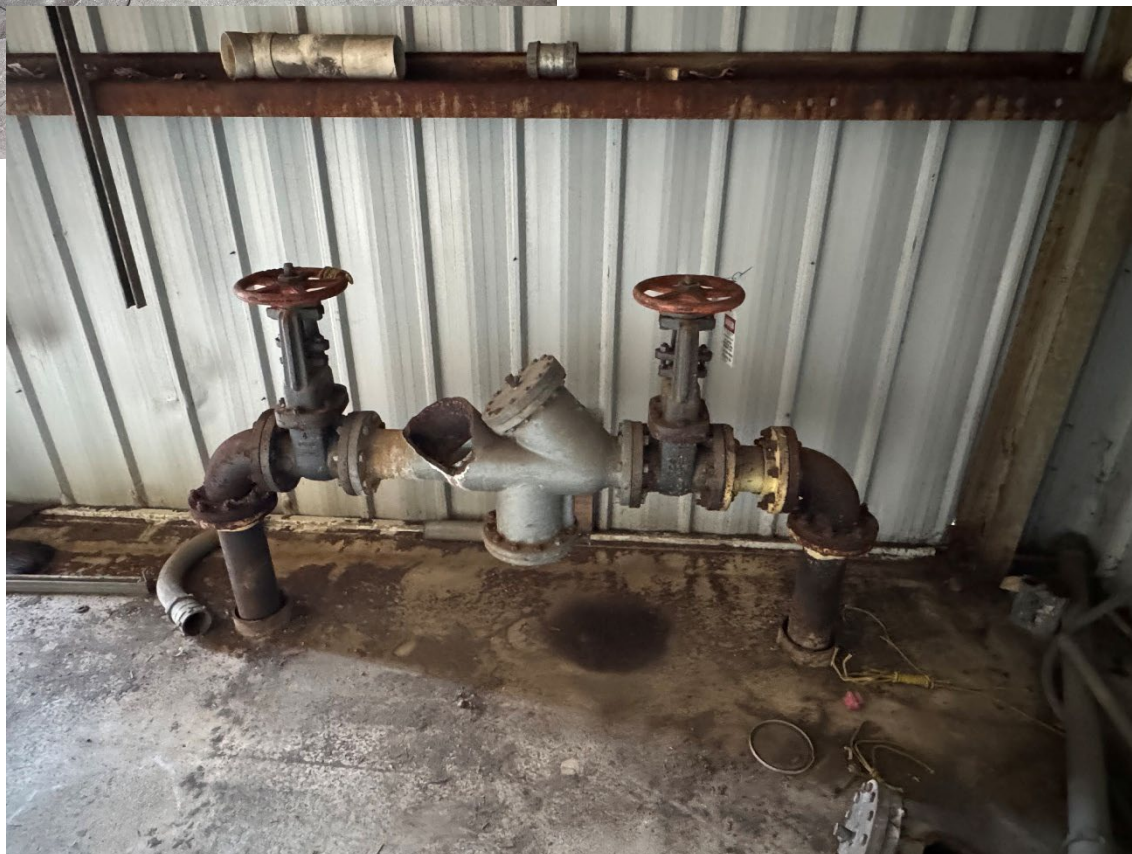
Photo 6 – Pipe riser inside Shed, with AACM gaskets in pipe flanges, and AACM packing inside screw valves. Demolition is planned to slab on grade, which means that this riser would be cut off at concrete. A certified asbestos contractor could cut the riser in-tact, wrap in two layers of 6-mil poly, and dispose as ACM. Other removal methods are also possible.

AACMs were identified within the Shed slated for demolition. Tetra Tech recommends that a licensed asbestos-abatement contractor in accordance with WAC 296-62 remove all asbestos-containing and asbestos-contaminated building materials prior to disturbance. Site specific recommendations are provided for your consideration:
