PORT OF TACOMA  
WEST HYLEBOS LOG DOCK REPAIRS  
SITE PLAN

**PORT OF TACOMA**  
**WEST HYLEBOS LOG DOCK REPAIRS**  
**REPAIR PLAN**  
**BENTS 39 TO 77**  
TOWNSHIP: 21N RANGE: 03E SECTION: 36  
M. ID: 201016.01 DAT-HRZ: WA83-SF VERT: MLLW 19.39' @ Tide 22 1933  
PARCEL: DRAWING SCALE: AS NOTED

PORT OF TACOMA  
WEST HYLEBOS LOG DOCK REPAIRS  
REPAIR DETAILS  
SHEET 3

| | SITE PHOTOGRAPHS | | WEST HYLEBOS LOG DOCK REPAIRS | | PORT OF TACOMA | | WEST HYLEBOS LOG DOCK REPAIRS | | APPROVED: | | APPROVED: | | APPROVED: | | APPROVED: | | APPROVED: | |

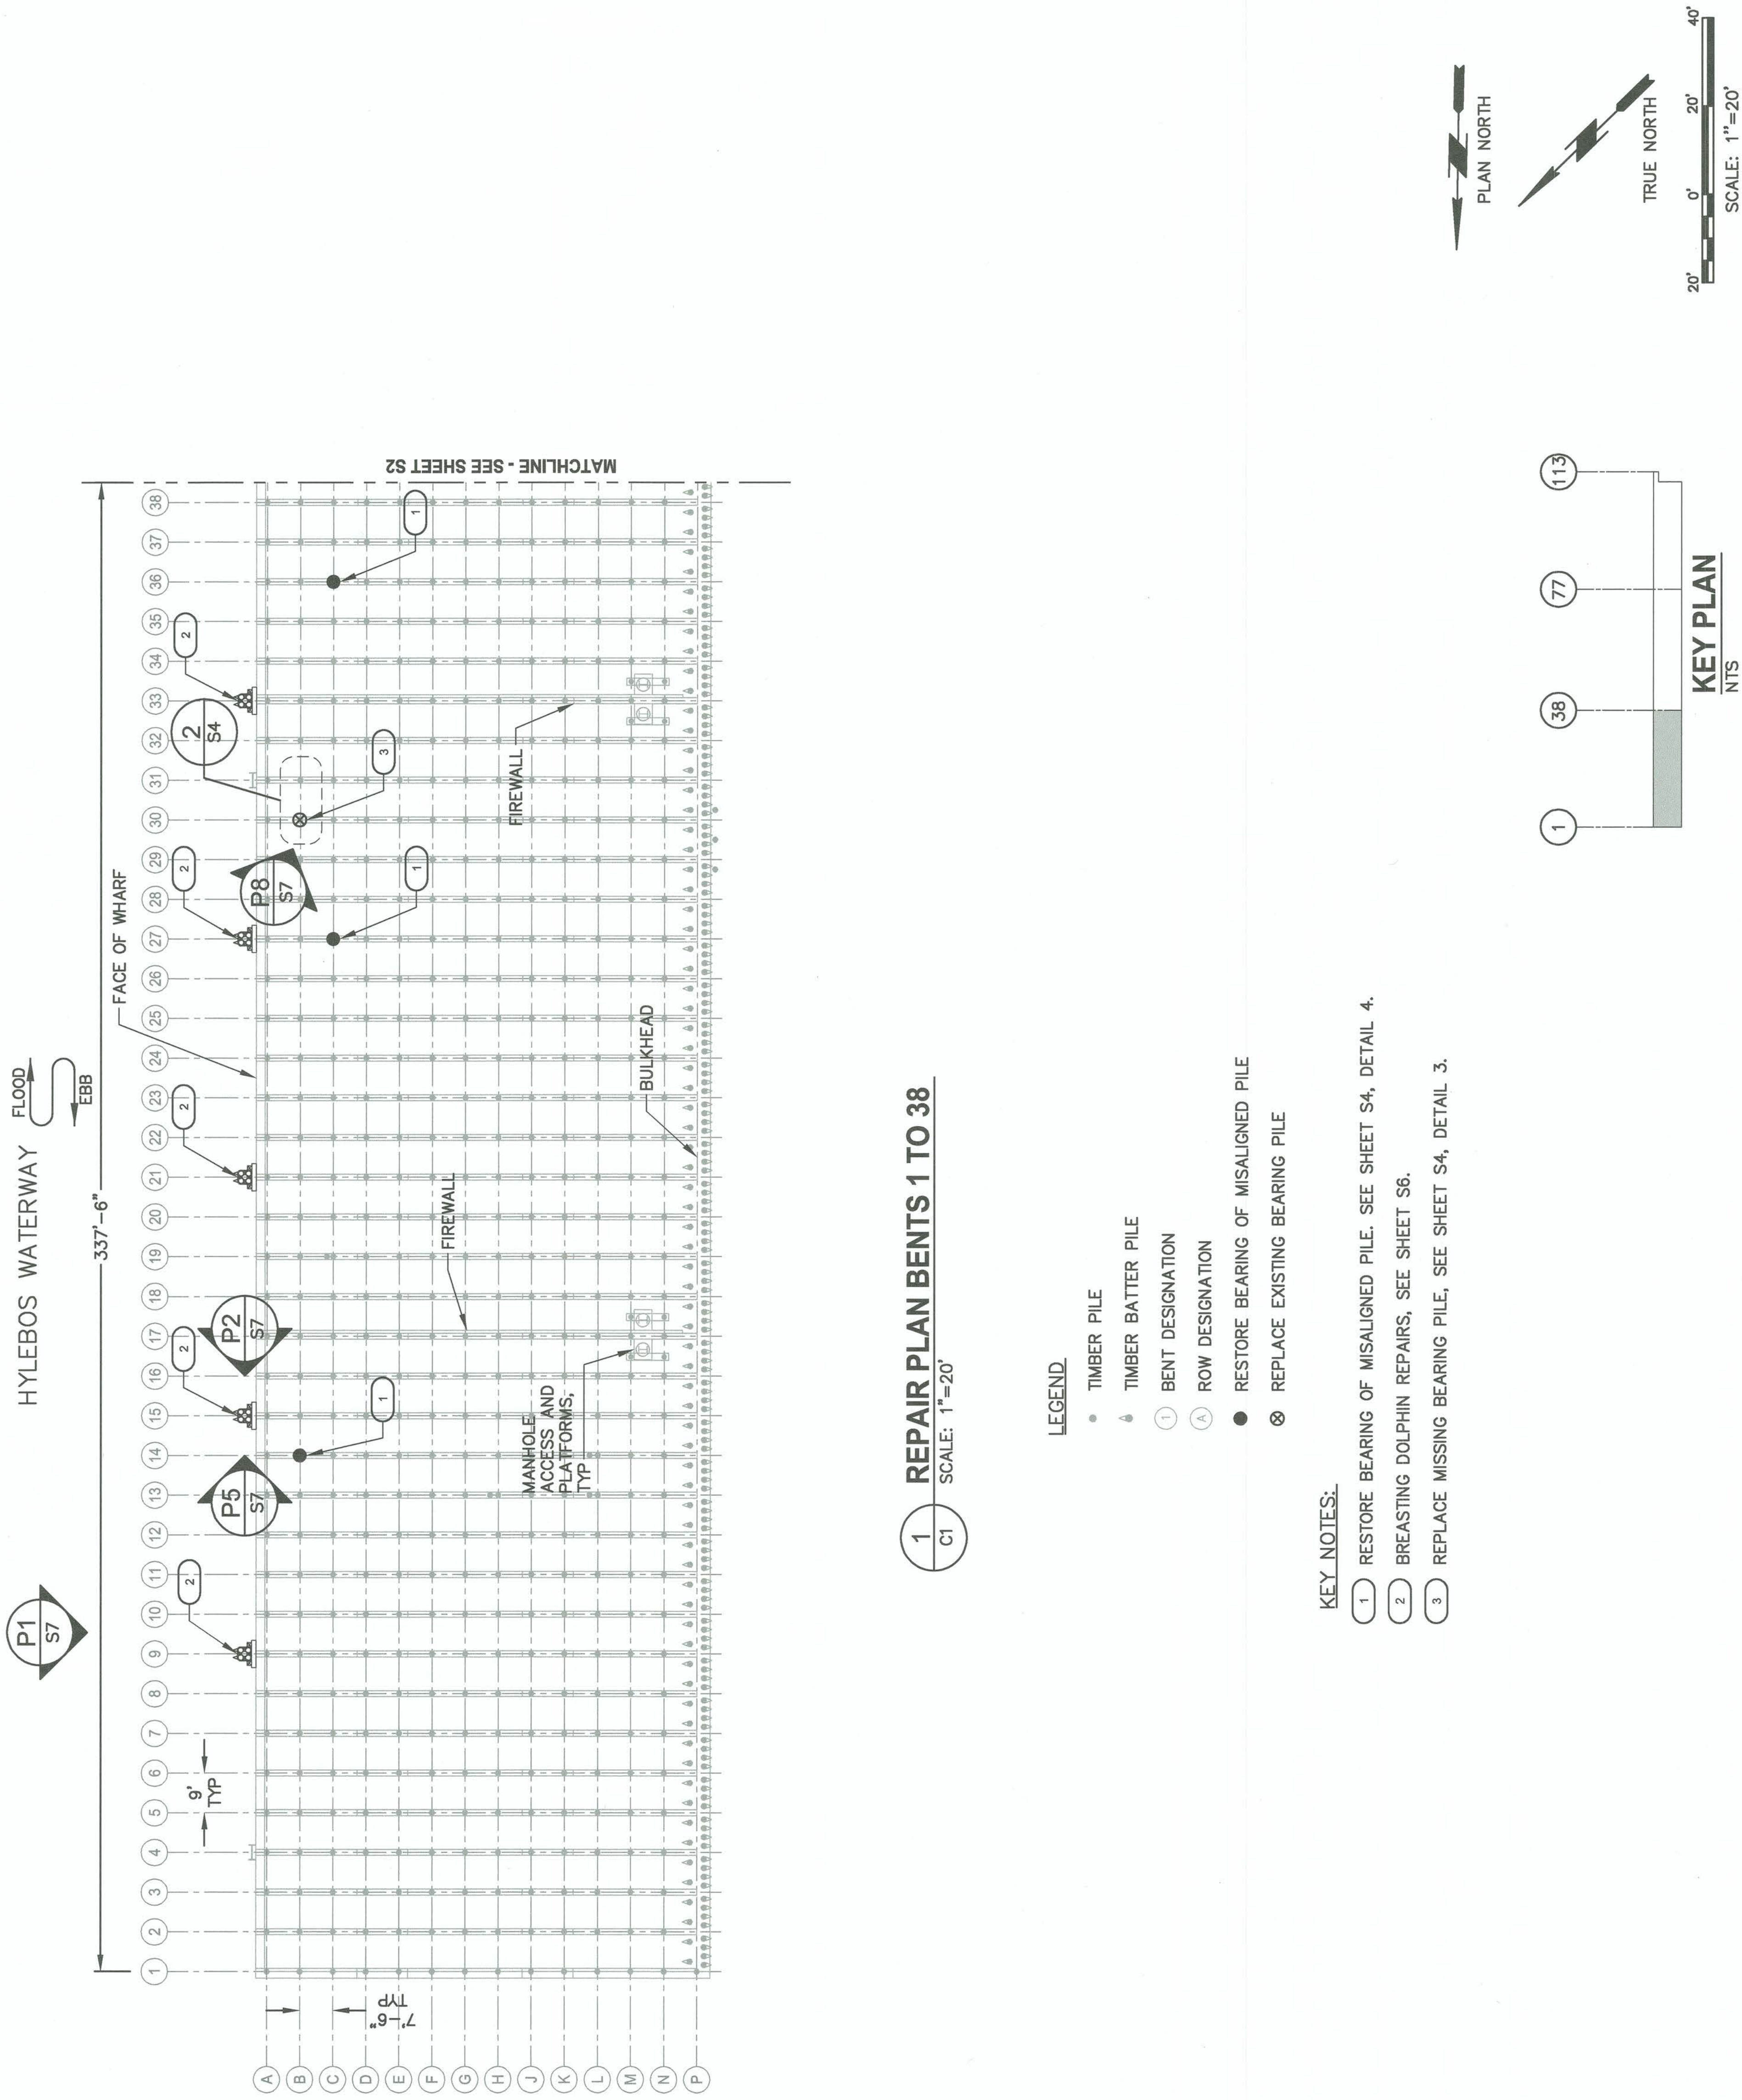
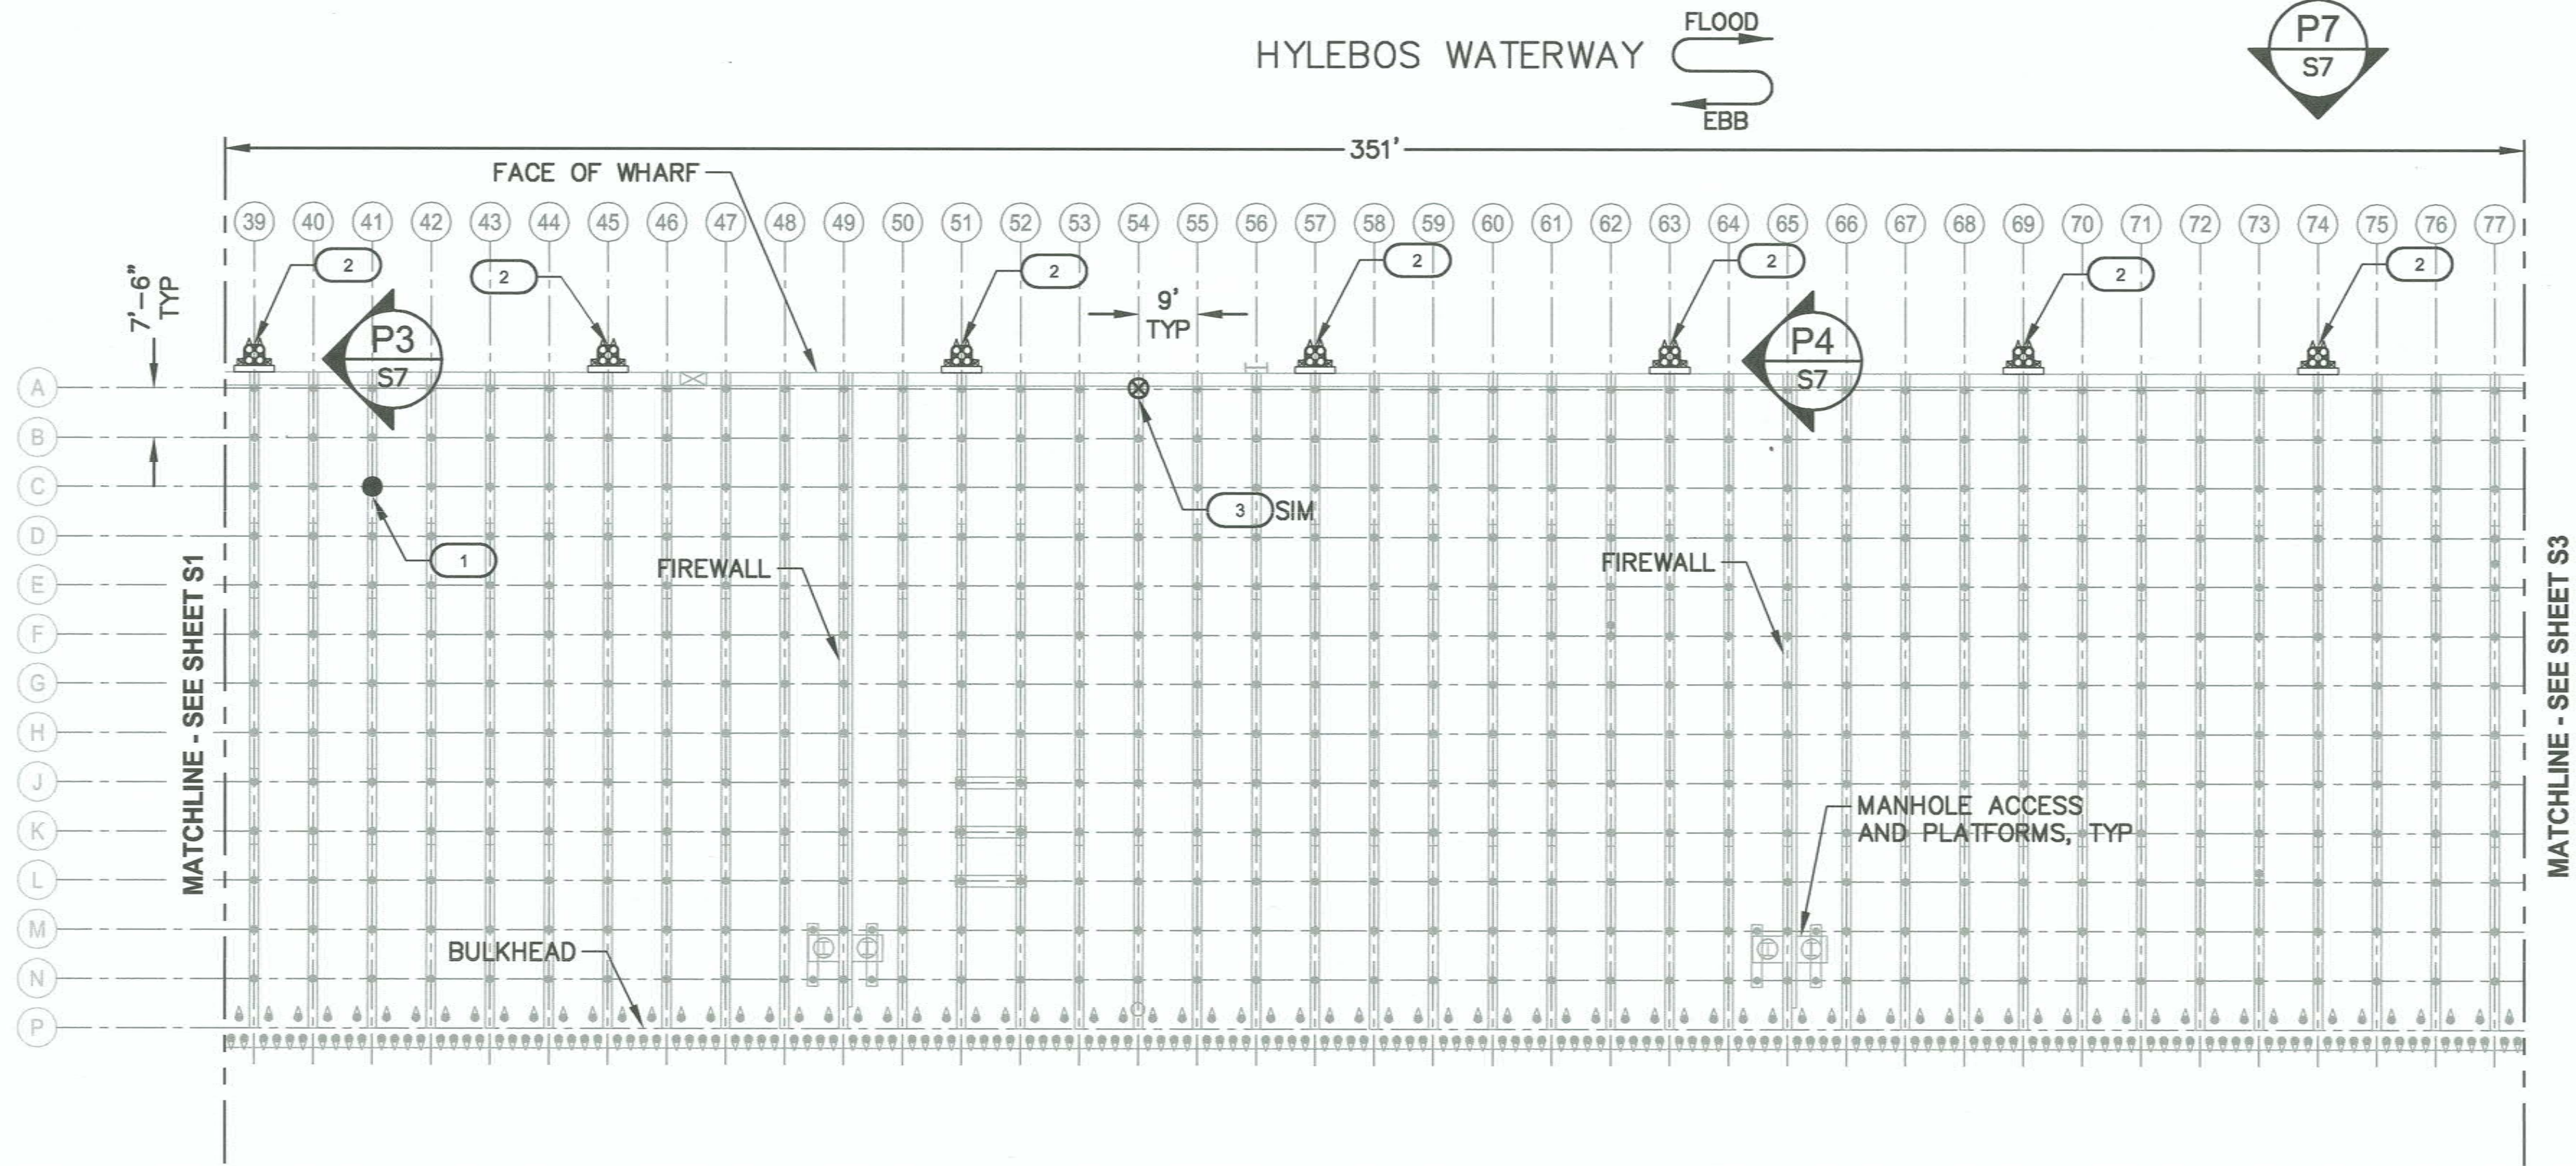
**2**  
C1 **REPAIR PLAN BENTS 39 TO 77**  
SCALE: 1"=20'

- ① RESTORE BEARING OF MISALIGNED PILE. SEE SHEET S4, DETAIL 4.
- ② BREASTING DOLPHIN REPAIRS, SEE SHEET S6.
- ③ REPLACE MISSING BEARING PILE, SEE SHEET S4, DETAIL 3.

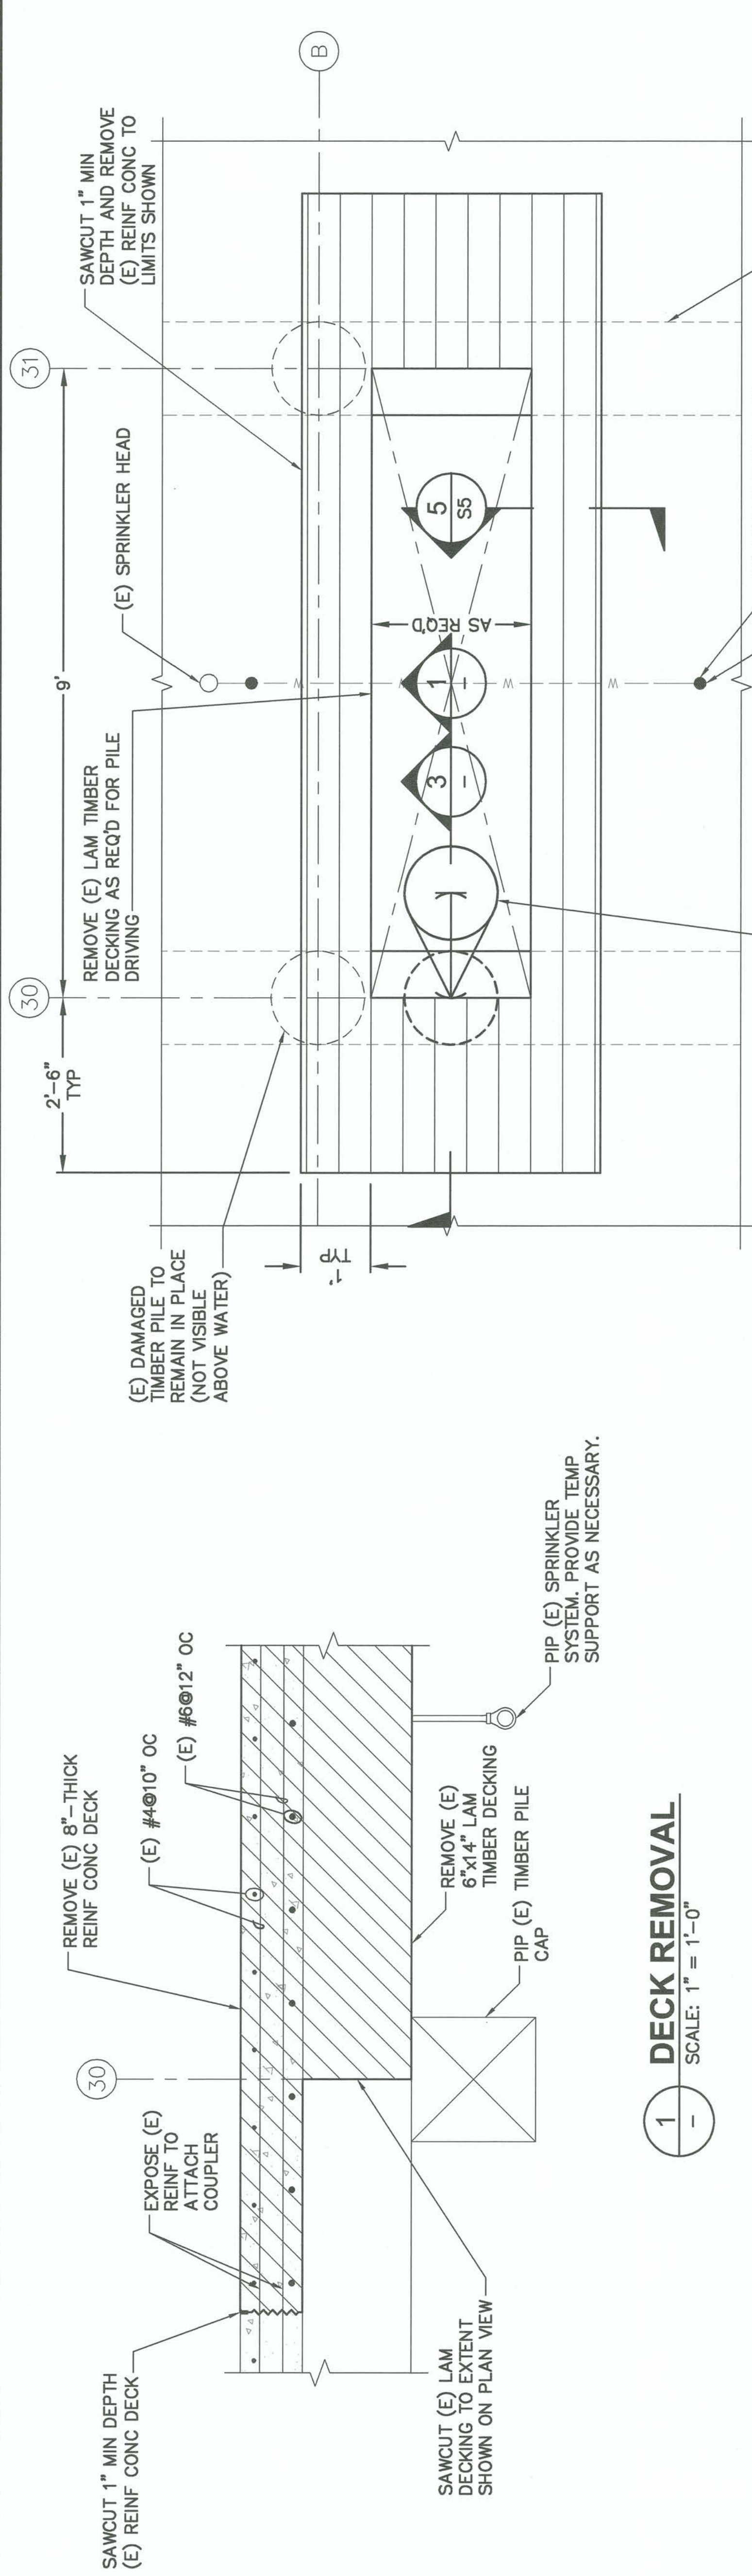
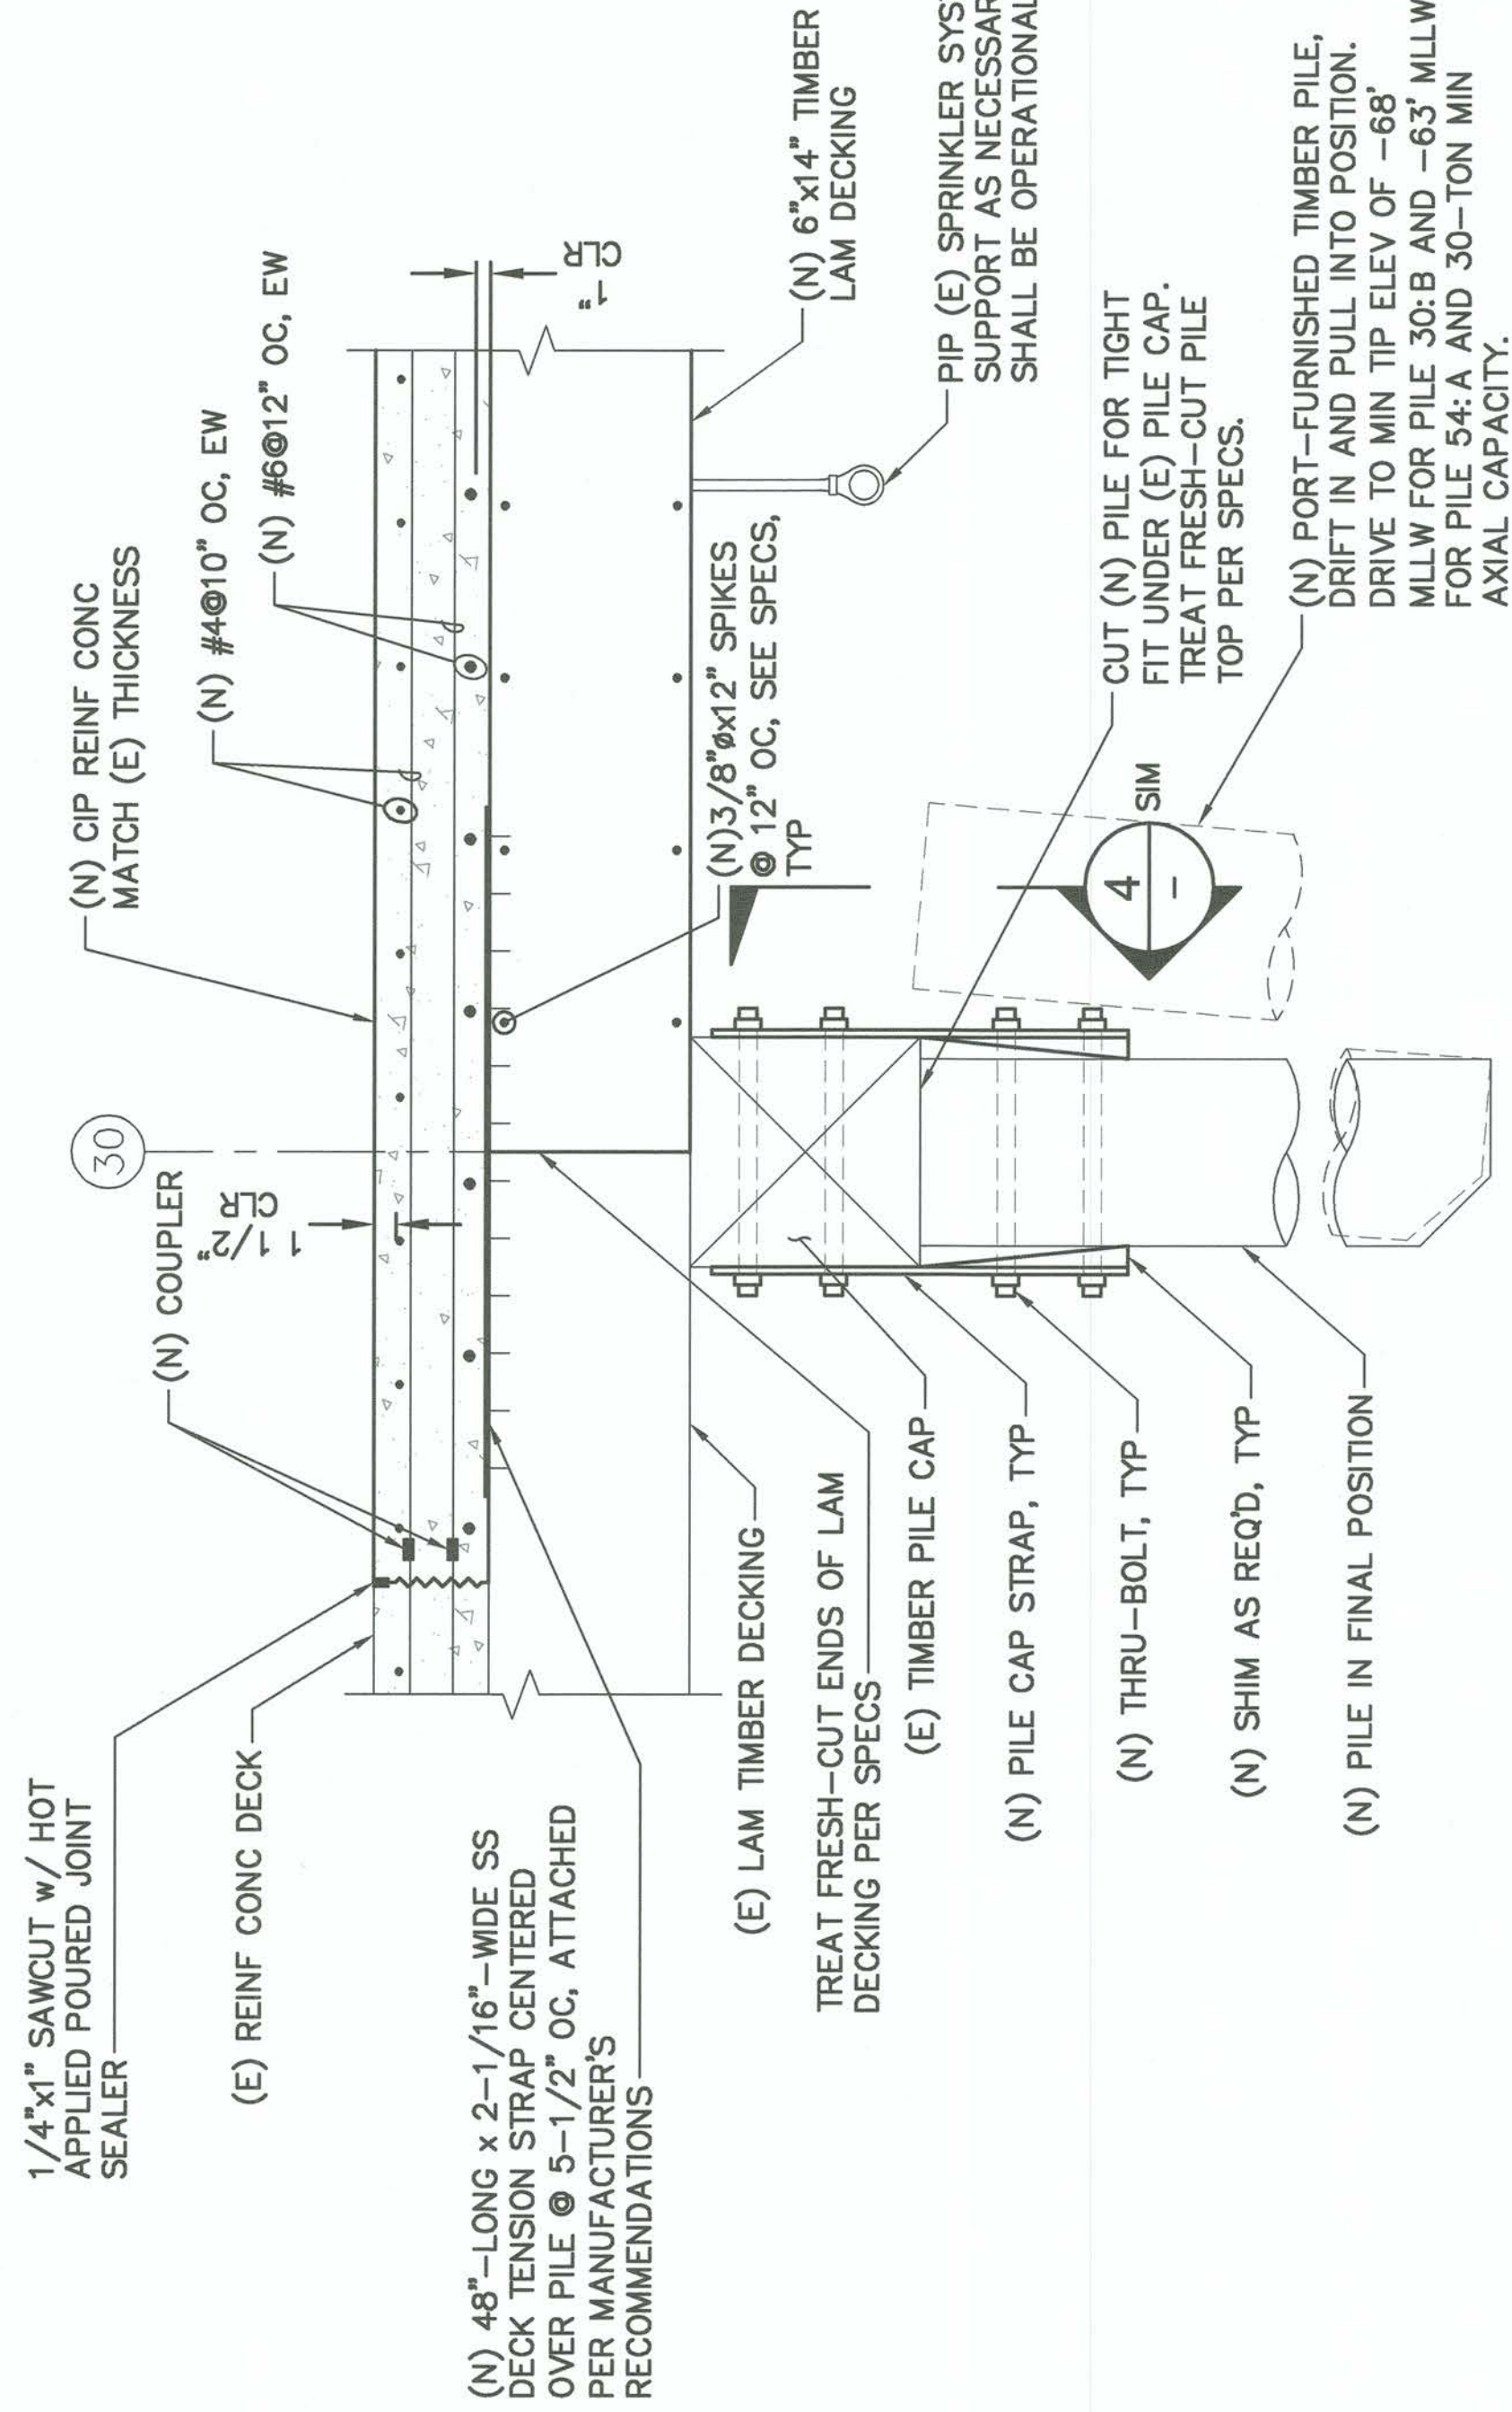
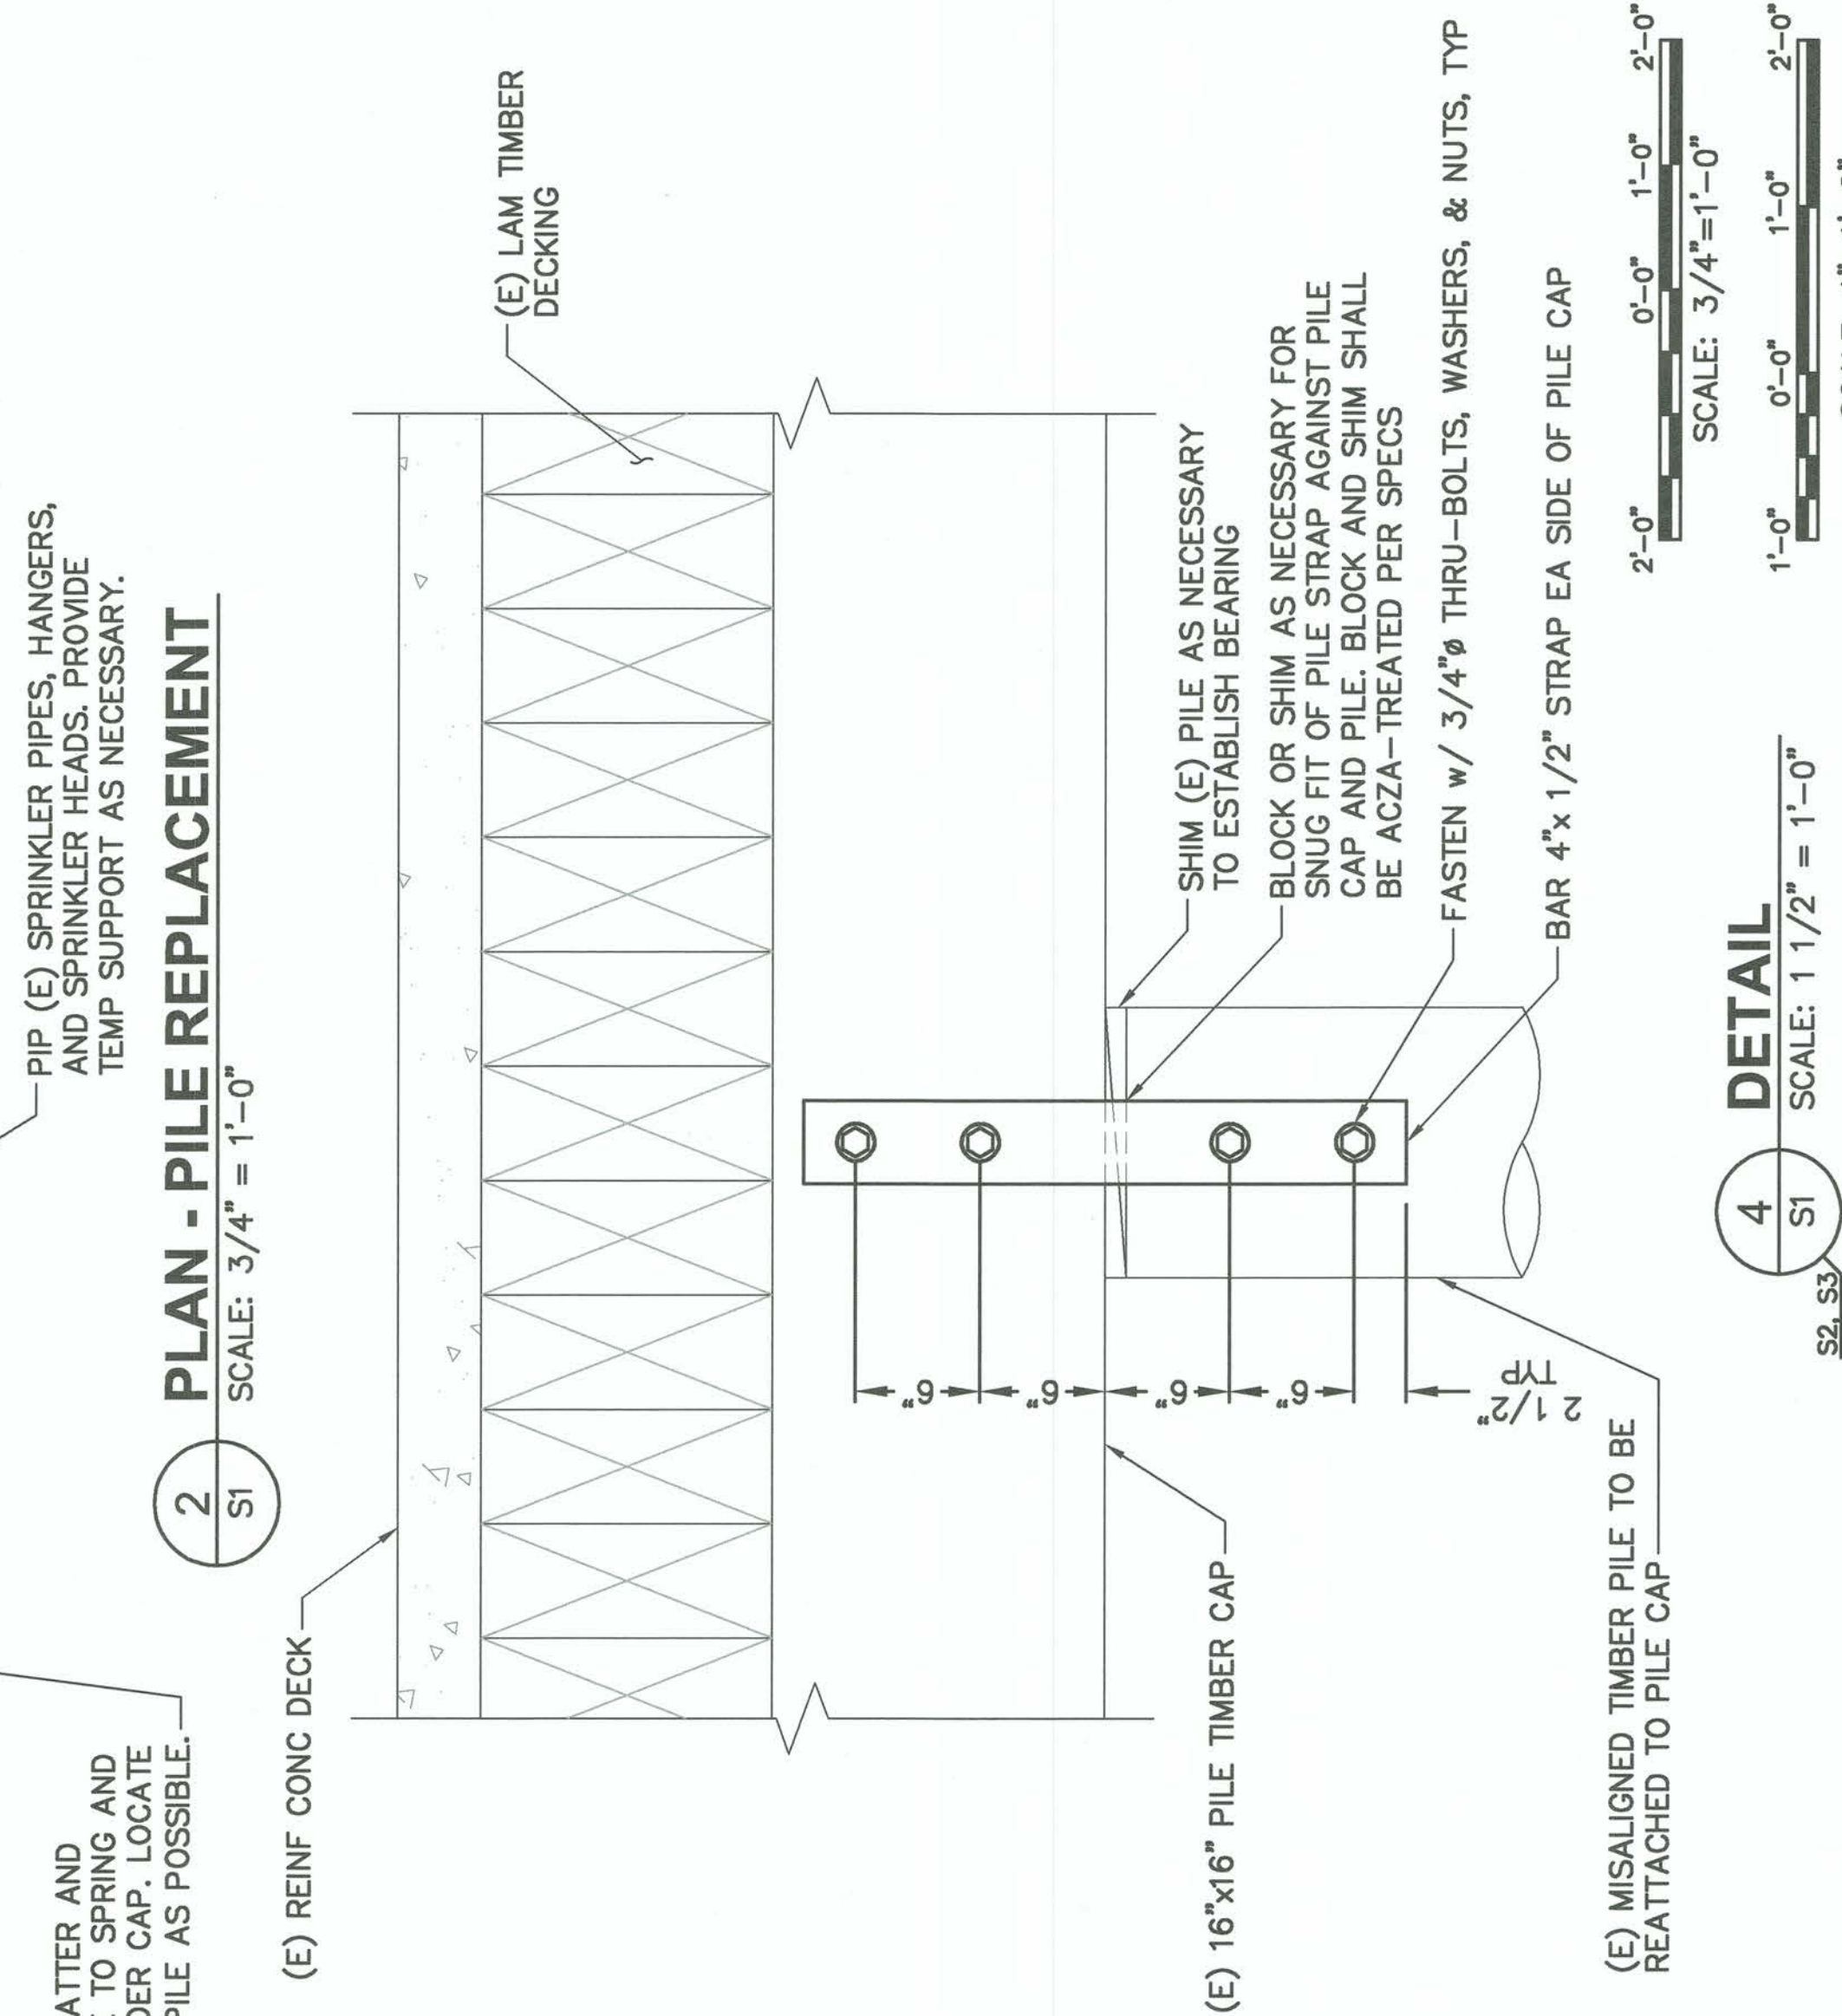
## SECTION - PILE REPLACEMENT

NOTE: DECK REMOVAL AND RESTORATION  
NOT REQUIRED AT PILE 54: A.

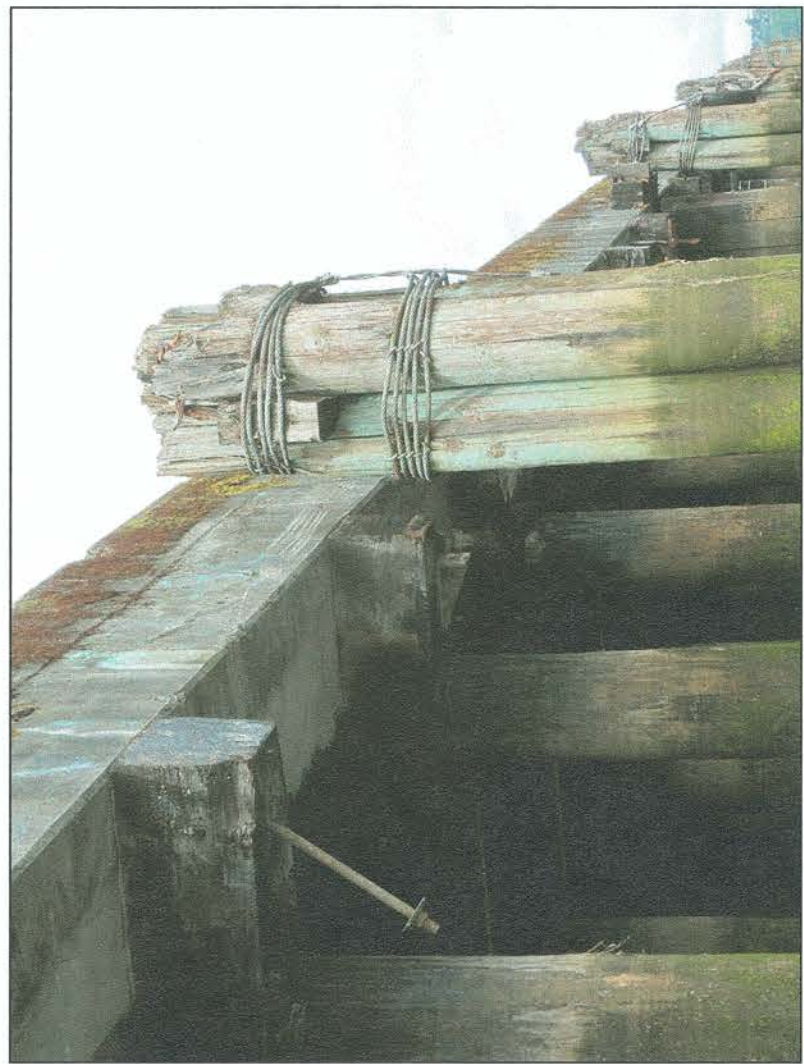
P3 BENT 39 DOLPHIN  
S2 LOOKING NORTHWEST

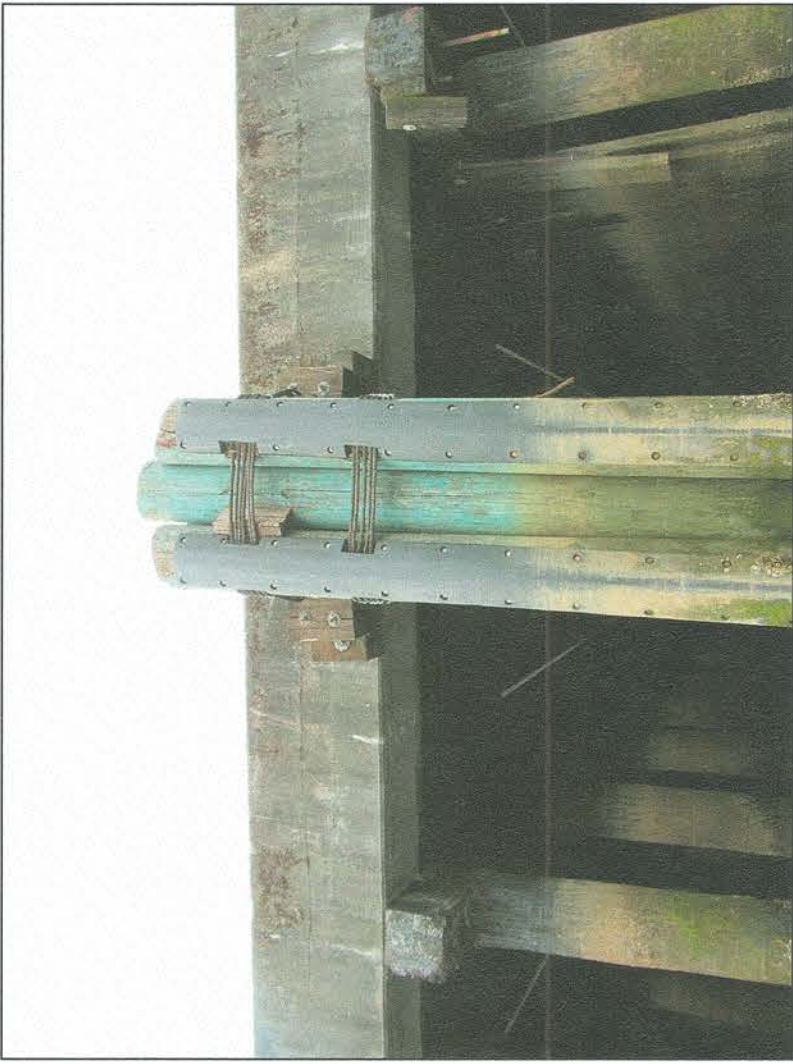
P6 BENT 98 DOLPHIN  
S3 LOOKING SOUTHWEST

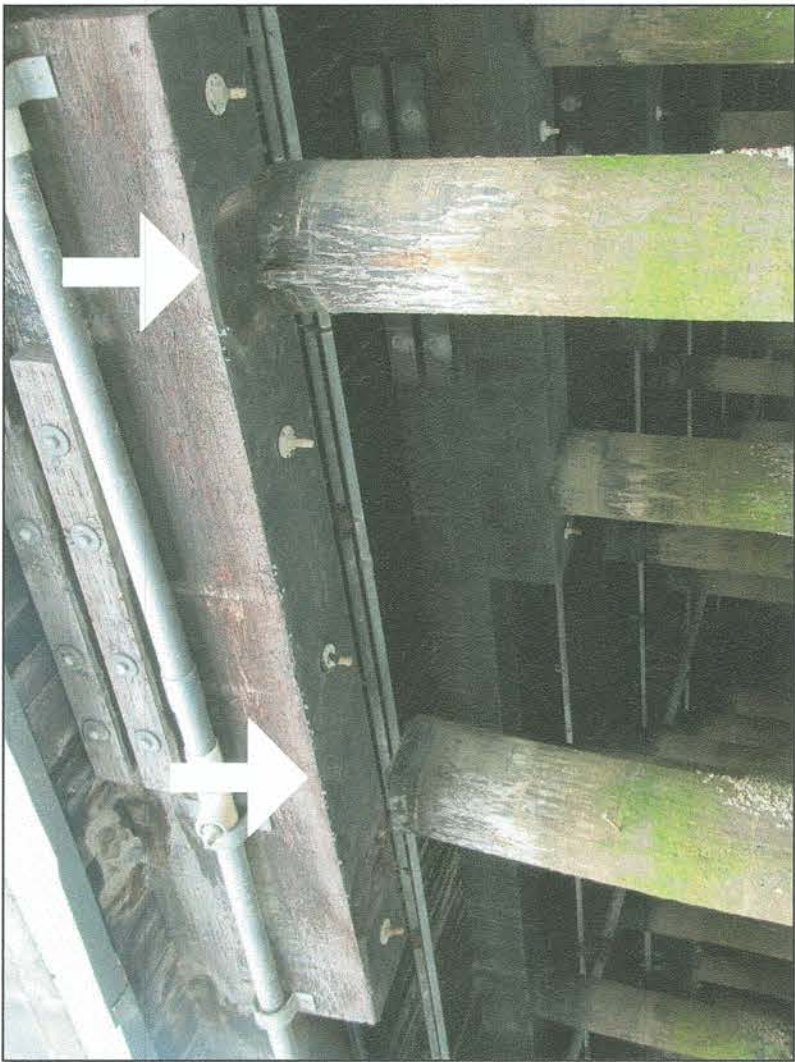
P9 MISALIGNED PILES B112:D & B112:E  
S3 LOOKING WEST

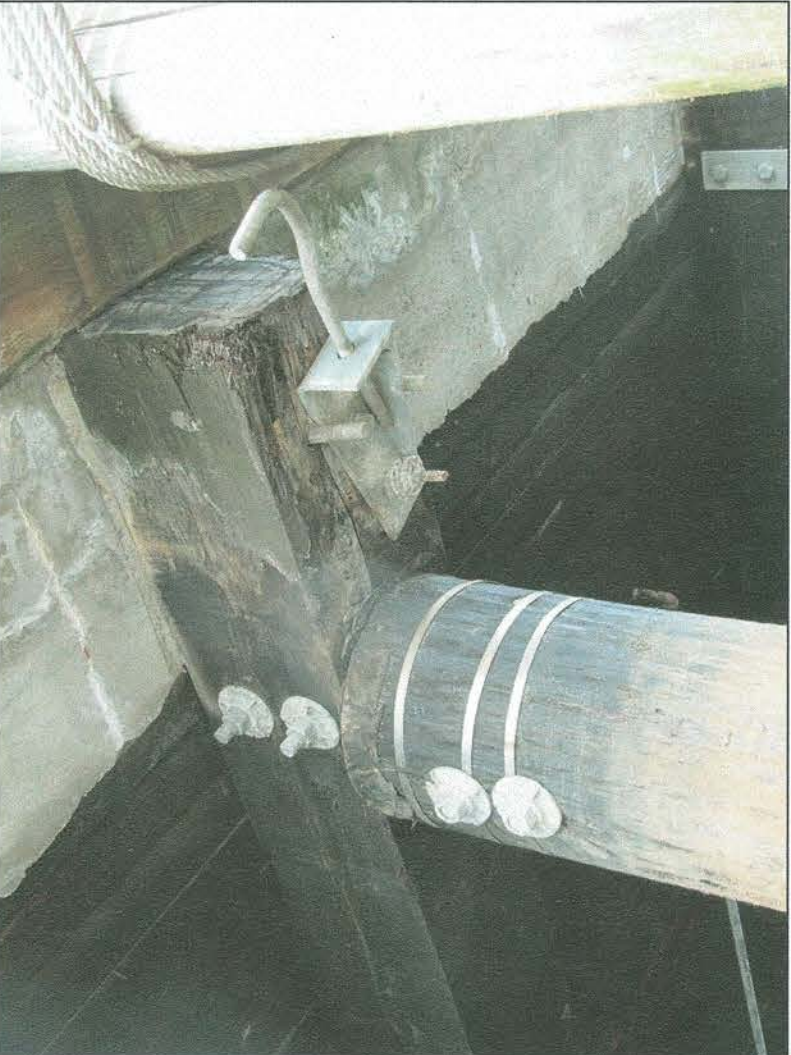
P2 BENT 15 DOLPHIN HOOK  
S1 LOOKING NORTHWEST

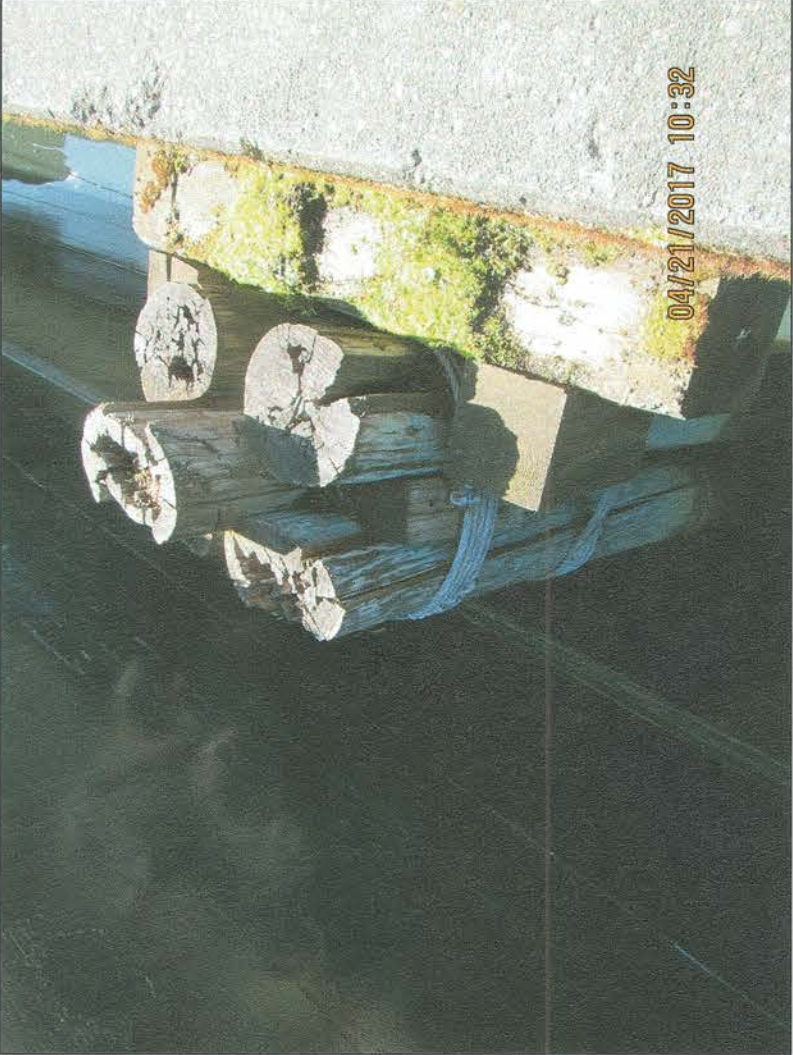
P5 BENT 15 DOLPHIN  
S1 LOOKING SOUTHEAST

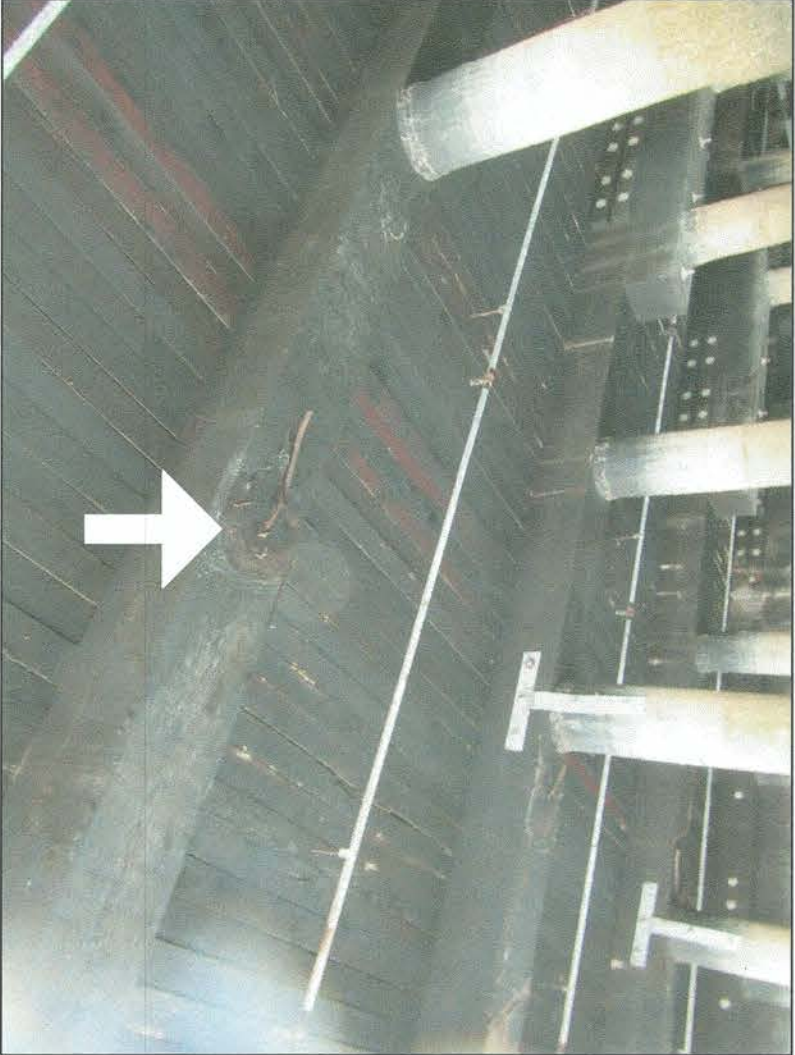
P8 MISSING PILE B30:B  
S1 LOOKING SOUTH

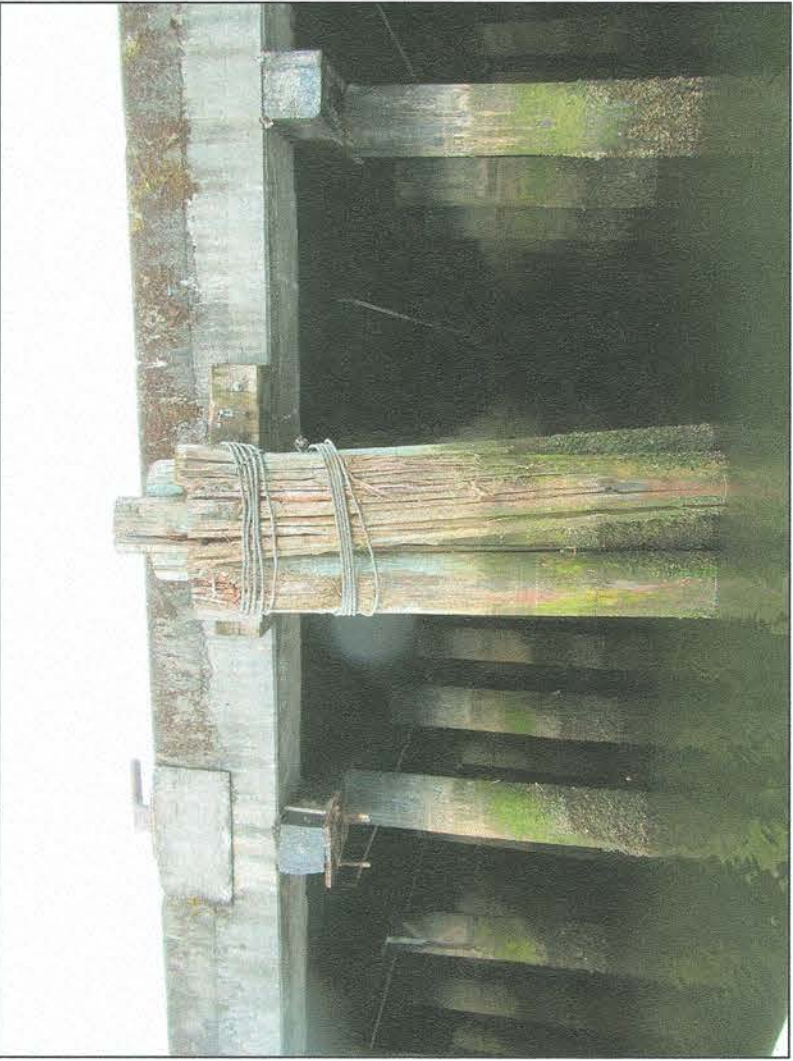
P1 BENT 9 DOLPHINS  
S1 LOOKING SOUTHWEST

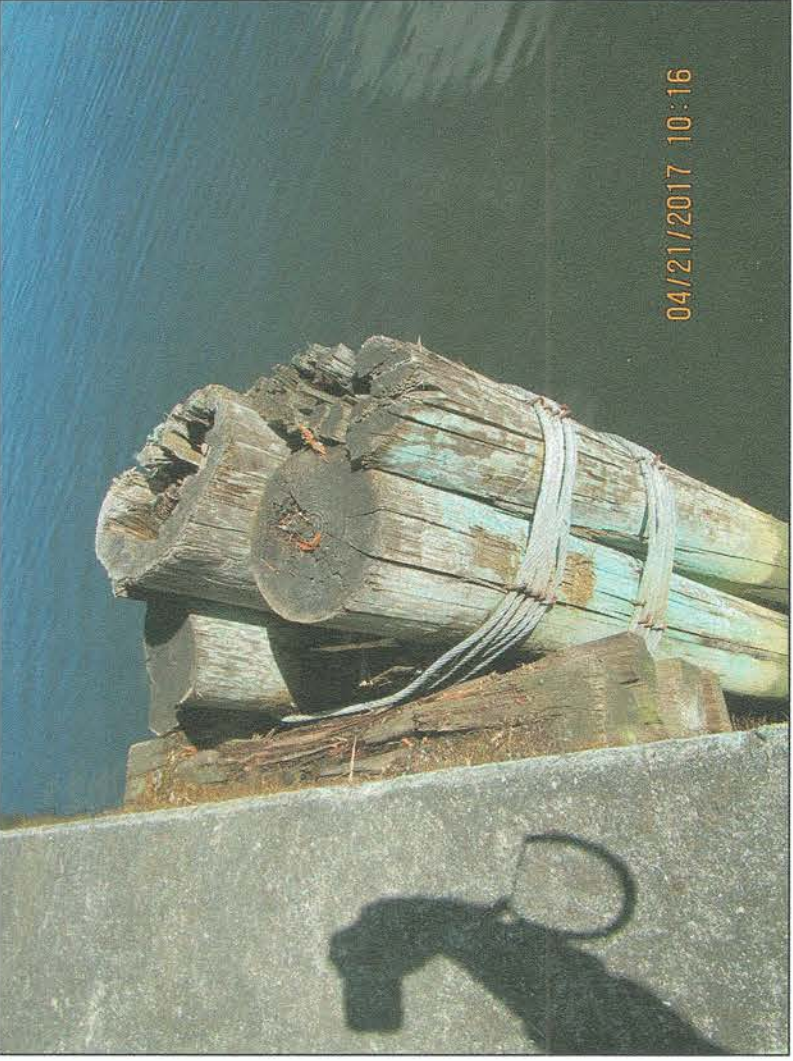
P4 BENT 63 DOLPHIN  
S2 LOOKING NORTHWEST
