PORT OF TACOMA  
WEST HYLEBOS LOG DOCK REPAIRS  
SITE PLAN

**PORT OF TACOMA**  
**WEST HYLEBOS LOG DOCK REPAIRS**  
**REPAIR PLAN**  
**BENTS 39 TO 77**  
TOWNSHIP: 21N RANGE: 03E SECTION: 36  
M. ID: 201016.01 DAT-HRZ: WA83-SF VERT: MLLW 19.39' @ Tide 22 1933  
PARCEL: DRAWING SCALE: AS NOTED

PORT OF TACOMA  
WEST HYLEBOS LOG DOCK REPAIRS  
REPAIR DETAILS  
SHEET 3

| | SITE PHOTOGRAPHS | | WEST HYLEBOS LOG DOCK REPAIRS | | PORT OF TACOMA | | WEST HYLEBOS LOG DOCK REPAIRS | | APPROVED: | | APPROVED: | | APPROVED: | | APPROVED: | | APPROVED: | |

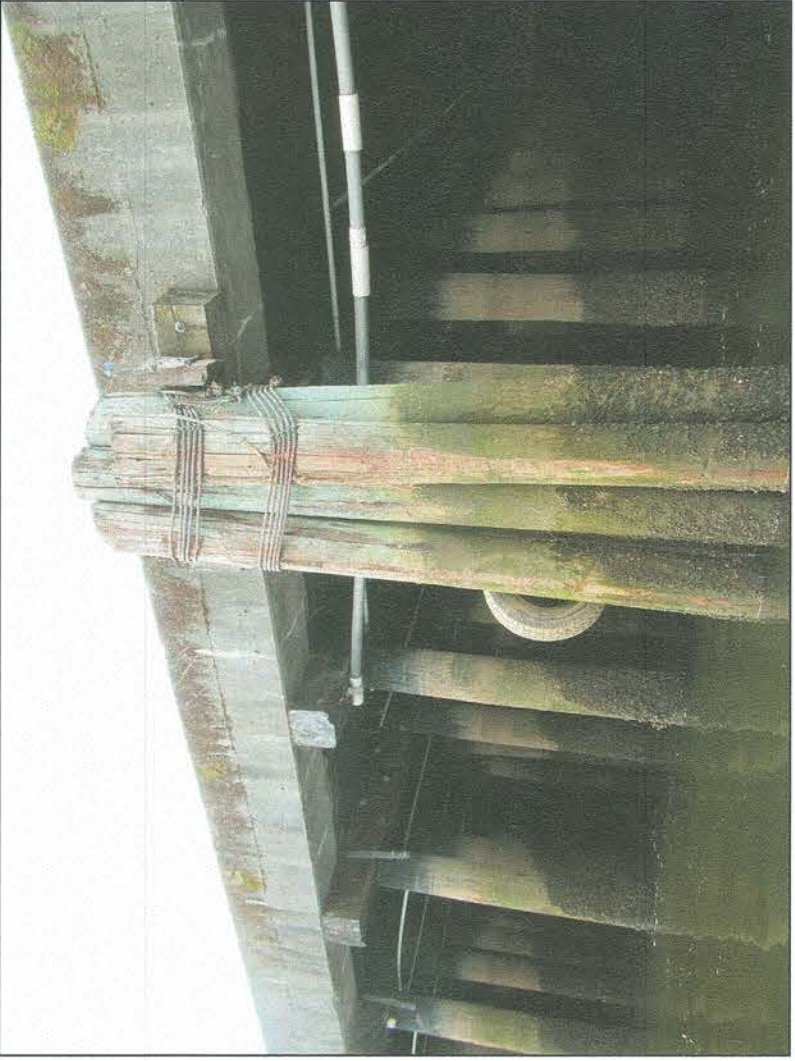
P7 BENT 74 DOLPHIN  
S2 LOOKING SOUTH
