APPENDIX A

Consent Decree and associated Environment
documentation

Re: Consent Decree No. 16-2-12406-8 Notice
Redevelopment Planning
Former Kaiser Aluminum Company Smelter
3400 Taylor Way

REMEDATION PLAN OVERLAY
PROPOSED AUTOMOTIVE FACILITY
PORT OF TACOMA, WASHINGTON

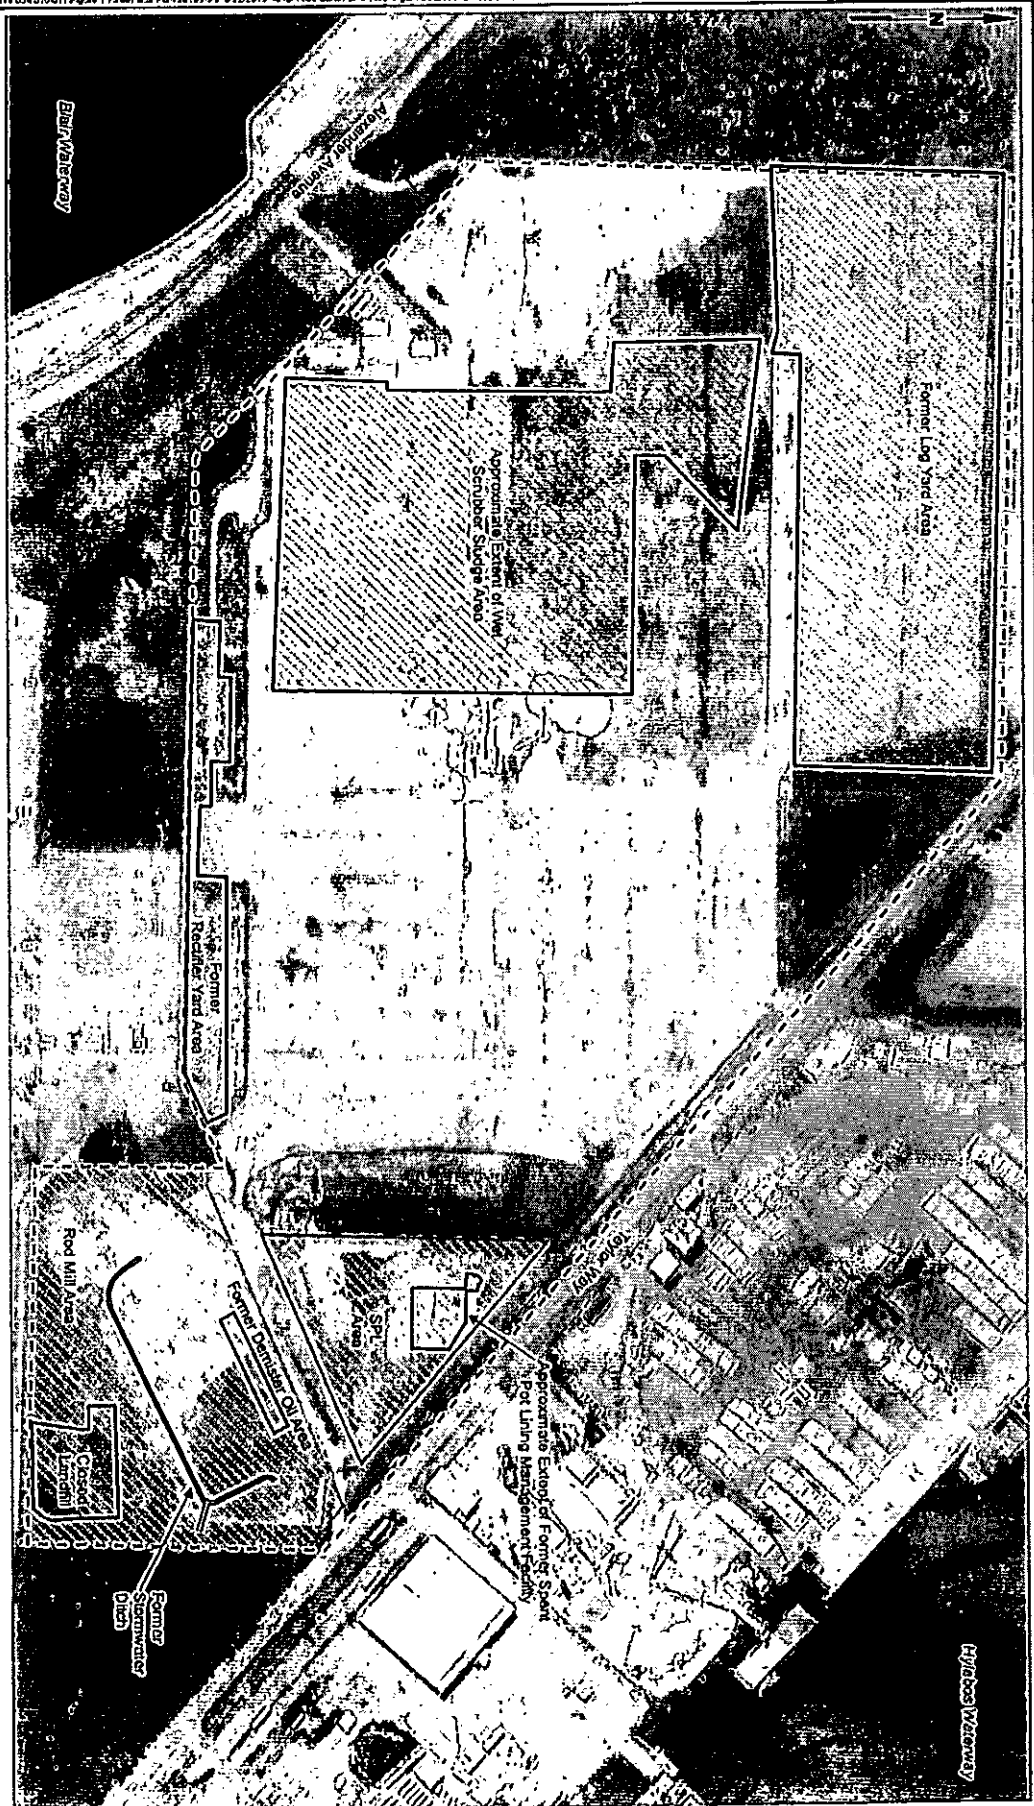
Figure
1

This cleanup action plan (CAP) describes the cleanup action at the former Kaiser Aluminum property (Site) located at 3400 Taylor Way in Tacoma, Washington (Figure 1). The 96-acre property is currently owned by the Port of Tacoma (Port). The purposes of this CAP are to describe the history and physical conditions at the Site, identify the Site-specific cleanup standards, identify the selected cleanup action, and describe monitoring to be conducted at the Site to document that cleanup has been completed. The following sections present a summary of the information specified by the Model Toxics Control Act (MTCA) regulations, WAC 173-340-380, to be included in the CAP. The information presented in this CAP is based on the evaluations and analyses developed and presented in the Remedial Investigation/Feasibility Study (RI/FS) report (Landau Associates 2012a). As documented in the RI/FS report, the cleanup action complies with WAC 173-340-350.

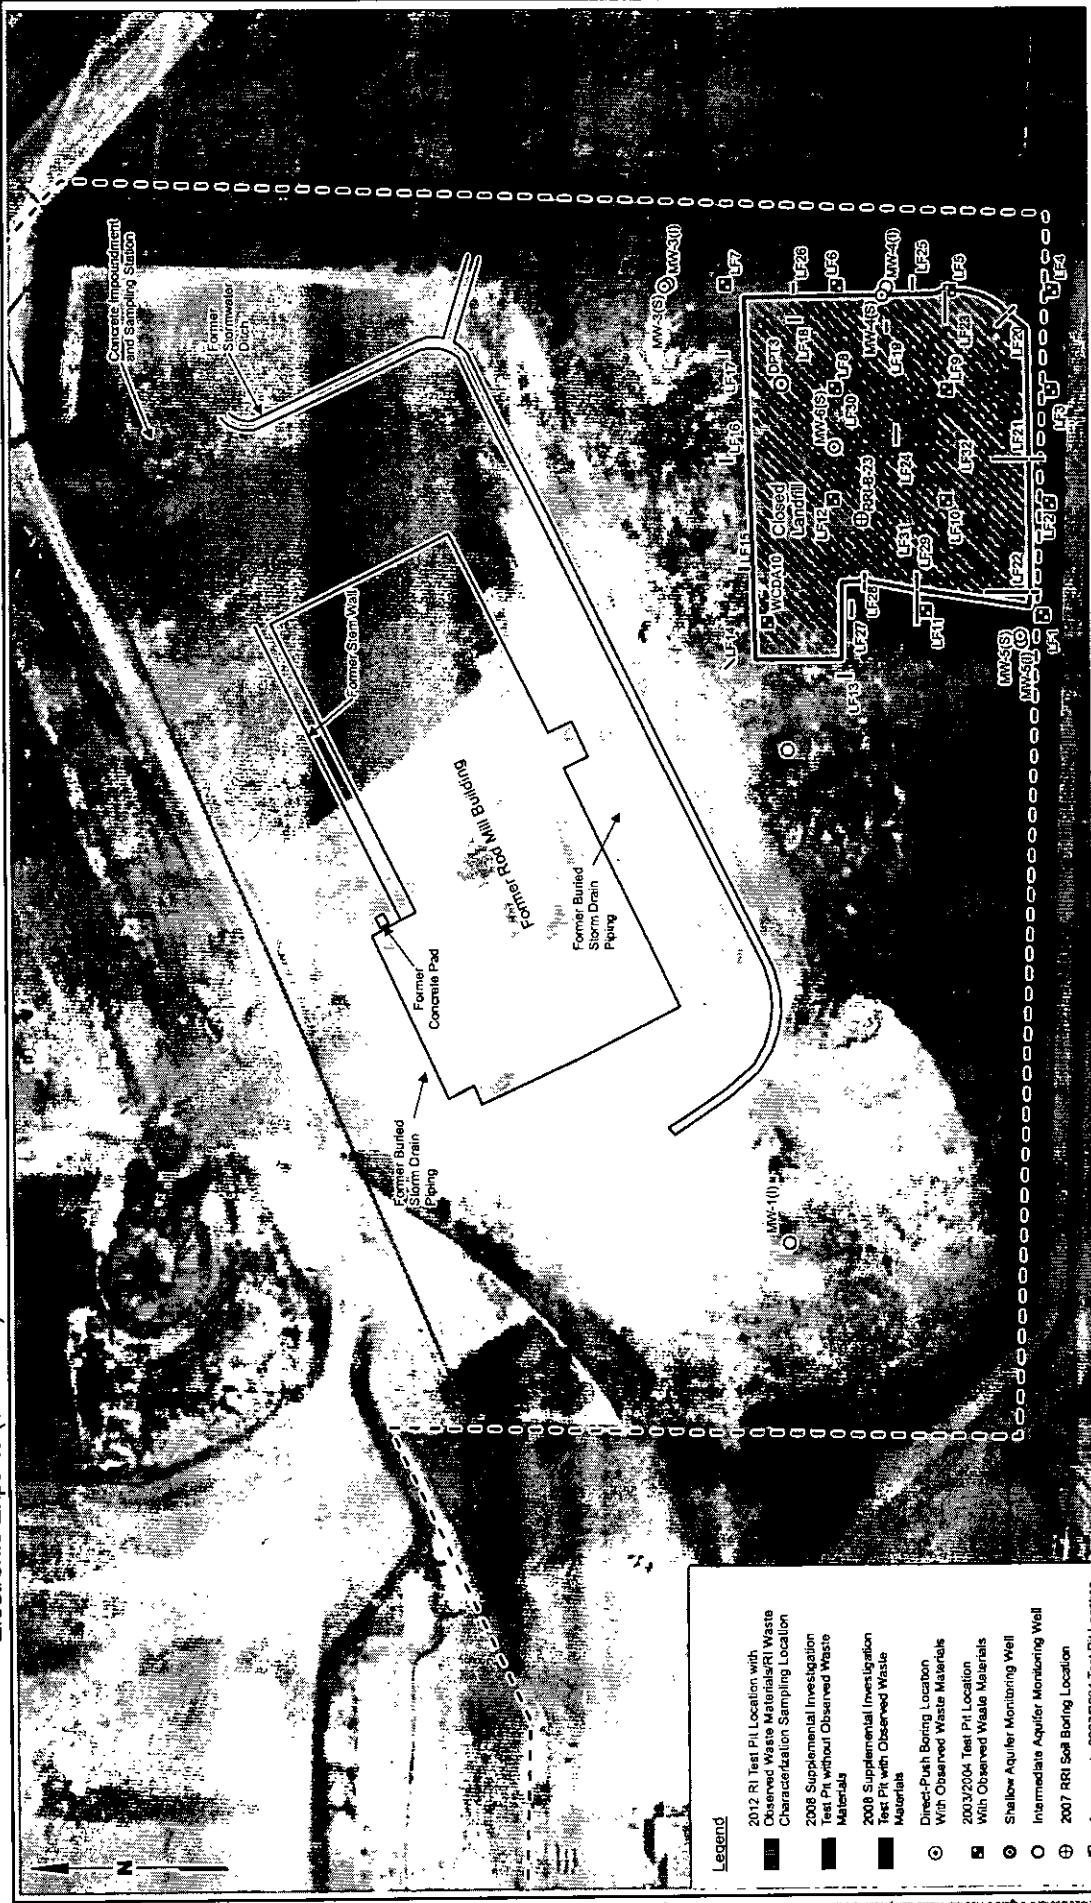
Kaiser CAP Report Tacoma, Washington	Rod Mill Area Closed Landfill RI and Previous Investigation Locations	Figure 5
---	---	--------------------

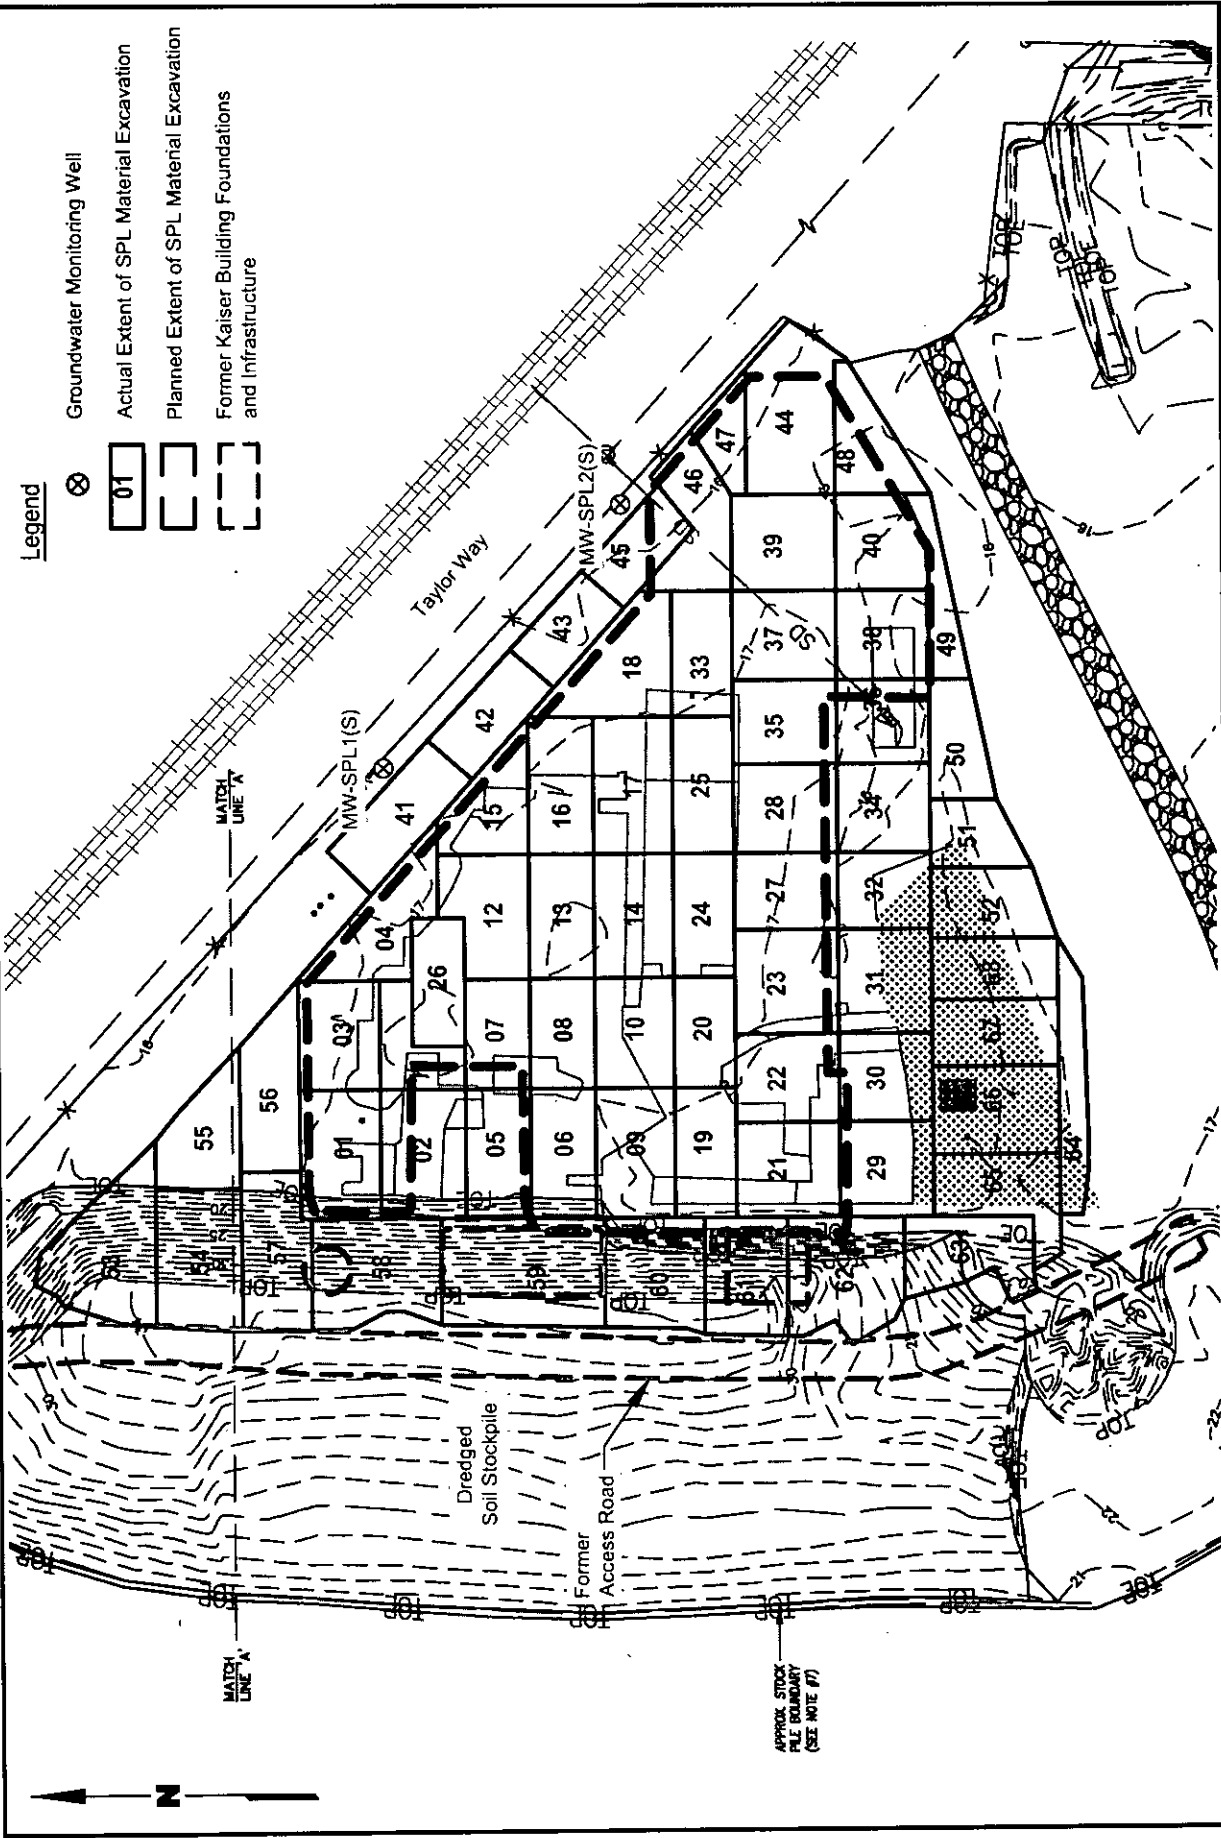
Kaiser CAP Report Tacoma, Washington	SPL Area Interim Action and Groundwater Monitoring Well Locations	Figure 7
--	---	---	--------------------

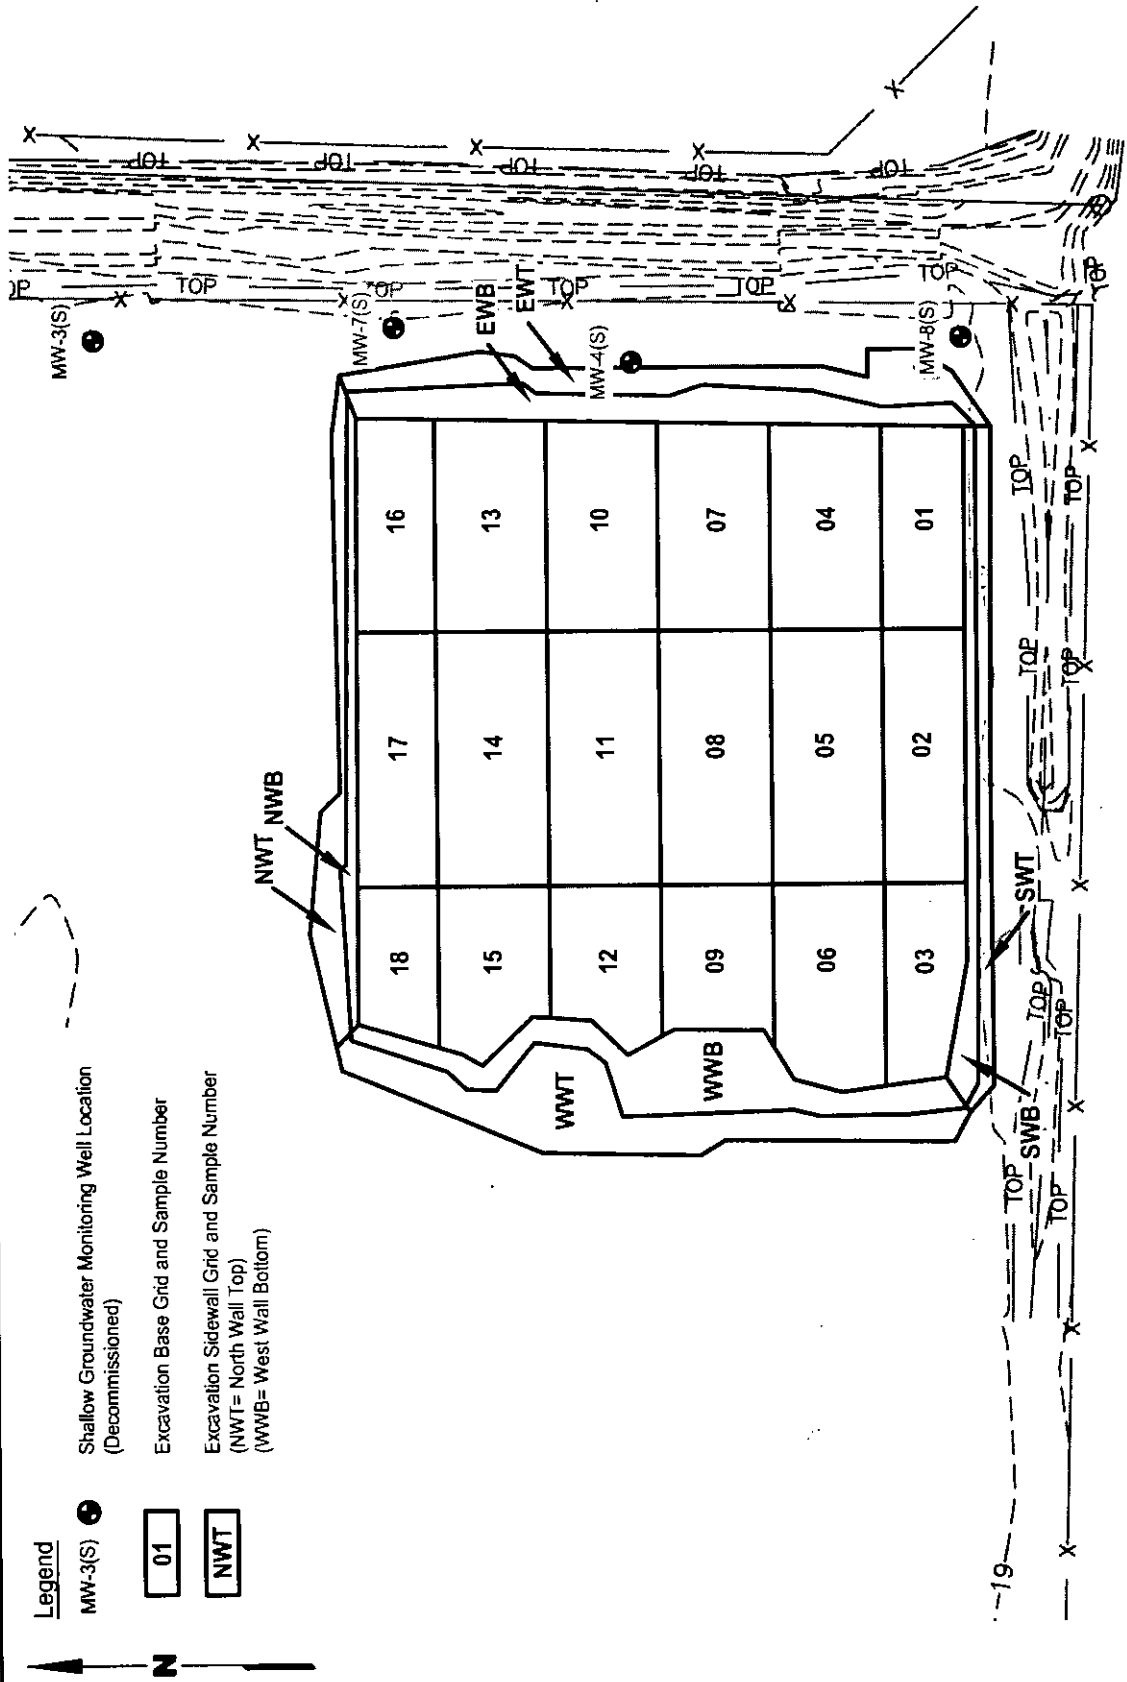
LANDAU ASSOCIATES, INC. | G:\Projects\118\032\020\006\CAP\Figure 8 Mill Soil Sampling.dwg (A) *Figure 8* 6/29/2016

Rod Mill Area Closed Landfill waste materials and associated contaminated soil were excavated within the approximately 0.9 acre area shown on Figure 8. Prior to excavation, the estimated extent of waste materials was surveyed and staked in the field; however, Landau Associates' personnel and

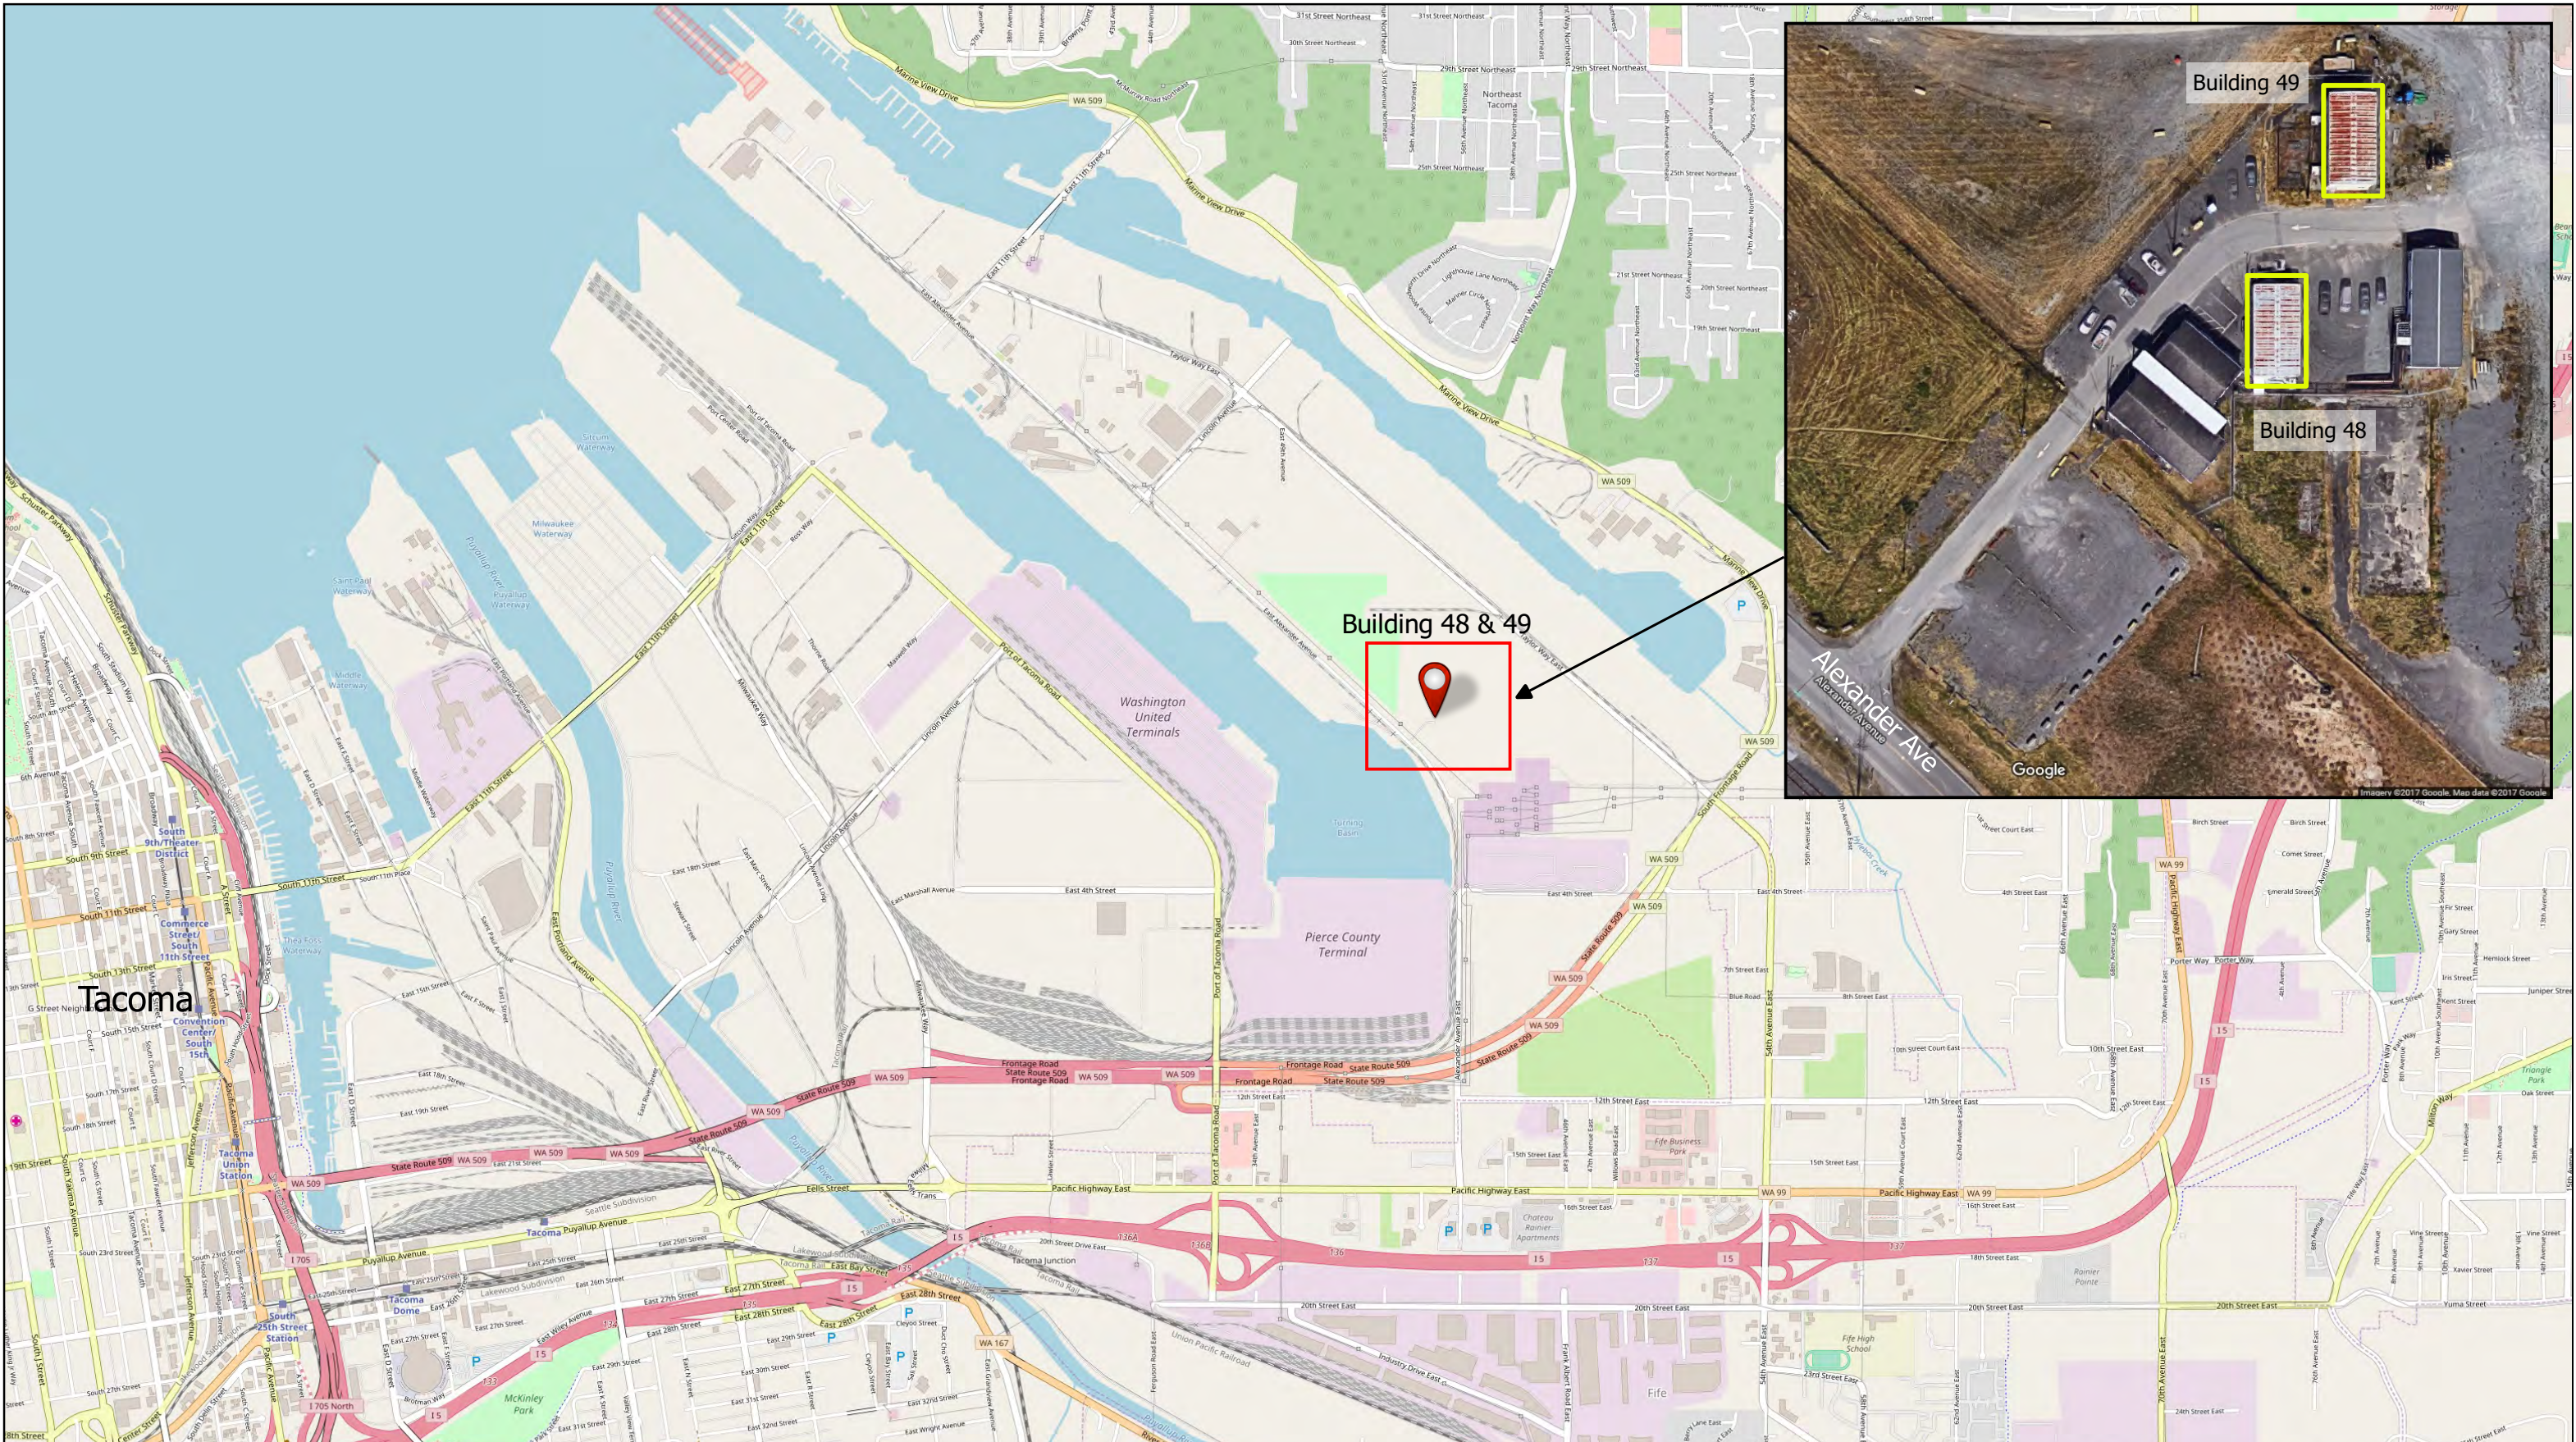
Figure 1 Site Map/Vicinity Map

Figure 1 is a site map/vicinity map showing the building location both locally and regionally. Figures 2 and 3 show interior and exterior layouts of the building.

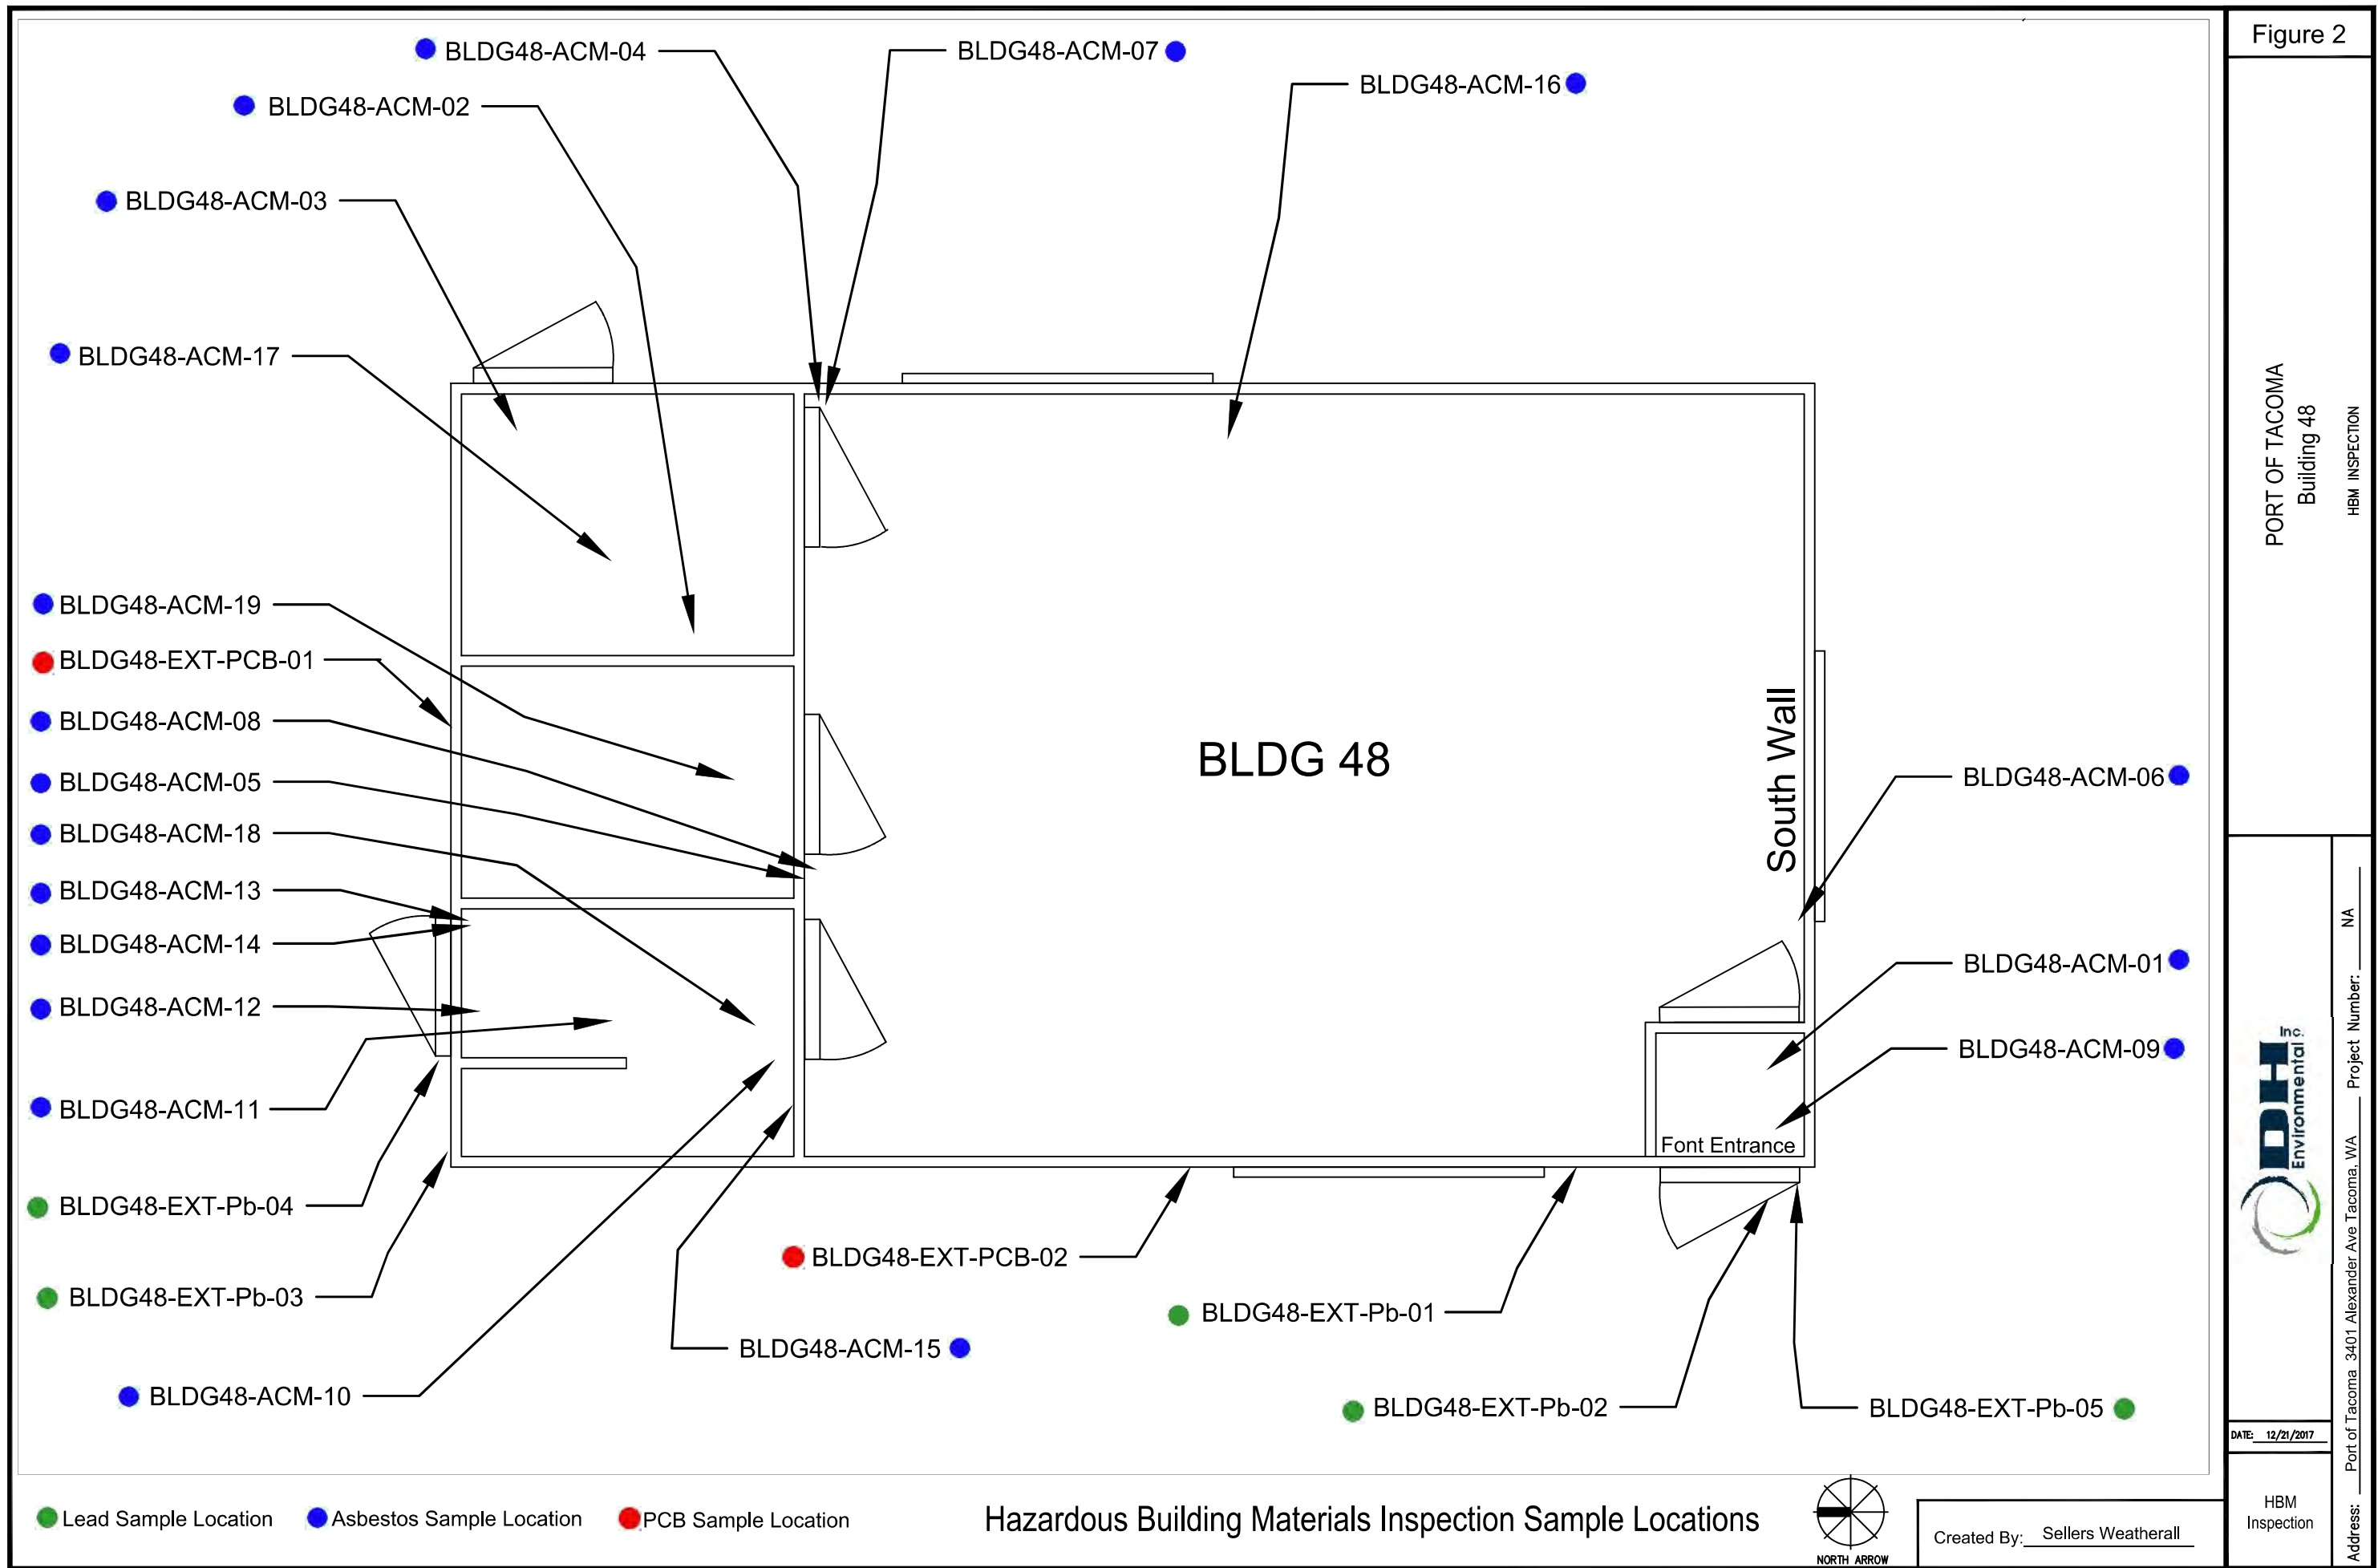
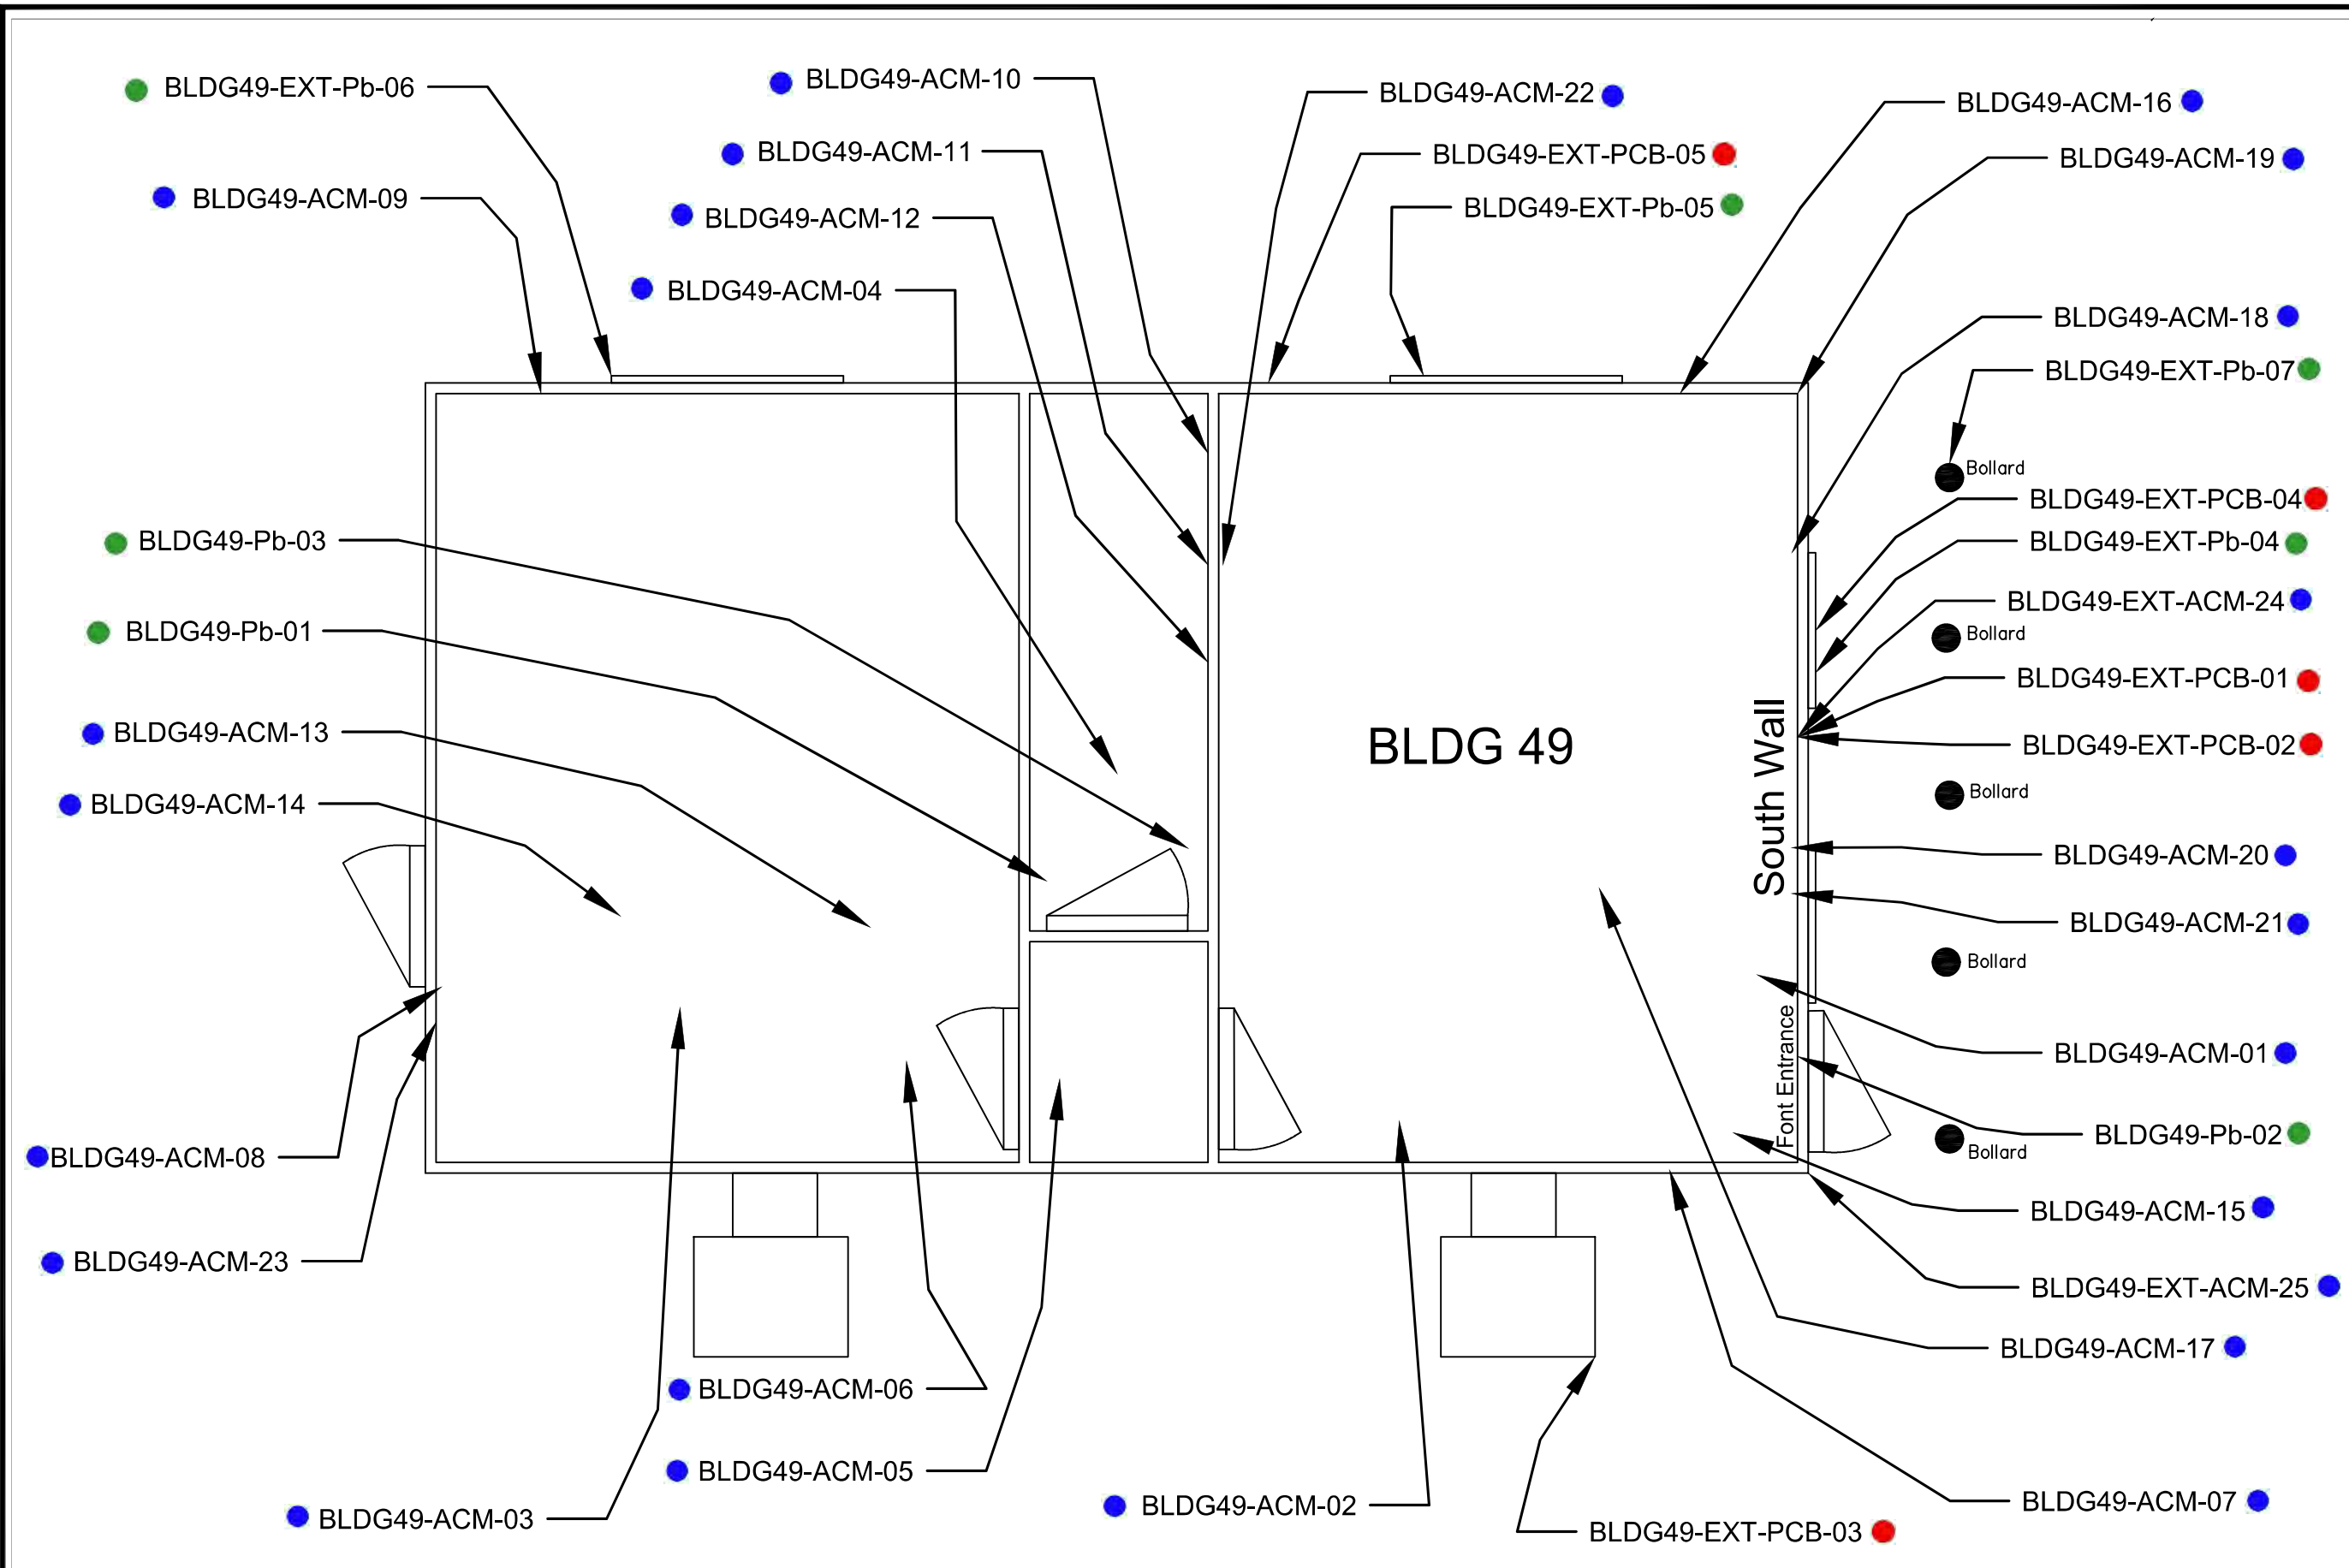
Figure 2 & 3 Sampling Locations – Interior/Exterior

● Lead Sample Location
 ● Asbestos Sample Location
 ● PCB Sample Location

Hazardous Building Materials Inspection Sample Locations
