2023 Facility Condition Assessment Report - Final

**Task Order No. 06 – West Hylebos Log Dock
On-Call Marine Structures Facility Condition Assessment Services 2023-2027
Contract No. 071856
Port of Tacoma
Tacoma, Washington**

December 22, 2023

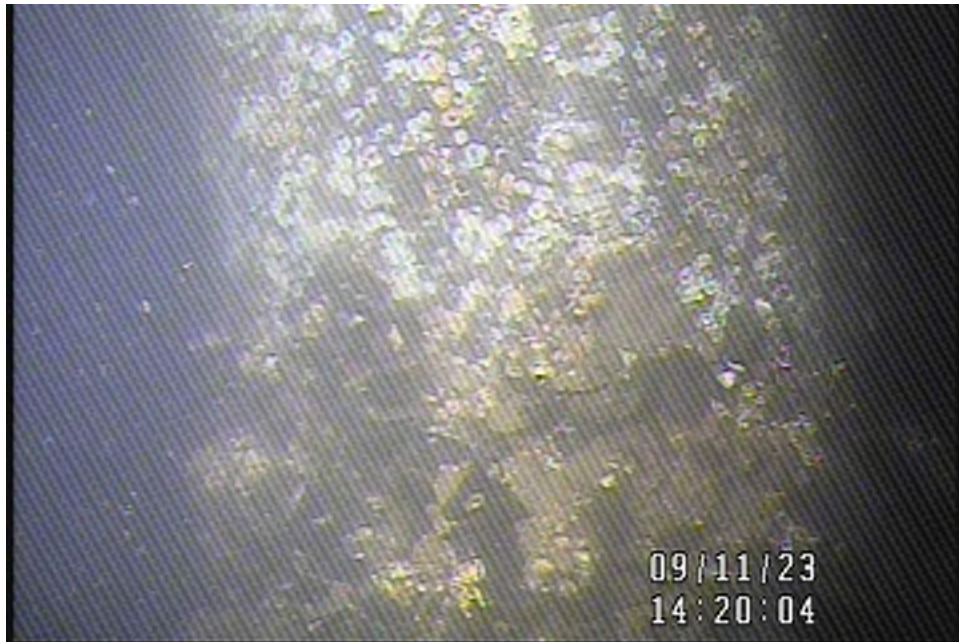
In general, the timber piles are in **fair** condition. Appendix A, photo 17 shows a typical underwater Level II pile cleaning. The majority of piles inspected exhibit minor to moderate signs of deterioration, including checks, shakes, splits, and gouges of less than ½-inch wide. Approximately 25 percent of the piles inspected show evidence of minor marine borer deterioration with less than 5 percent loss of section. Pile 4:B has major damage consisting of marine borer damage with 50 percent section loss (Appendix A, Photo 18). Pile 25:B is rated as major damage due to it being partially nonbearing under the pile cap.

Photo 17 – Typical Level II Pile Cleaning Underwater.
