TO: William Evans, Dan Crawford, and Jan Shawyer, Port of Tacoma  
FROM: Grant Hainsworth and Nicole Ott, CRETE Consulting Inc.  
PROJECT: 1940 E. 11<sup>th</sup> Street (former Brown & Haley)  
SUBJECT: Review of RI and FS Documents  
DATE: January 8, 2014

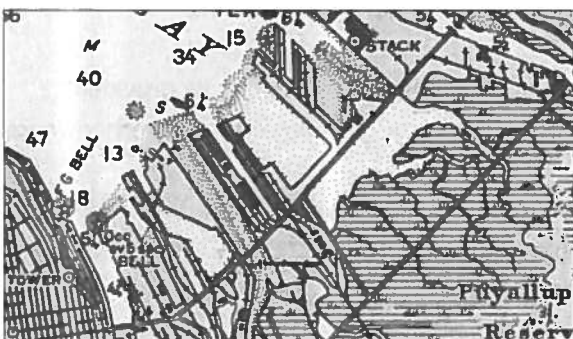
Figure 1. 1934 Nautical Chart.

East 11<sup>th</sup> Street was originally constructed in the late 1800s and early 1900s as a thin strip of filled land connecting Marine View Drive to Downtown Tacoma via the Murray Morgan Bridge. In the vicinity of the subject site, tidal water was present on both sides of the roadway until at least 1934 (Figure 1). A 1943 drawing describing widening of East 11<sup>th</sup> Street shows a pre-existing bulkhead on the southeastern side of the existing road and constructed backfill at a 2:1 slope extending further to the southeast (Figure 2). To date there has been no investigation of the 11<sup>th</sup> Street embankment, underground utilities within the road right-of-way, or other features in that area which may be influencing local hydrogeology.

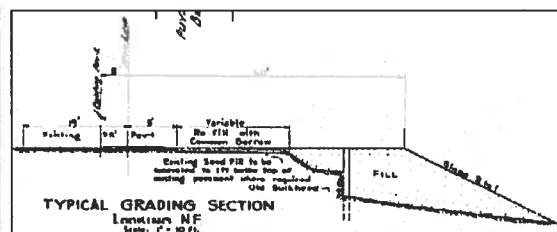
Figure 2. 1943 11<sup>th</sup> Street Widening Section
