QUESTIONS & RESPONSES #02

RFQ TITLE 071645 | FABULICH CENTER BUILDING ENVELOPE RESTORATION

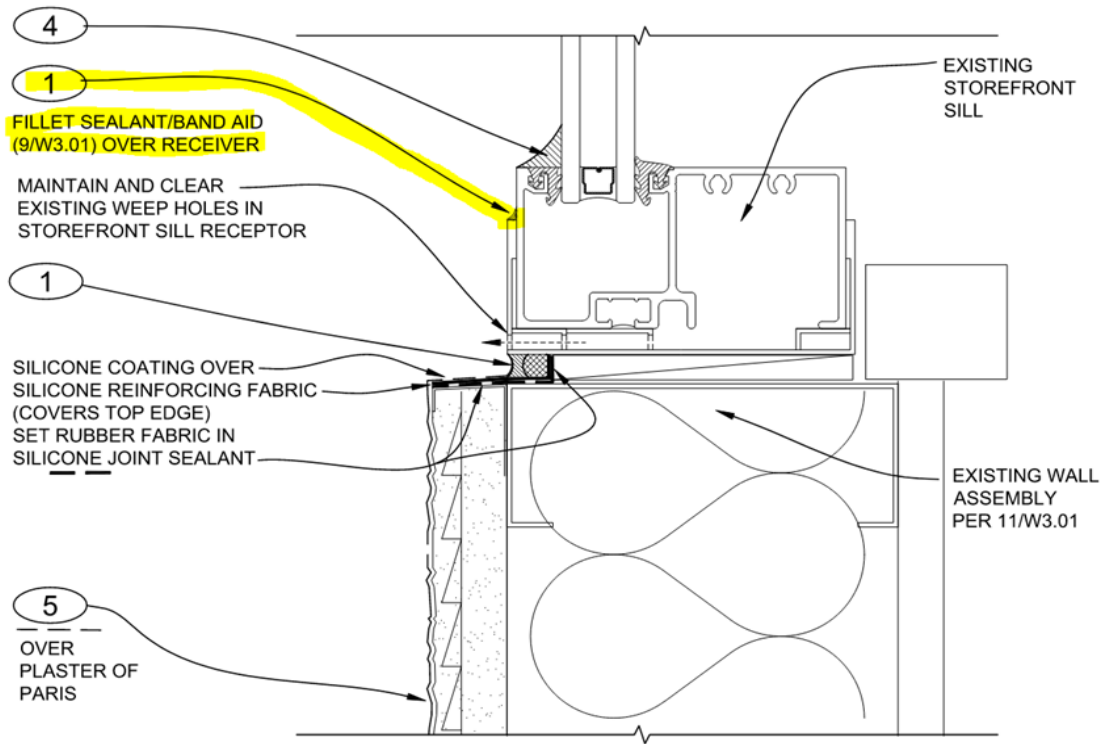
7 STOREFRONT SILL AT PLASTER

W3.01 SCALE: 6"=12" (do not scale)

The detail of the fillet joint where the sill/header meets the window system is misleading. One detail 7/W3.01 shows it very simply as a fillet, probably standard. Whereas 3/W3.02 indicates it should be installed per 9A/W3.01 which is like a massive cove joint more in line with a wet seal application.	“Bond break tape is not needed at the small sealant fillet as noted on repair keynote 1, delete this scope. Add the fillet sealant/band aid over receiver” scope to detail 10 on W3.01 to match detail 7 on sheet W3.01.” The small fillet sealant/ band aid is not need at detail 3 because it has overhead protection. See diagram on page 2.	W3.01
The fillet joint where the sill/header can meets the window system is only shown as being addressed where there is plaster below at the sill location (Detail 7). It is not shown being addressed at the Head (Detail 3) or Sill at concrete base (Detail 10). Since it's a small item I'd prefer to get everyone bidding it the same way.	“Bond break tape is not needed at the small sealant fillet as noted on repair keynote 1, delete this scope. Add the fillet sealant/band aid over receiver” scope to detail 10 on W3.01 to match detail 7 on sheet W3.01.” The small fillet sealant/ band aid is not need at detail 3 because it has overhead protection. See diagram on page 2.	W3.01

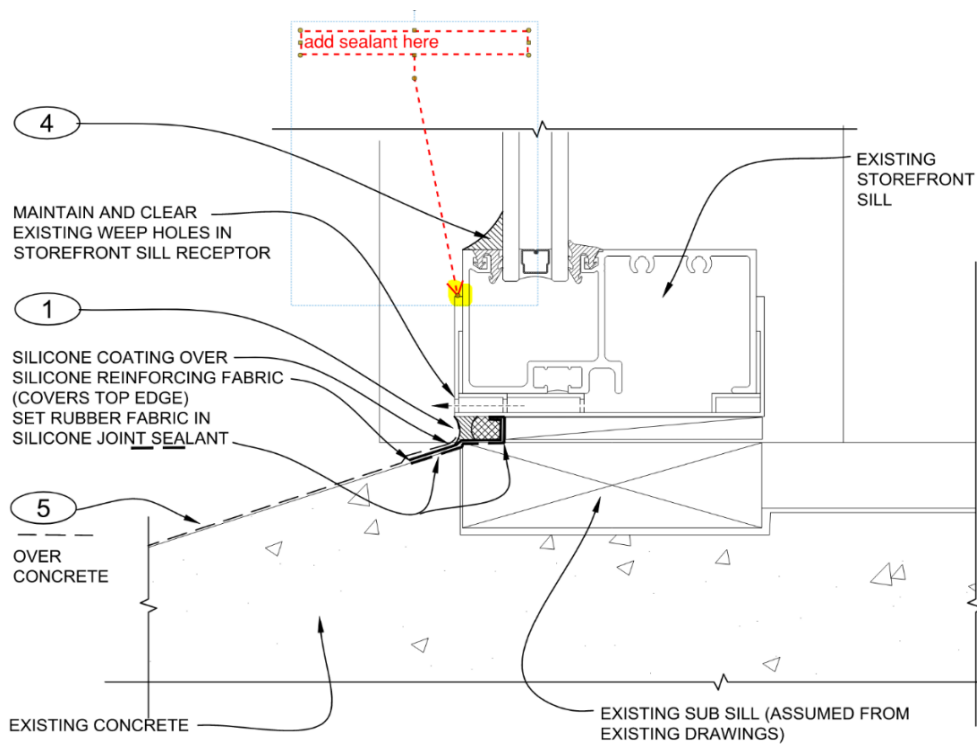
10 STOREFRONT SILL AT CONCRETE BASE

W3.01 SCALE: 6"=12" (do not scale)
