To: Dan Crawford, Port of Tacoma
From: Suzanne Dudziak, Greylock Consulting LLC
Date: March 10, 2014
Re: Sampling & Analysis of Building Materials at 4918 & 5024 Marine View Drive,
Tacoma, Washington on February 25, 2014

subject: PIONEER PSA: 069750 Task Order #04: Marine View Drive Properties Hazardous Materials Assessment

Hazardous Materials Survey

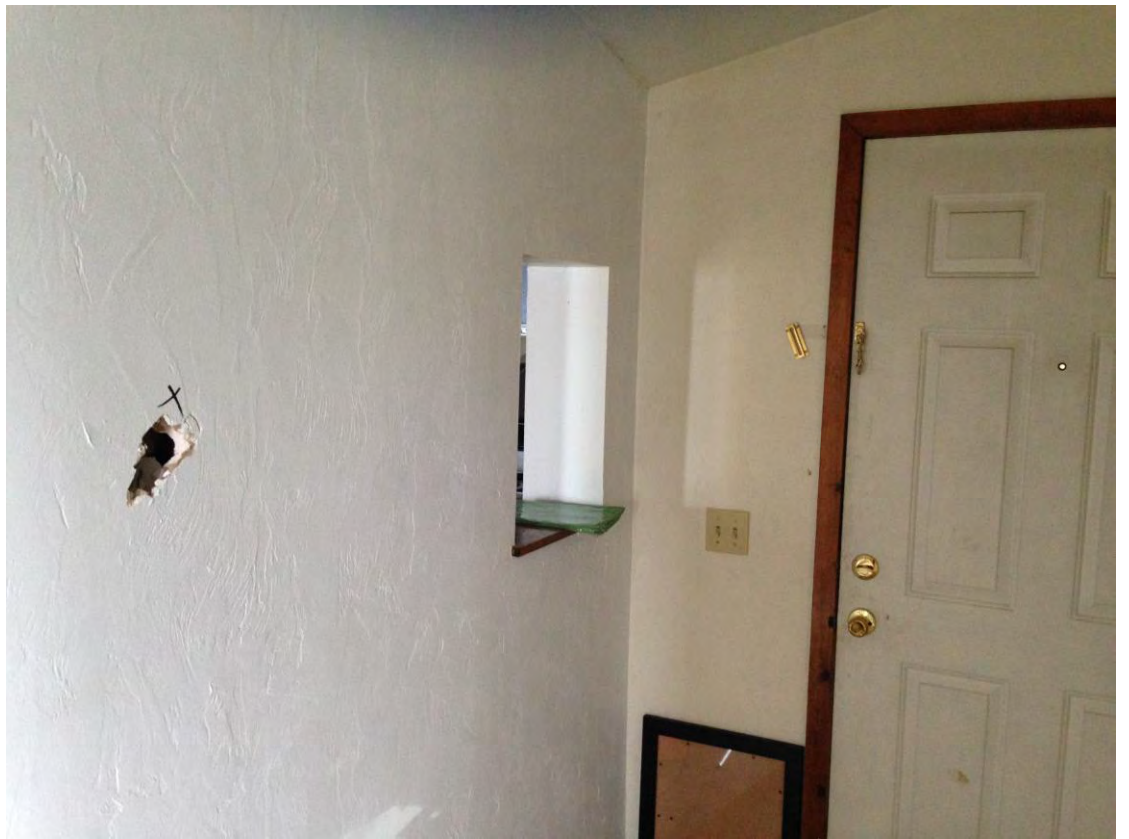
Photo No. 6: 4720 –
Interior Carpet and Tile
Floors

Description:
Interior carpet and floor
tile sample location in
4720 building.

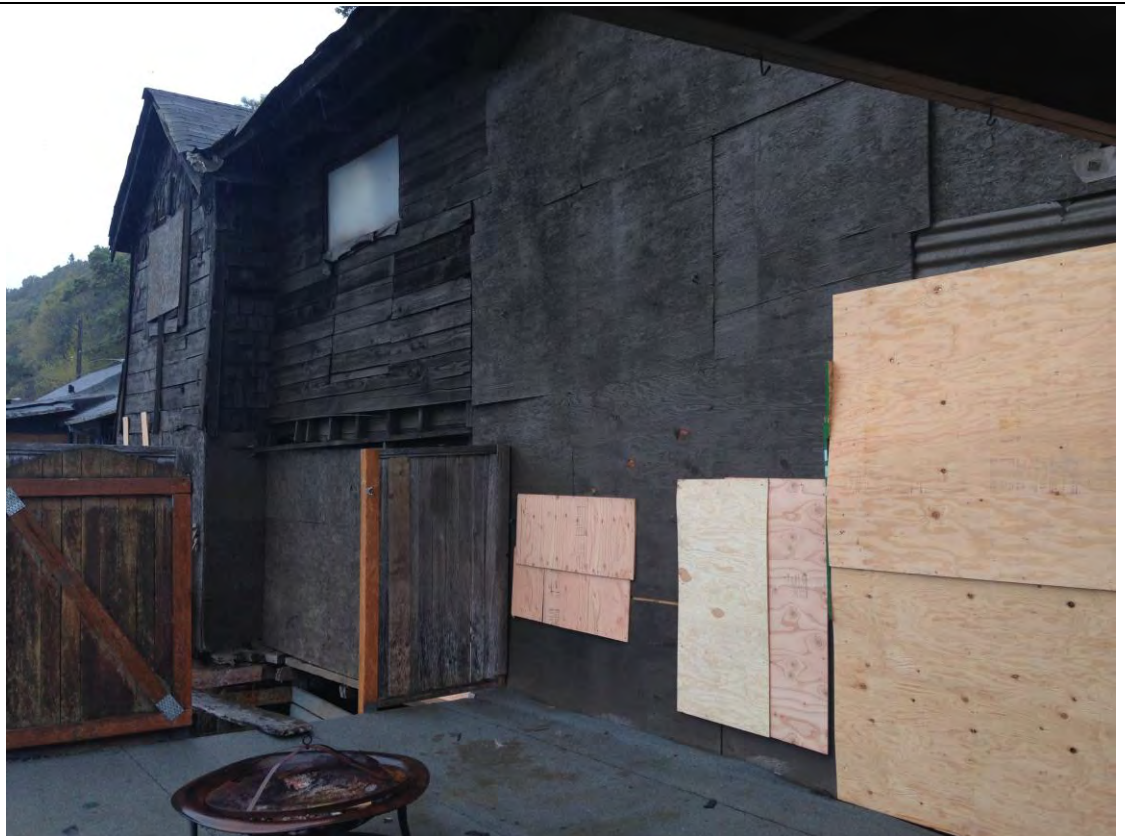
Photo No. 12: 4722 –
Exterior Brown Paint

Description:
Dark brown exterior
paint on western
exterior side of 4722
building.

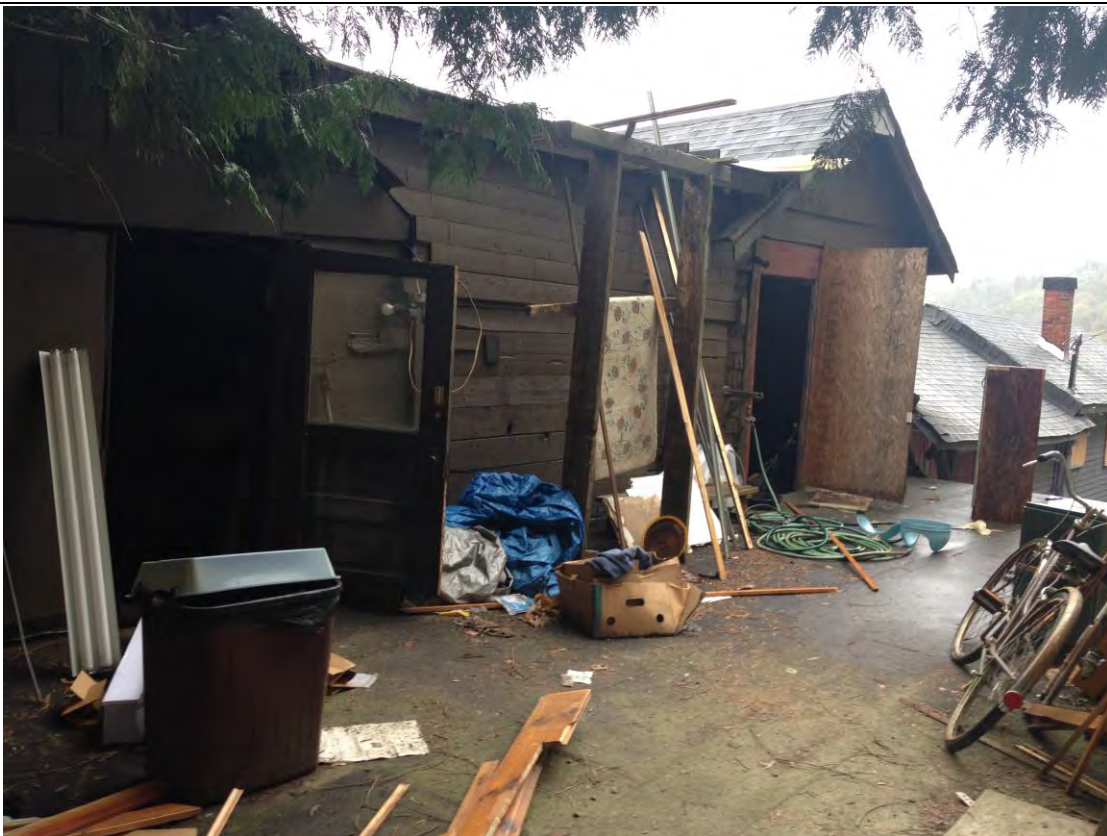
Photo No. 16: 4722 –
Streetside Roofing

Description:
Dark brown paint and
large flat roofing
shingles visible from
street side of upper
section of 4722
building.

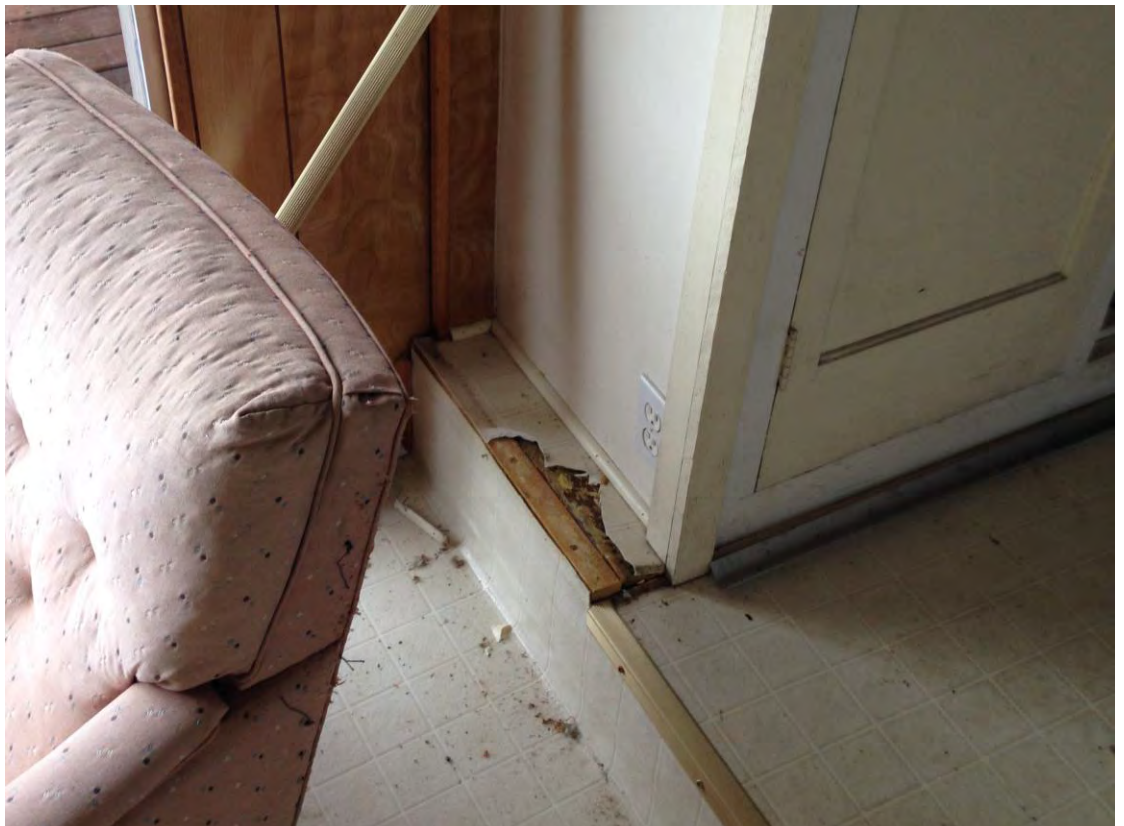
Photo No. 20: 4728 –
Kitchen Vinyl Floor

Description:
Vinyl floor tiles sampled
in 4728 building.

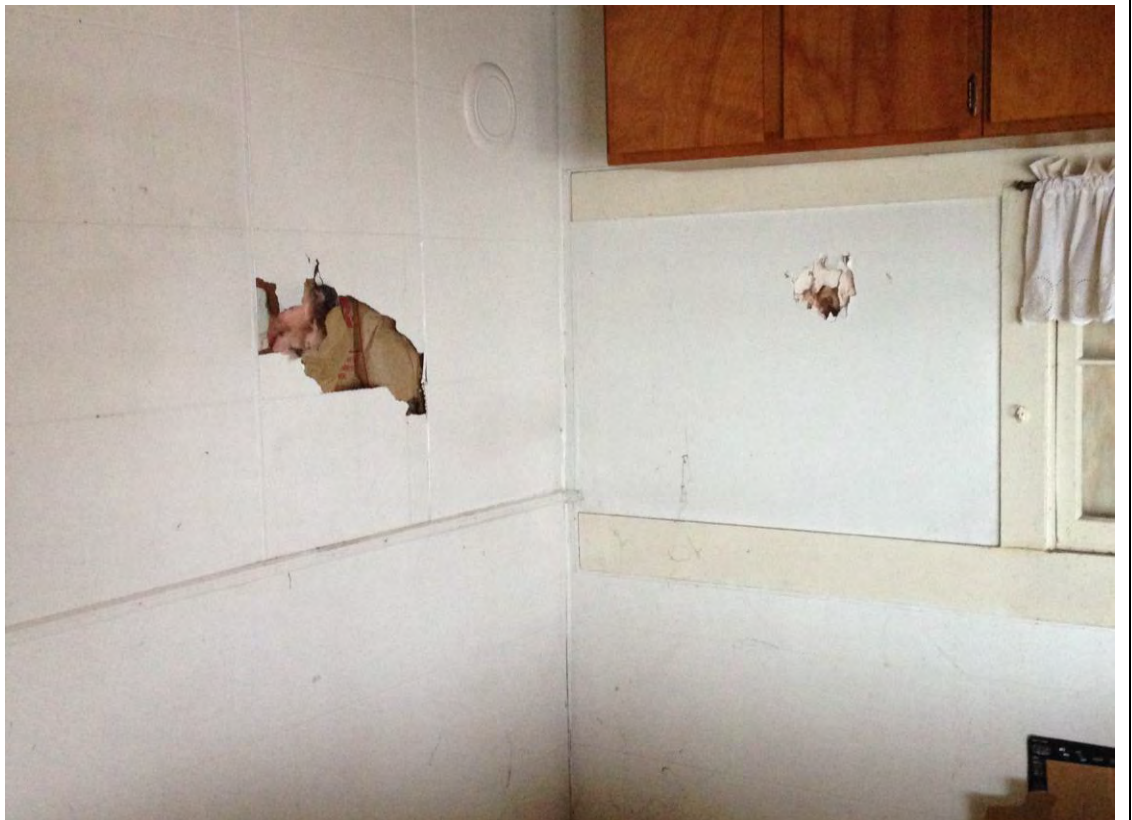
Photo No. 24: 4728 –
Kitchen Wall Area

Description:
White painted walls and
drywall/insulation
material in 4728 kitchen
area.

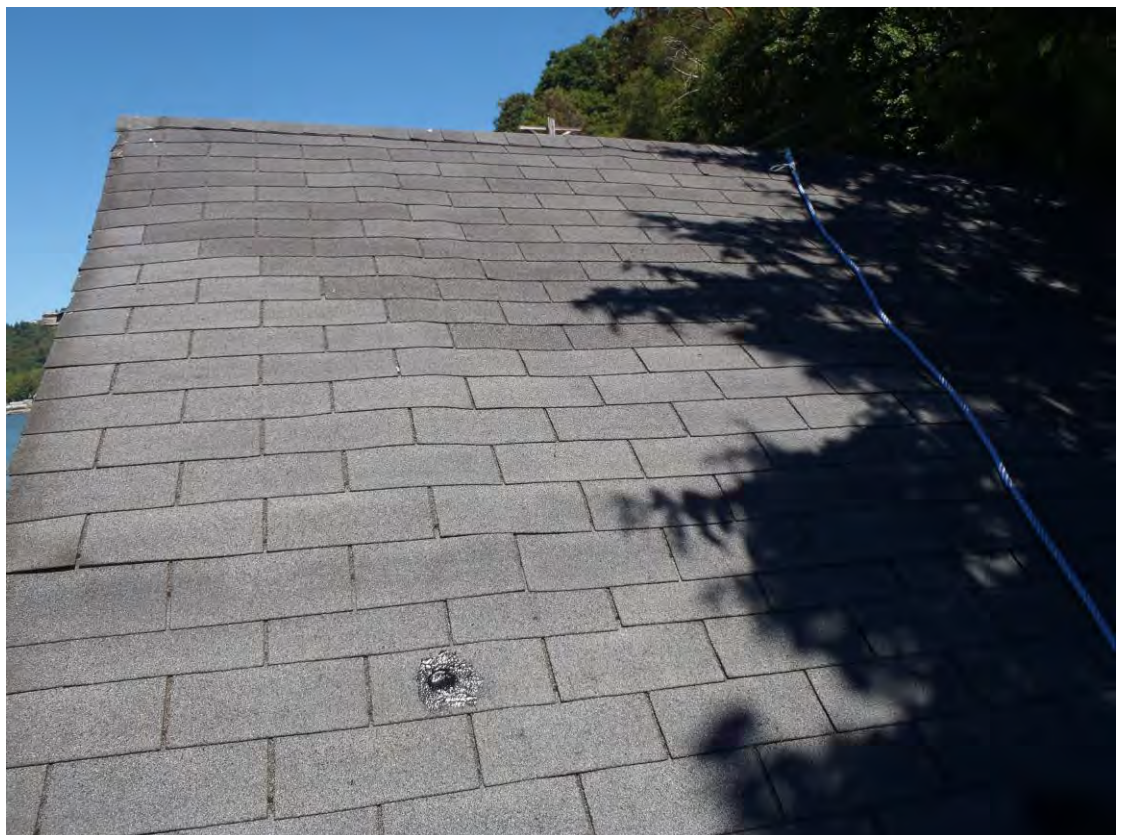
Photo No. 32: 4722 –
Roofing Materials

Description:
Patched core sample
location on 4722 middle
peak roof area.

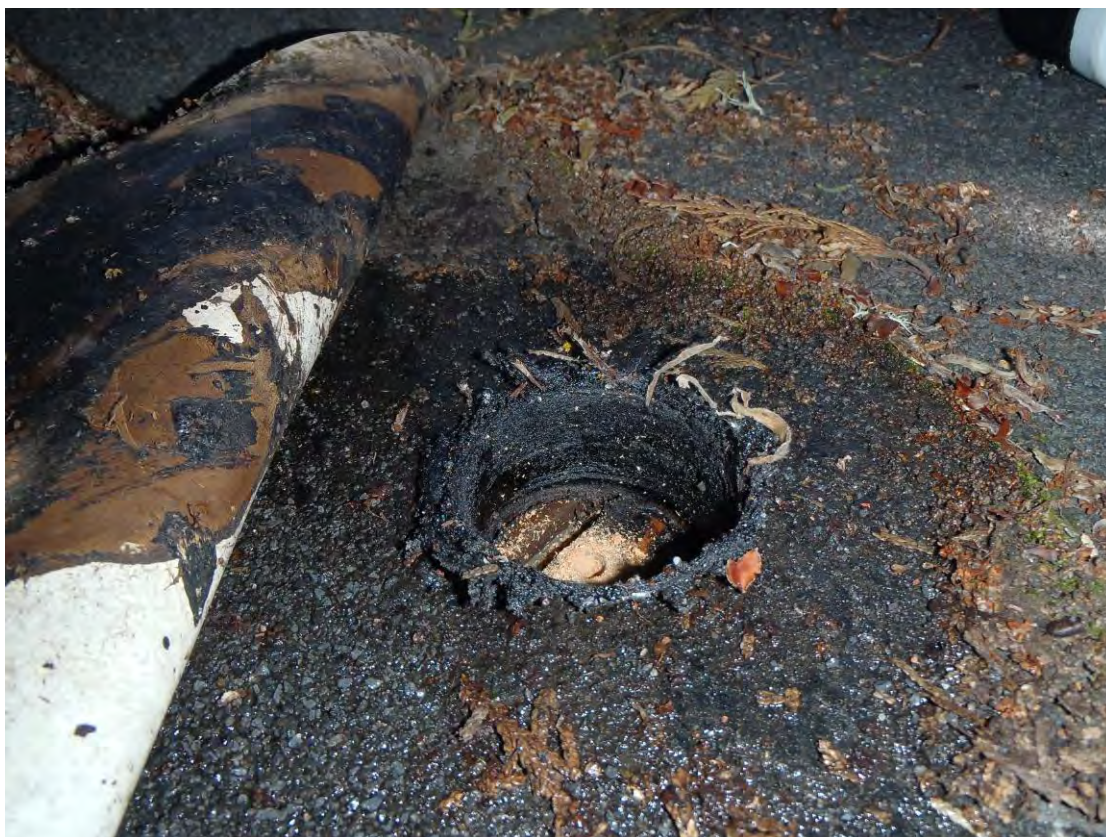
Photo No. 33: 4722 –
Roofing Materials

Description:
Core sample taken
from beneath rubber
protective layer
surrounding vertical
metal pipe on southern
flat 4722 roof area.

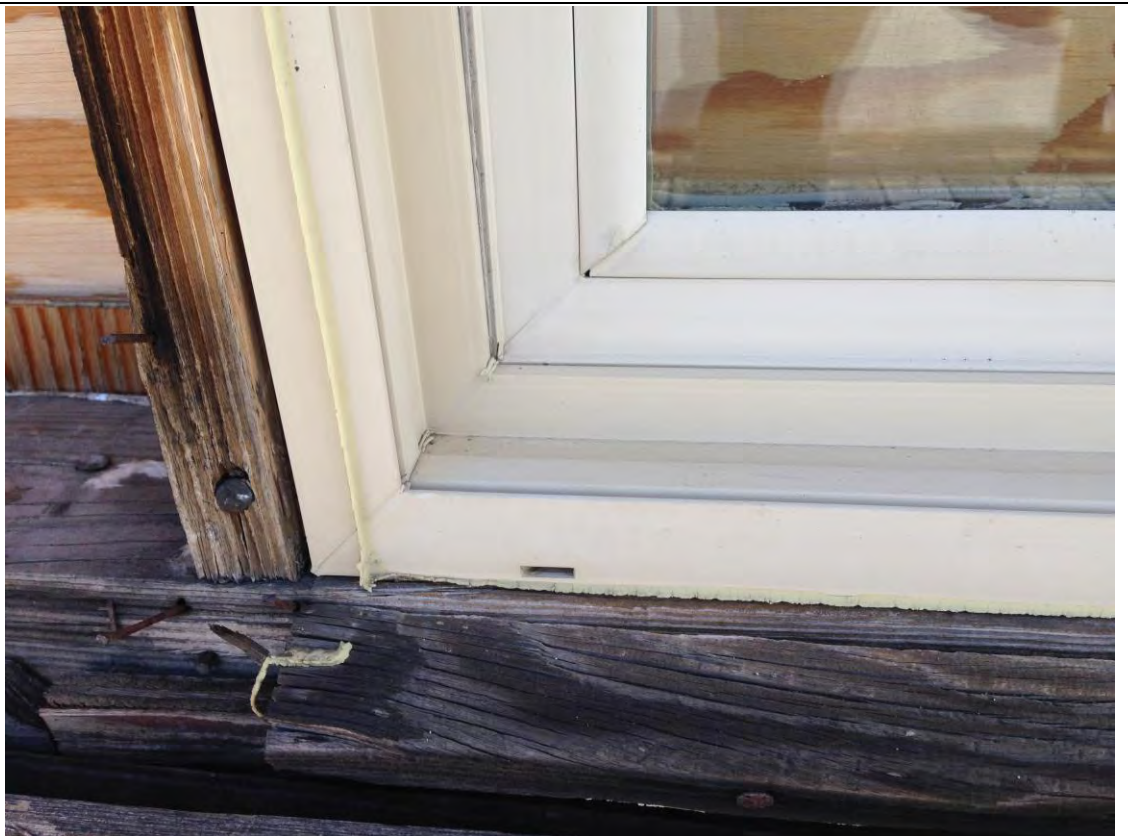
Photo No. 16: Western Exterior Window Caulk

Description:
Western exterior window caulk. Sample OS-5024-114-040215.

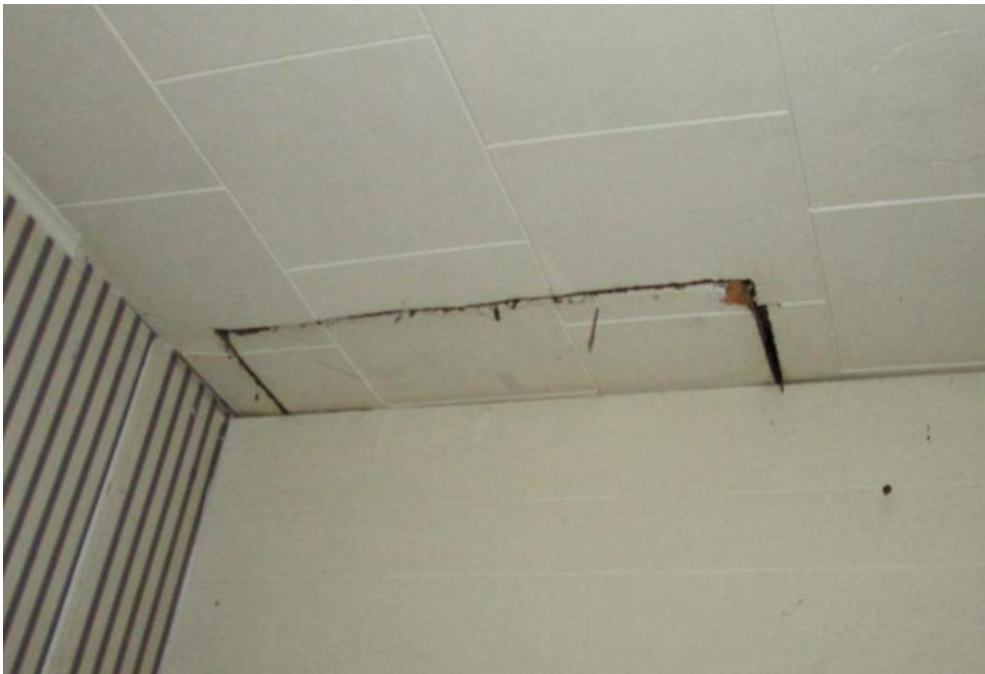
Sample 4918-5 Caulk/Window Glaze 3% Chrysotile
Photograph #4		Description

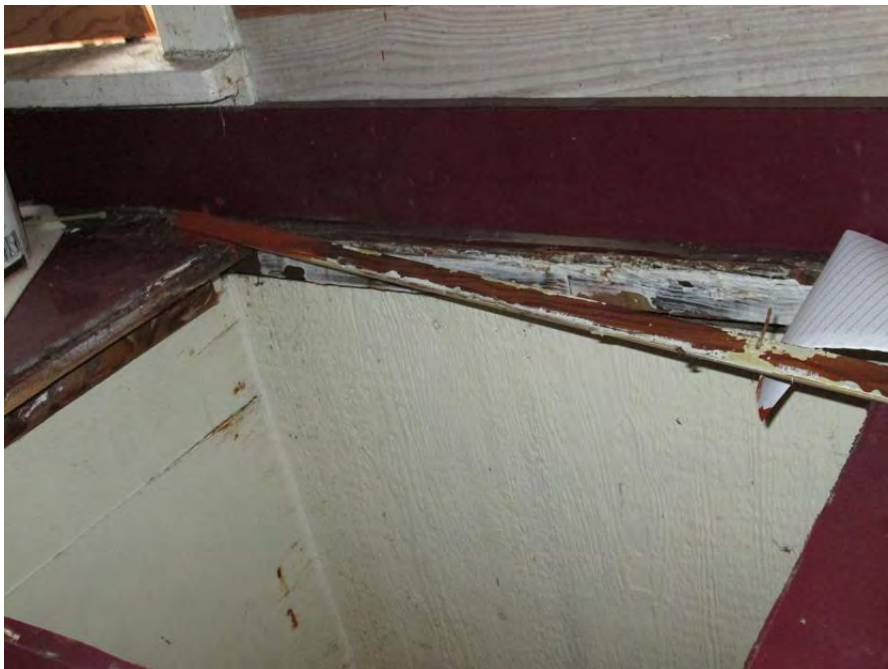
Sample 4918-12 Caulk, Kitchen

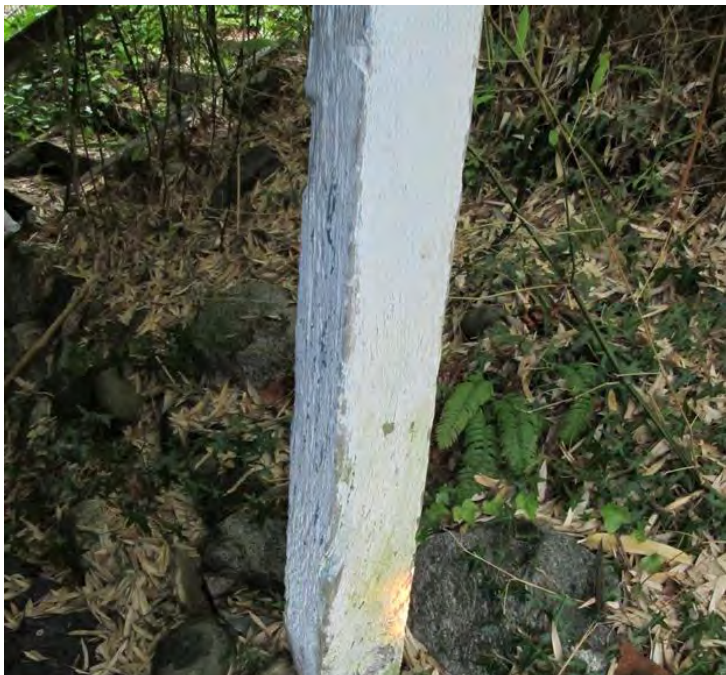
Photograph #8		Description

<p>4918 LBP Survey</p> <p>8- White Paint on Post</p>

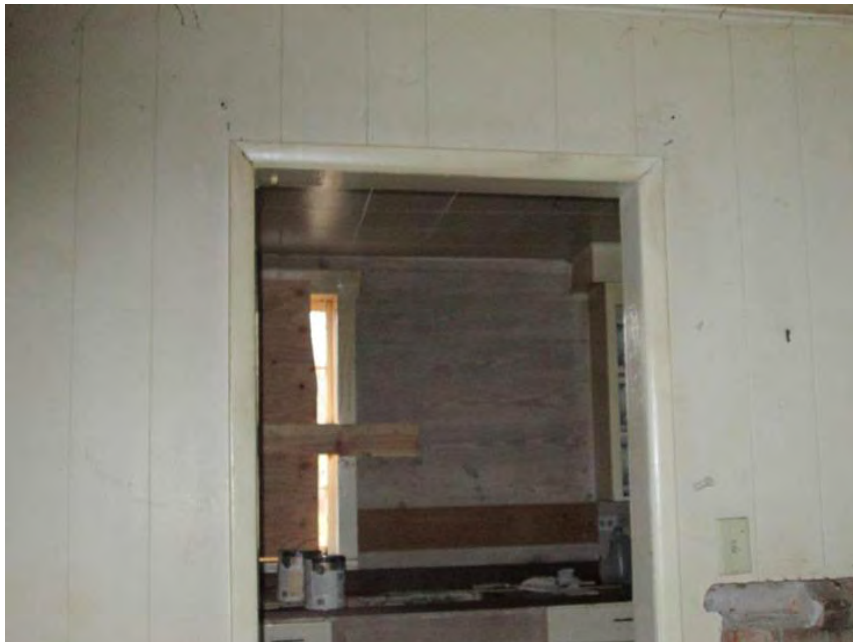
4918 LBP Survey 25, 26 -White Paint on Entrance Way Frame

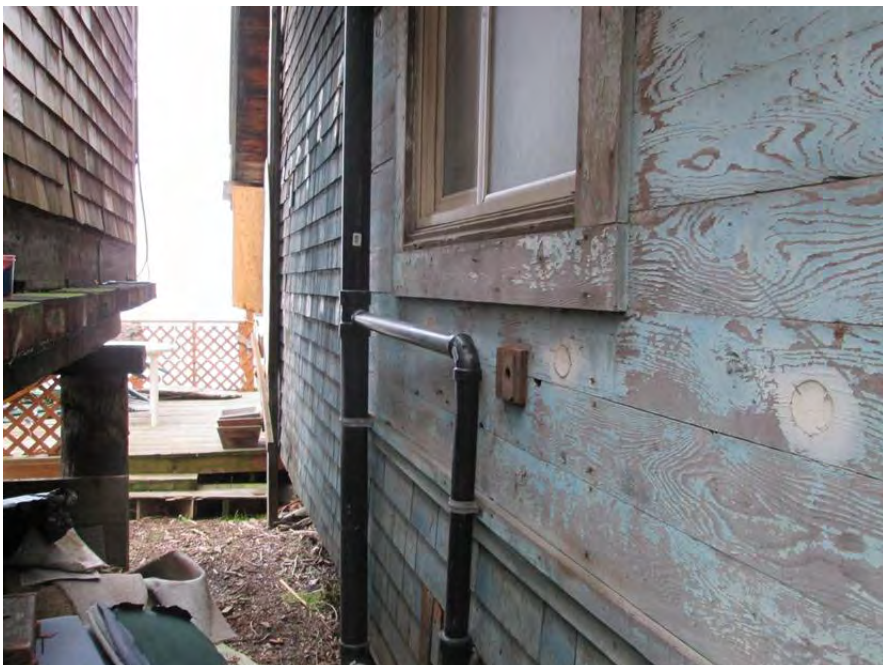
Photograph #12		Description

5024 LBP Survey 5 -Green Paint on Window Frame

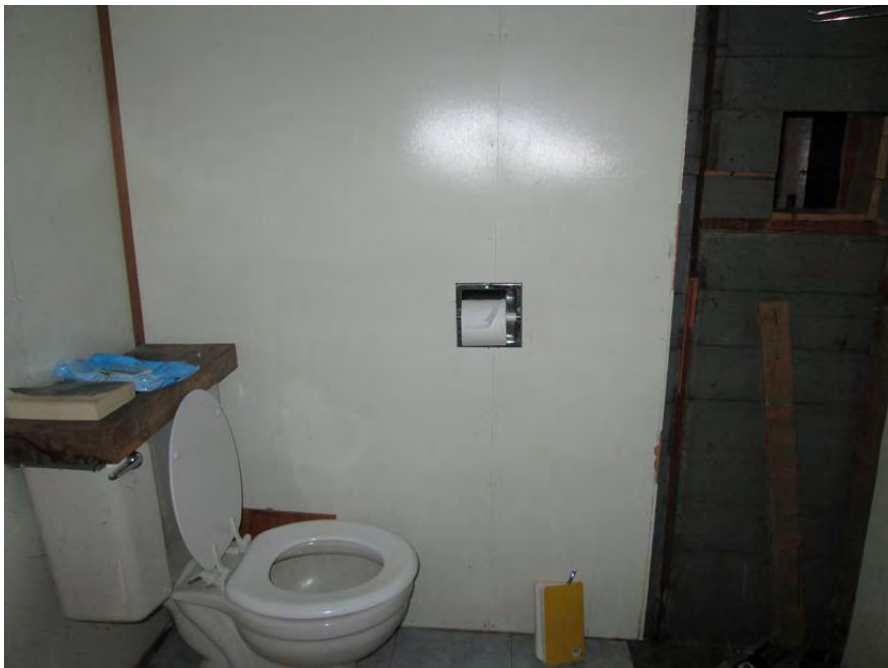
5024 LBP Survey 19, 45 -Gray Paint in Bathroom

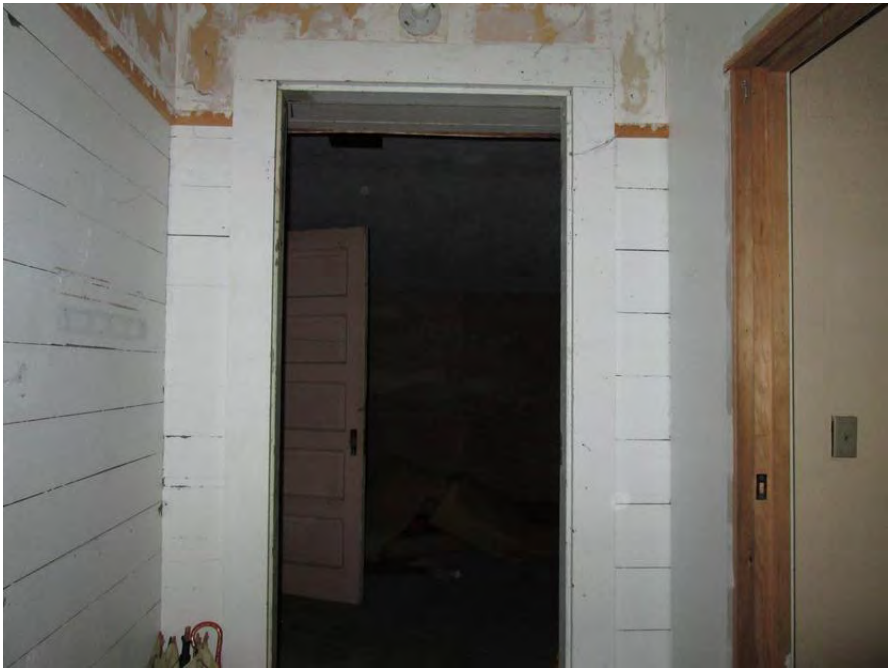
Photograph #14		Description

5024 LBP Survey 22 -White Paint in Entrance Way

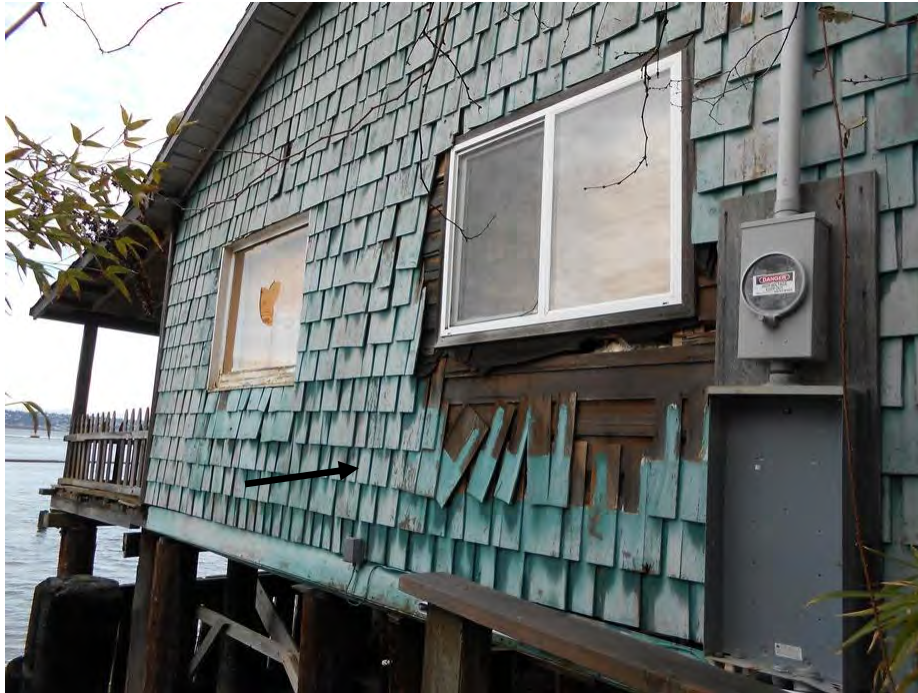
1. Sample 4918-22514-1 Green Shingles

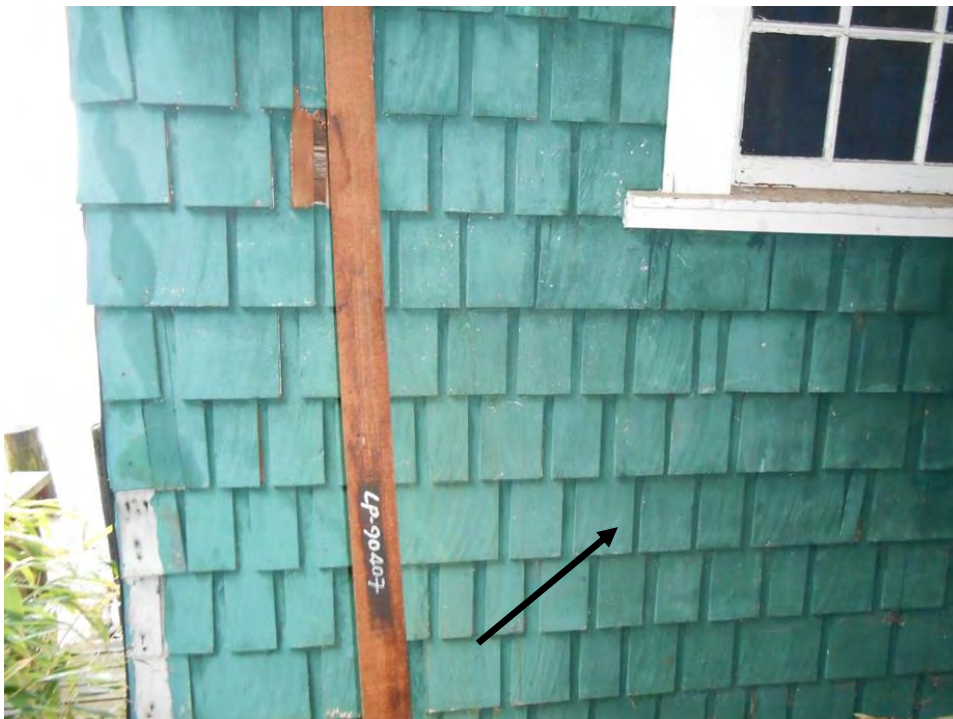
2. Sample 4918-22514-2 Green Shingles

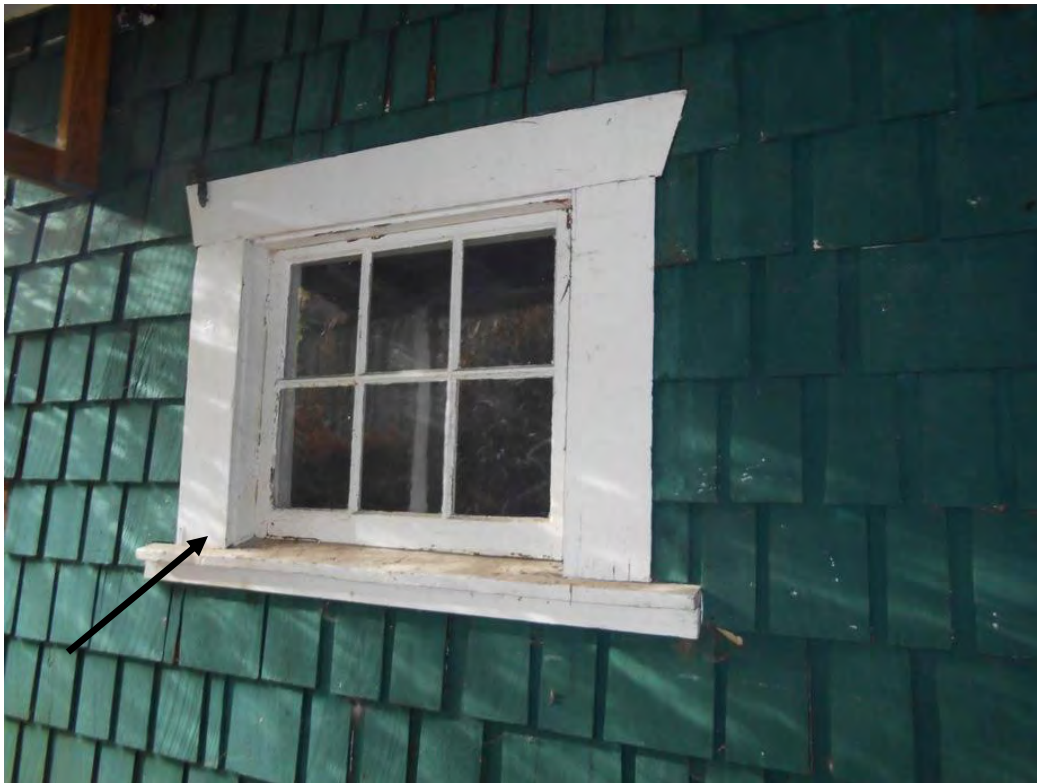
3. Sample 4918-22514-3 White Window Framing

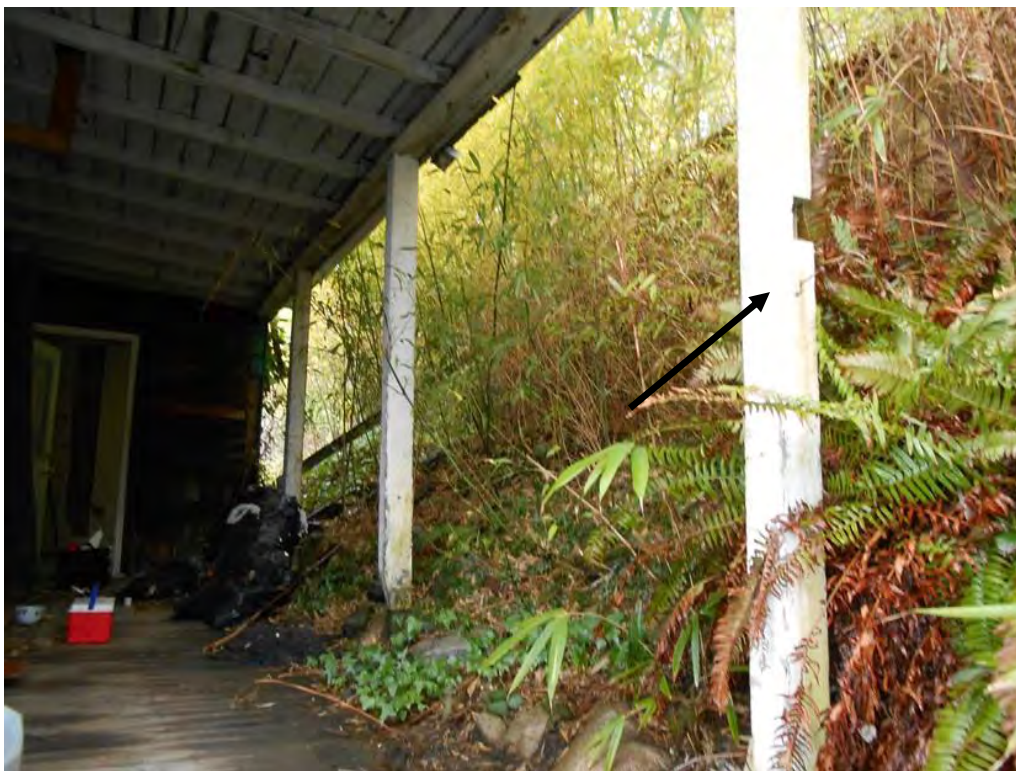
4. Sample 4918-22514-4 White Posts

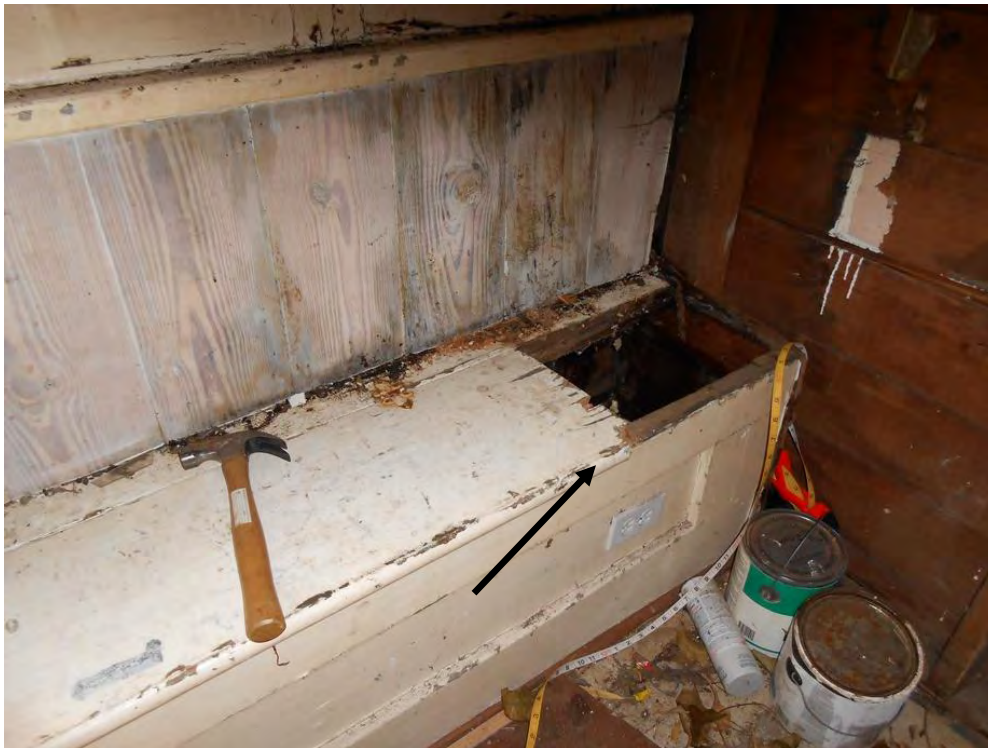
5. Sample 4918-22514-5 Bench

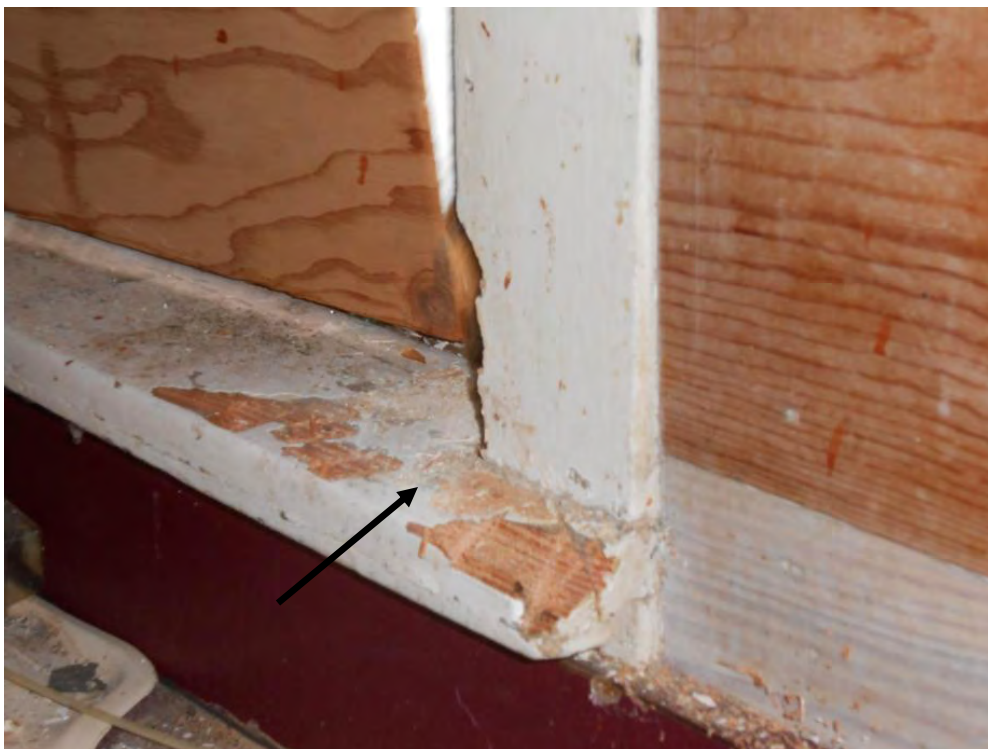
6. Sample 4918-22514-6 Window Framing

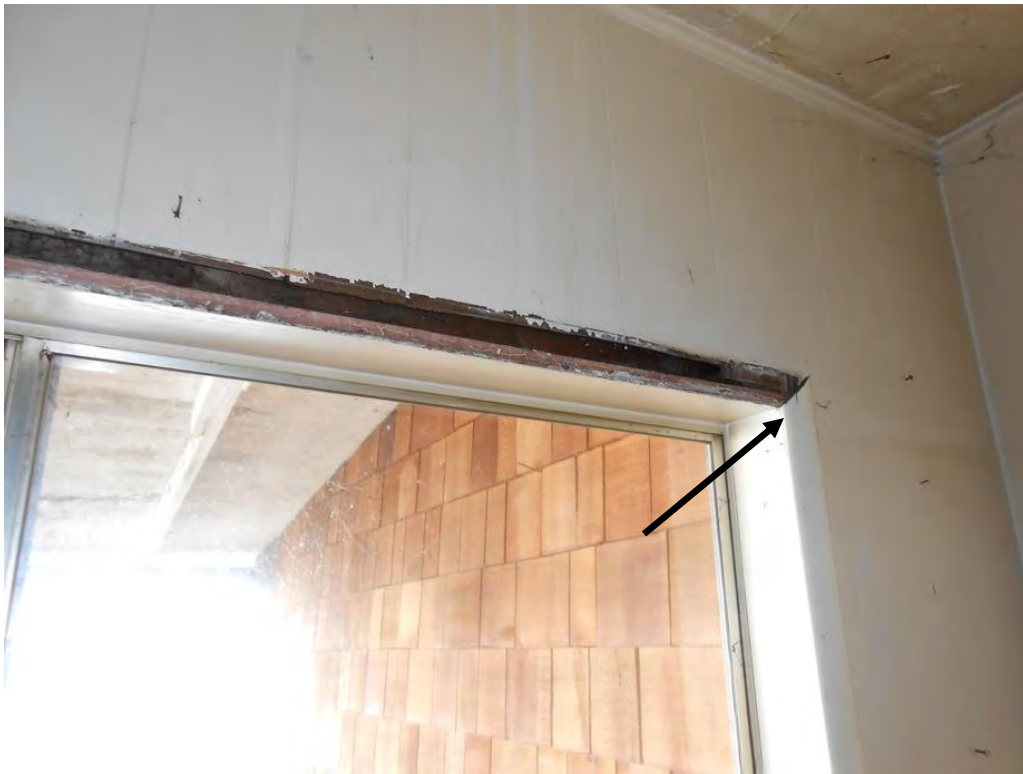
7. Sample 4918-22514-8 Window Framing

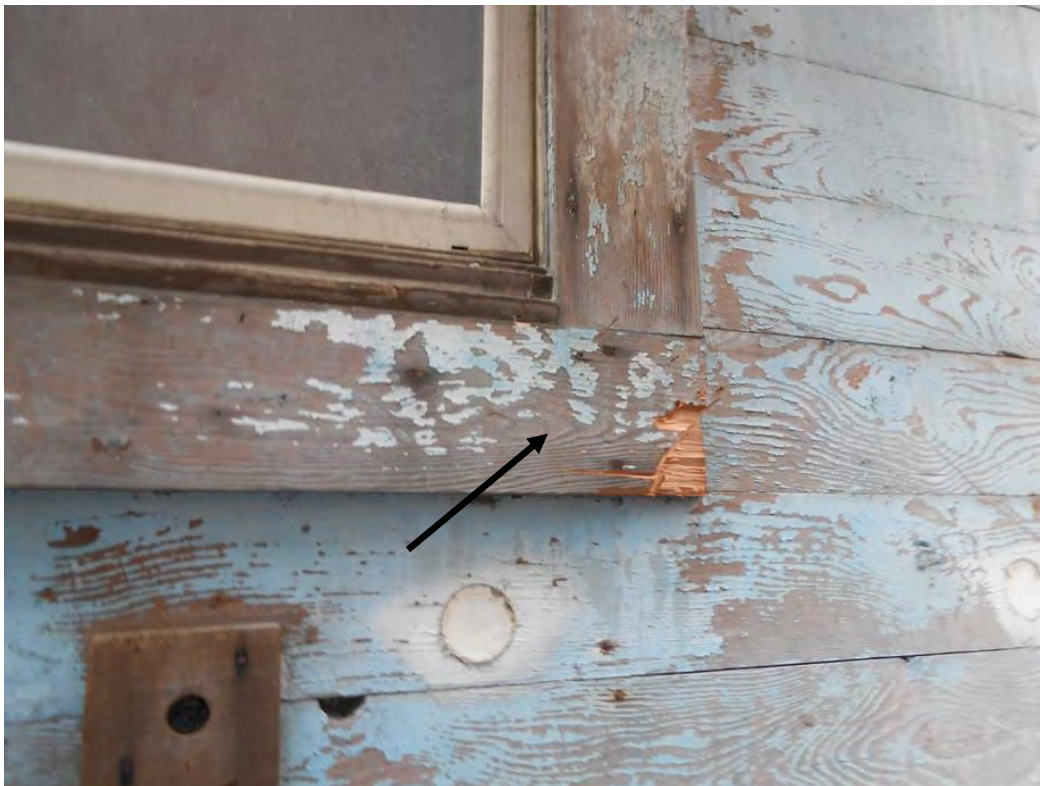
8. Sample 5024-22514-1 Window Framing

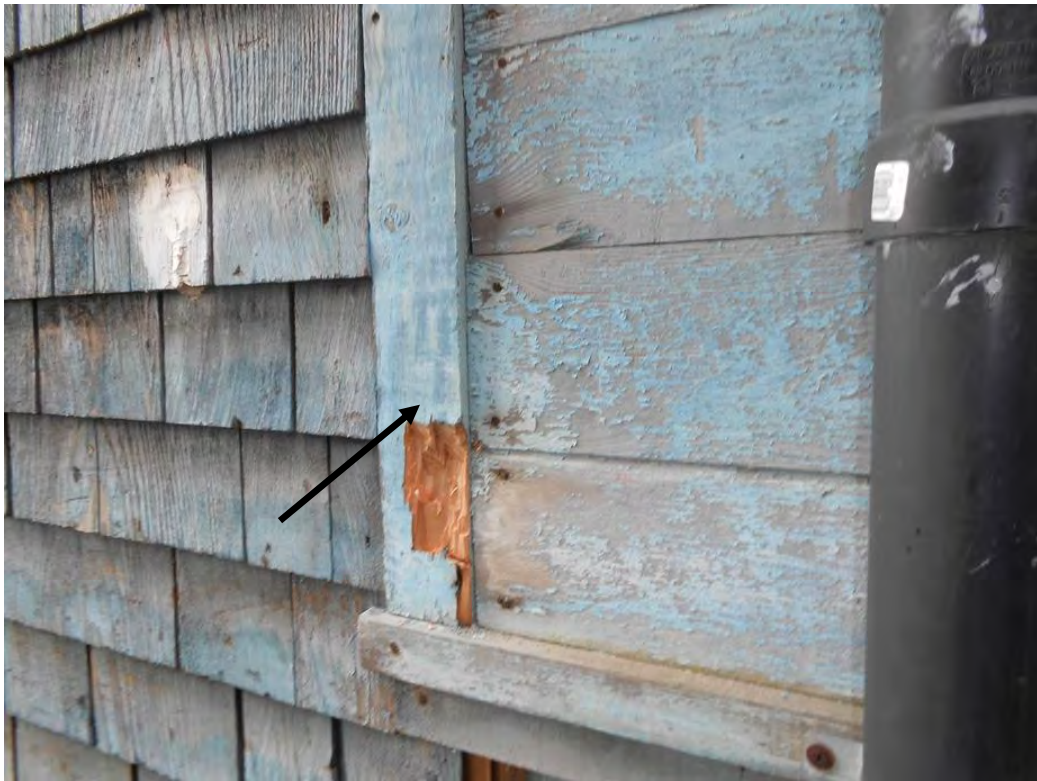
9. Sample 5024-22514-2 Window Framing
